# Case Study: Oso, Washington, Landslide of March 22, 2014—Material Properties and Failure Mechanism

Timothy D. Stark, F.ASCE<sup>1</sup>; Ahmed K. Baghdady, S.M.ASCE<sup>2</sup>; Oldrich Hungr, M.ASCE<sup>3</sup>; and Jordan Aaron, S.M.ASCE<sup>4</sup>

**Abstract:** This paper describes investigation, testing, analysis, and slope history used to determine the two-phase failure mechanism involved in the 2014 landslide near Oso, Washington. The first phase involves a slide mass located above the frequent landslides in the lower portion of the slope and extends to near the slope crest. This slide mass had a large potential energy, which moved downslope, and pushed the water-filled colluvium that had accumulated along the slope toe across the valley, resulting in it flowing almost 1.5 km. Evacuation of the Phase I slide mass left the upper portion of the slope unbuttressed and oversteepened, causing a second landslide (Phase II) but it primarily remained on the source slope because the back edge of the Phase I slide mass prevented further movement and the dense and unsaturated upper soils did not undergo a significant strength loss like the water-filled colluvium. DOI: 10.1061/(ASCE

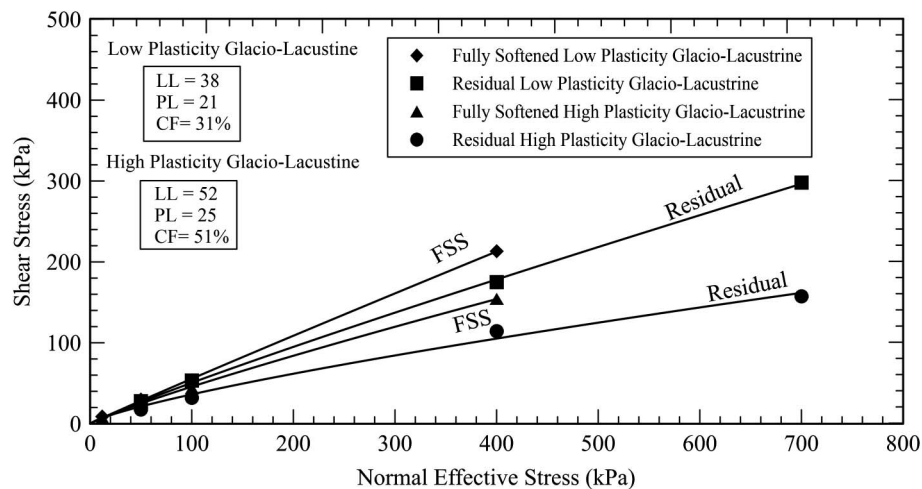
**Fig. 3.** Fully softened and residual strength envelopes for advanced glaciolacustrine clay deposits

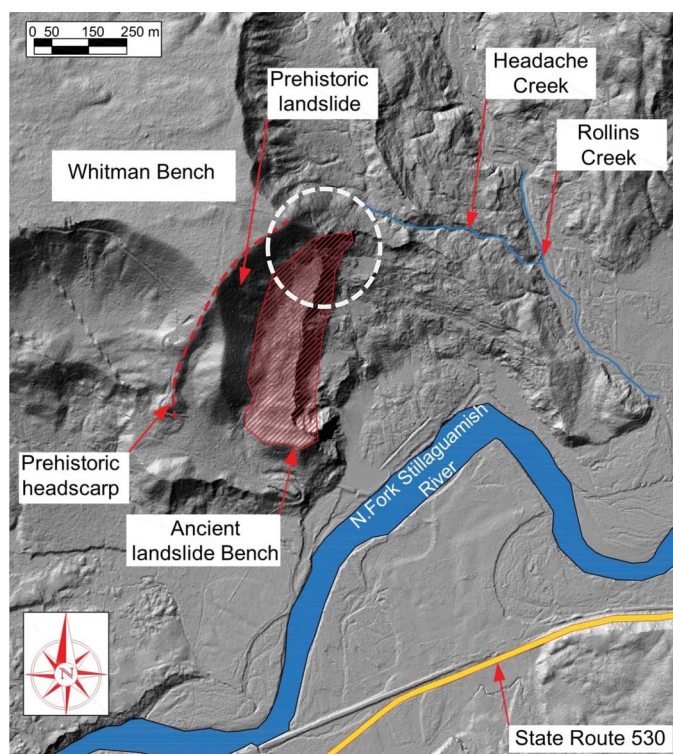
**Fig. 4.** 2013 LiDAR-derived topography showing the Oso, Washington, landslide in context with the Ancient Landslide Bench (base courtesy of Puget Sound Lidar Consortium)

The occurrence of a large prehistoric landslide at the location of the 2014 landslide is important because it created the Ancient Landslide Bench shown in Fig. 4 that supported and protected the Whitman Bench from landslides in the lower portion of the slope primarily caused by river toe erosion and precipitation. Based on the geometry of neighboring high-elevation landslides also shown in Fig. 4, it is anticipated that the ancient landslide at this location occurred through the weak varved lacustrine layers in the upper portion of the advanced glaciolacustrine deposit and evacuated some of the overlying Whitman Bench. After this landslide,

the lower portion of the slope (see dashed white circle in Fig. 4) and provided little support to the overlying Whitman Bench in 2014, compared with the wide bench at the western end. The eastern portion of the Ancient Landslide Bench was significantly narrower than the western end because the river flows almost directly north into the slope at the eastern end and then runs parallel to the slope toe toward the west, causing more erosion and landslides on the eastern side than the western side. For example, Fig. 7 shows the river cutting deeper into the slope on the eastern end than the western end in 1947, 1951, 1965, and 2006 based on the river location obtained from aerial photographs in these years. Fig. 8 shows the northward progression of the scarps into the Ancient Landslide Bench on the eastern end from 1967 to 2013, which left the Whitman Bench slope marginally supported after the 2006 landslide.

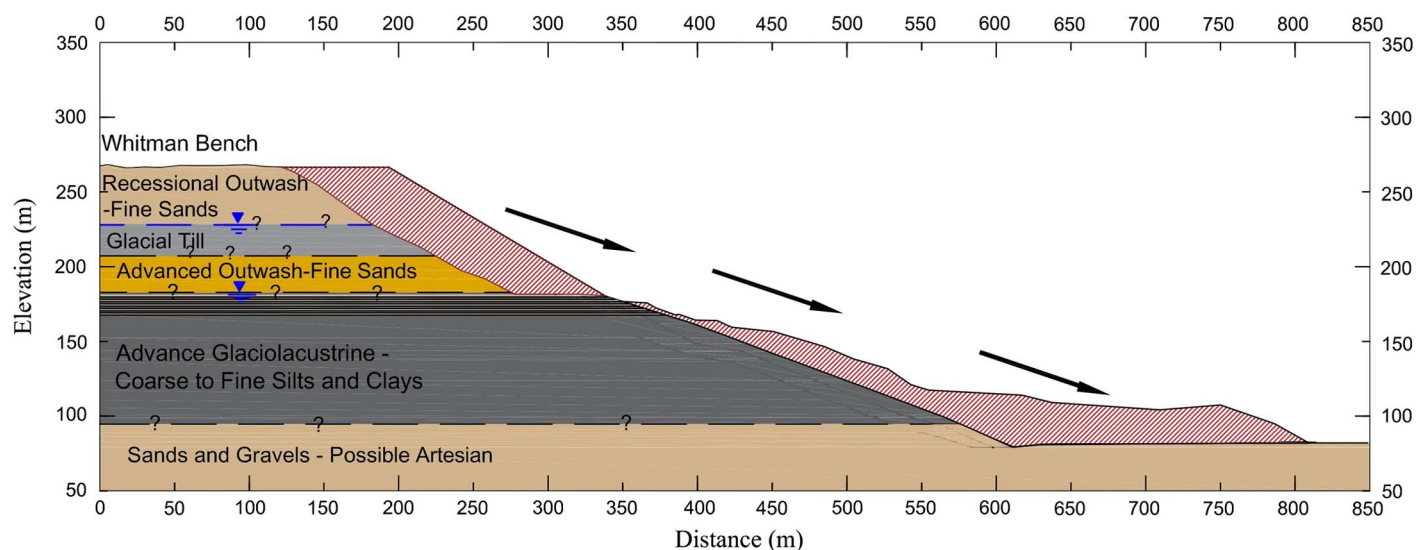
a bench or ledge was created that supported the overlying Whitman Bench slope (Fig. 5) and protected the Whitman Bench from oversteepening by landslides in the lower portion of the slope primarily caused by river toe erosion until after 2006.

**Fig. 5.** Hypothesis of prehistoric landslide showing depletion zone, slide mass in valley, and landslide bench near the top of the upper glaciolacustrine deposit based on LiDAR image in Fig. 4 at cross section location shown in Fig. 1

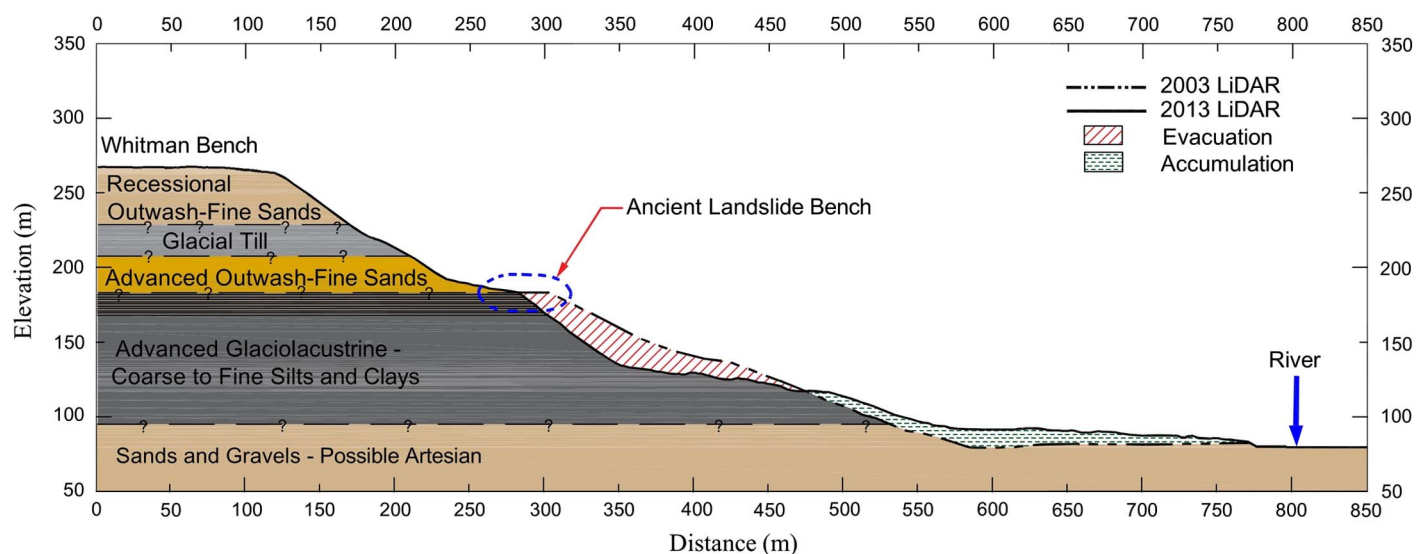
Fig. 6 presents the slope cross section shown in Fig. 1 and the difference in slope topography from the 2003 and 2013 LiDAR images. Using the difference in topography from 2003 and 2013,

**Fig. 6.** Differences in surface topography between 2003 and 2013 and locations of the depletion and accumulation zones for the 2006 landslide at the cross-section location shown in Fig. 1

the depletion and accumulation zones for the 2006 landslide were determined and are shown in Fig. 6. These zones show that the source of the 2006 landslide mass is the advanced glaciolacustrine deposit and the resulting colluvium moved the river to the southern extent of the accumulation zone. This is important for concluding that the Stillaguamish River erosion did not contribute to the 2014 landslide because the river was pushed significantly south (horizontal distance of approximately 800 m in Fig. 6) of the Ancient Landslide Bench (horizontal distance of approximately 300 m in Fig. 6) after the 2006 landslide. More importantly, the colluvium from the 2006 landslide added to the existing colluvium that had accumulated along the slope toe.

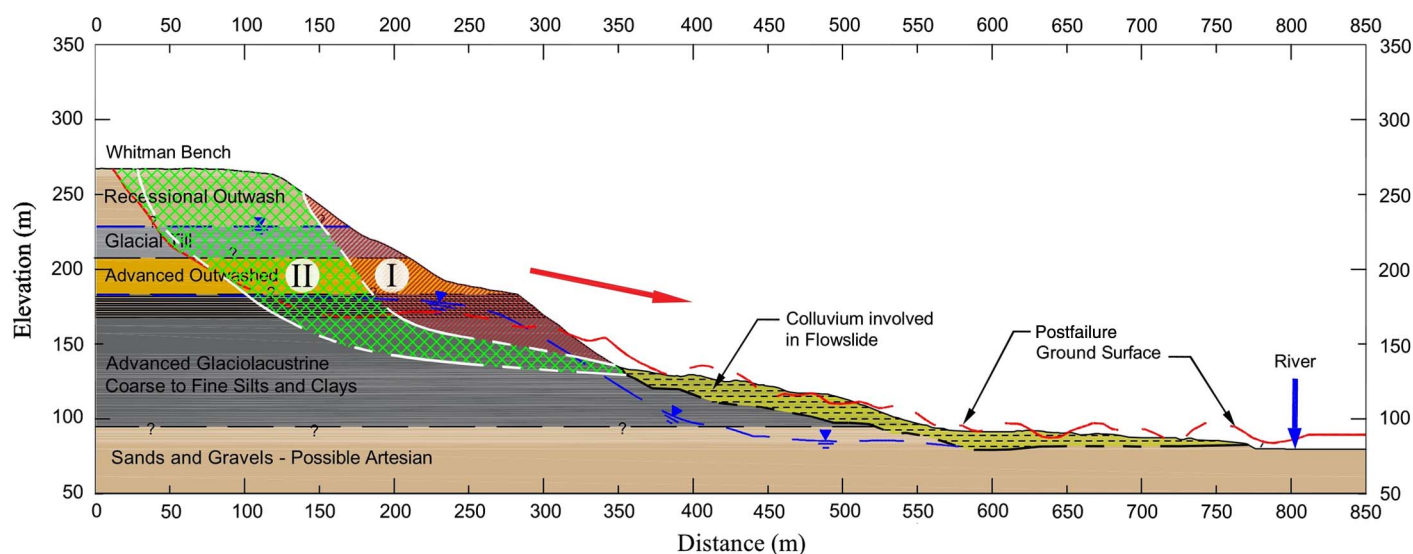
Based on inverse 2D limit equilibrium stability analyses using the software packages *SLIDE* and *SLOPE/W* and the soil properties in Table 2, Fig. 9 shows the probable failure surface for the initial instability that triggered the first phase (Phase I) of the 2014 two-phase failure mechanism. This instability initiated in the eastern portion of the Ancient Landslide Bench slope (Fig. 7) where the

**Fig. 9.** Two-phase failure mechanism prior to 2014 landslide with the Phase 1 failure surface based on field observations and inverse slope stability analyses at cross section location shown in Fig. 1

bench had been oversteepened by prior sliding in the lower portion of the slope. The failure surface in Fig. 9 is based on field observations and inverse stability analyses that yielded a factor of safety of approximately unity for a variety of compound failure surfaces and piezometric levels estimated from the inverse analysis of the 2006 landslide.

In summary, Fig. 9 summarizes the two large slope movements involved in the two-phase failure mechanism, which was initially described in a 1 June 2015 *Seattle Times* newspaper article (Doughton 2015). The Phase I slide mass moved first with significant speed and momentum, as described by an eyewitness (described subsequently), and impacted the colluvium that had accumulated on the lower part of the slope. The Phase I slide mass impacted, pushed, and overrode the water-filled colluvium in front of it and caused the colluvial flow slide that moved rapidly across the river and the valley, entombed the unexpected neighborhood, SR530 highway, and beyond. The steep valley slope then remained unsupported and some 2 min later the Phase II slide mass slid down the cleared slope but did not move far because the materials were primarily unsaturated, dense, and frictional so it stopped at the back edge of the Phase I slide mass.
