GEOTECHNICAL RECONNAISSANCE OF THE 2011 FLOOD ON THE LOWER MISSISSIPPI RIVER

June 18, 2012

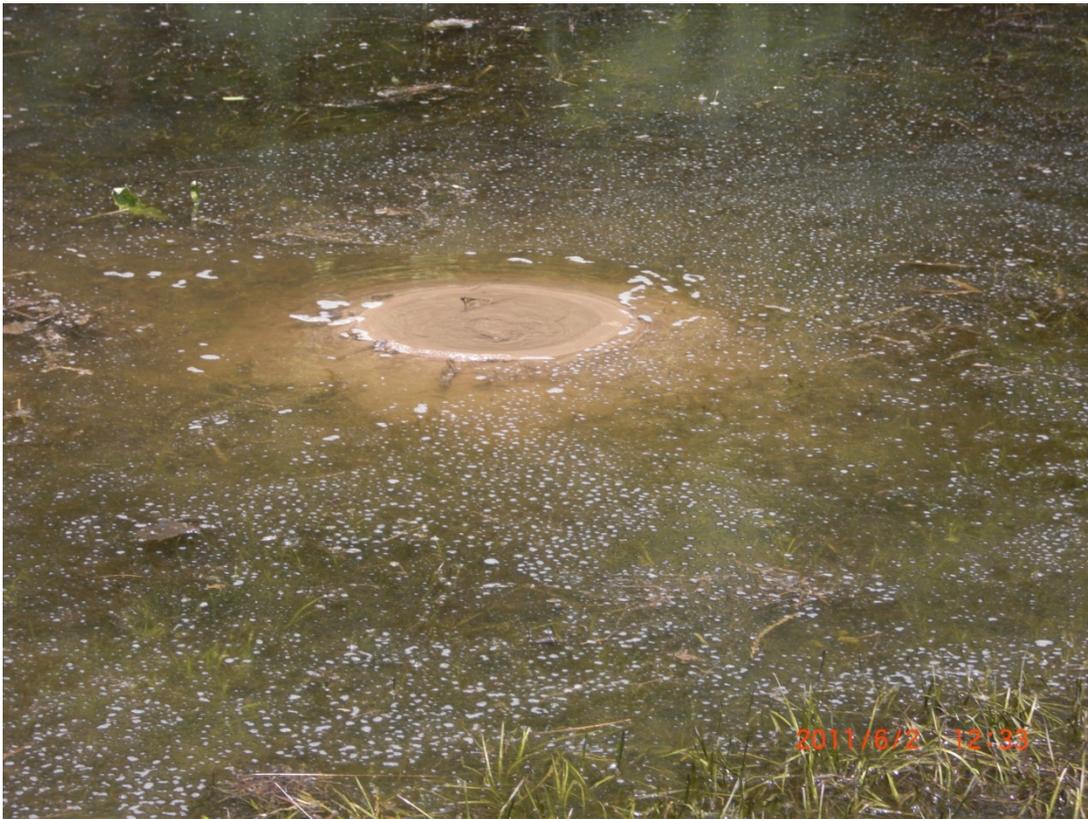
Sand Boil on Protected Side near Old River Lock, June 2, 2011

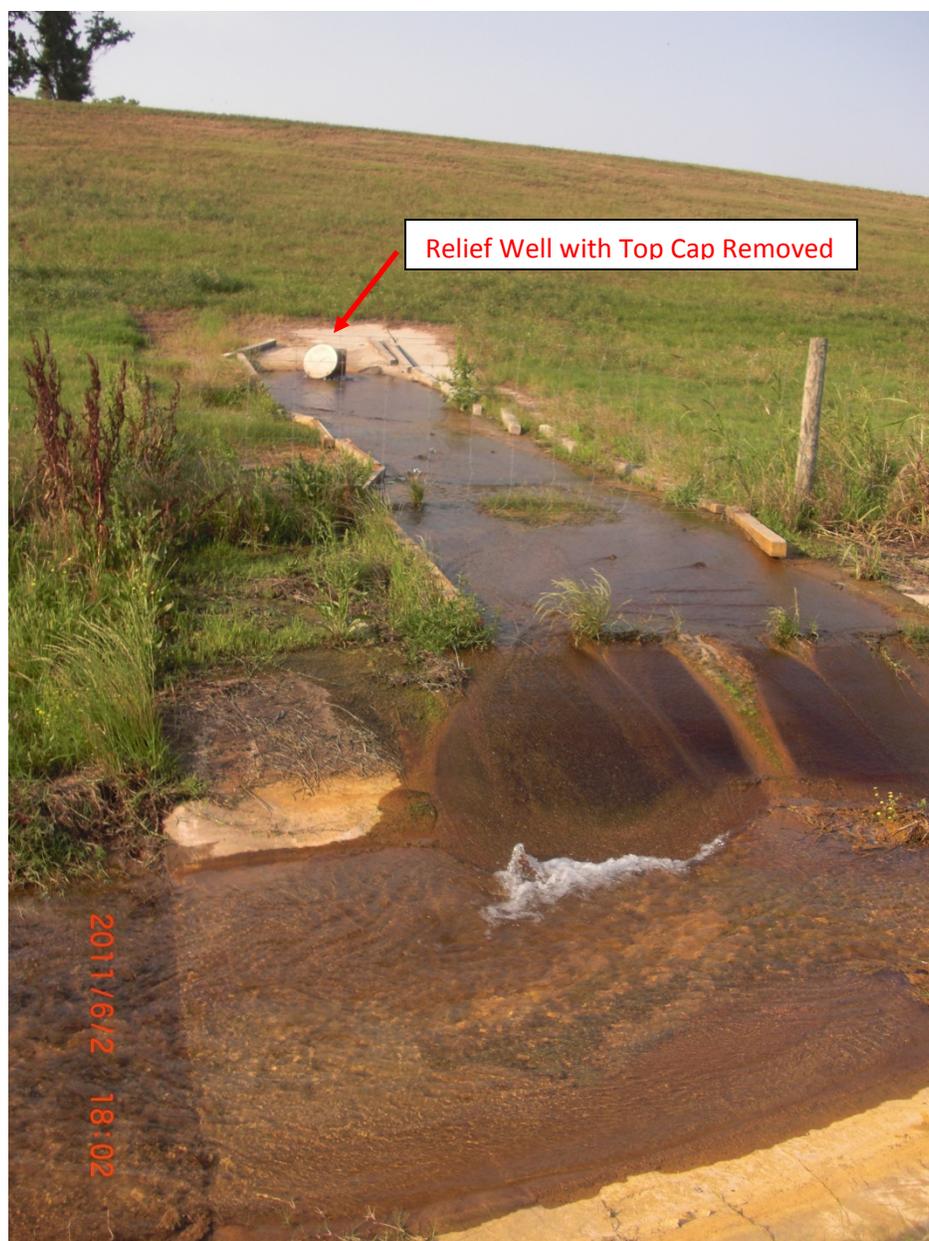
Figure 2.4 Relief well producing flow along 415 near Arbroth, Louisiana on June 2, 2011

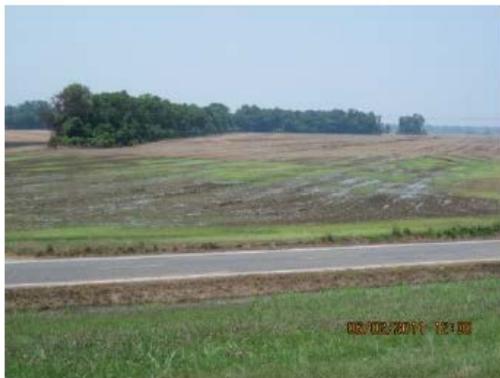
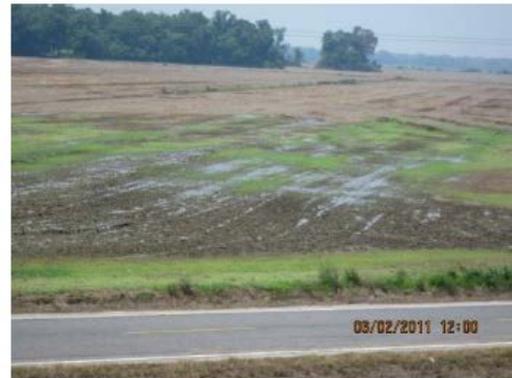
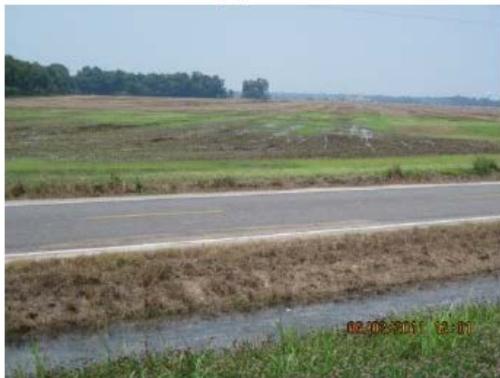
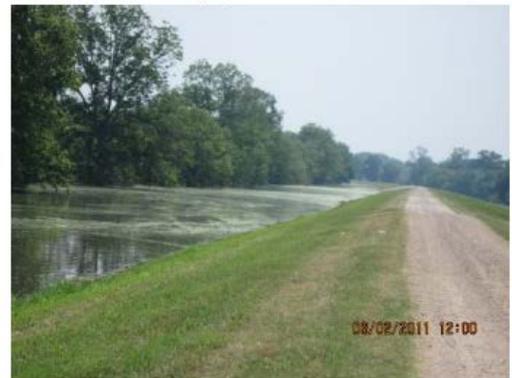
At a levee north of Baton Rouge, Louisiana (N 30° 50' 12.42" W 91° 38' 03.72" and see Figure 4.1 for location), "sheet" seepage was observed. The observed sheet seepage is shown in Figure 4.2 and corresponds to seepage over a larger area than a sand boil. Sheet seepage occurs at a low gradient over a large area with relatively uniform soil conditions because seepage is evident but sand boils are not developing. The sheet seepage corresponds to underseepage and not seepage through the levee because water is observed in the ditch at the toe of the levee and across the road from the levee but no seepage was observed on the dry side slope of the levee. The river level at this location was about six feet below the levee crest.

Figure 4.2 (a) Overview of sheet seepage from levee crest (note: no repair deemed necessary), (b) close-up of sheet seepage from levee crest, (c) drainage ditch at levee toe filled with water and sheet seepage visible on opposite side of road on Mississippi River Right Levee at River Mile 290 (N 30° 50' 12.42" W 91° 38' 03.72", 2 June, 2011 at 12:00 pm), and (d) Mississippi River level at this location

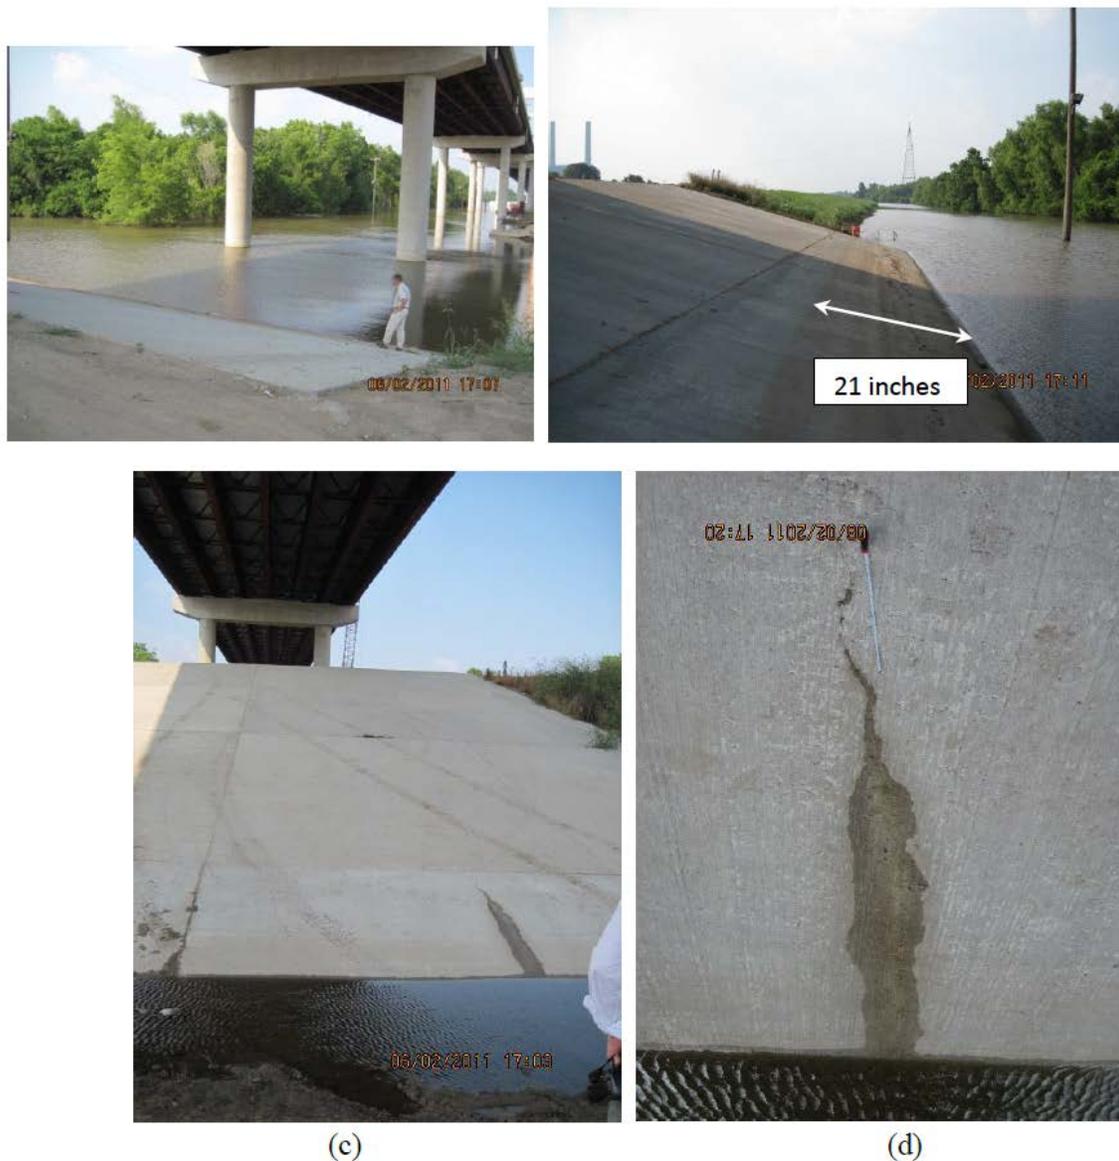
This example of emerging seepage is interesting because the presence of a concrete apron on the dry side of the levee made the emerging seepage readily visible and its location easily recordable. Thus, this location is suitable for investigating partially saturated seepage through levees and in particular, how quickly the wetting front migrates through a partially saturated levee. The emerging seepage exited the levee and migrated through a small crack in the concrete apron (see Figures 4.3 (c) and (d)).

Figure 4.3 (a) Overview of Mississippi River level under the John James Audubon Bridge, (b) close-up of Mississippi River side showing river level had dropped about two feet from its high water mark on the concrete apron (see double-sided arrow), (c) overview of emerging seepage from downstream side of levee, and (d) close-up of emerging seepage through concrete apron (see tape measure for scale) on Mississippi River Right Levee at River Mile 262 (N 30° 43' 05.04" W 91° 21' 31.14", 2 June, 2011 at 17:00 – 17:20)

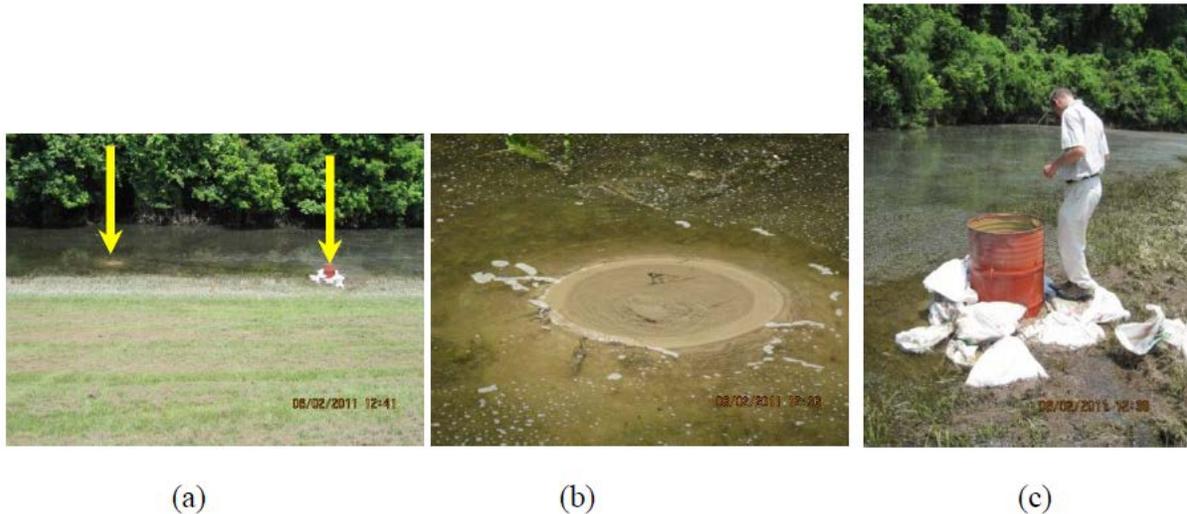
protected side toe of the levee. The sand boils are shown in Figure 4 and one of the boils had already been stabilized with sand bags. In addition, a steel drum had been installed on top of the sand boil to reduce the hydraulic gradient at the exit point. Shortly after then GEER Team's visit, a ring of sand bags was placed around the other sand boil to prevent the erosion of foundation materials. The two sand boils are located directly in line with some nearby utility poles and may be the location of prior utility poles or where the effectiveness of the natural fine-grained blanket was reduced by some other means.

Figure 4.4 (a) Overview of sand boil and remediated sand boil at toe of levee just down river from Old River Navigation Lock sheet seepage from levee crest, (b) closeup of unremediated 12 inch sand boil, and (c) closeup of remediated sand boil with sand bag ring and metal drum to reduce uplift pressure and erosion of foundation soils at levee toe on Mississippi River Right Levee at River Mile 304 (N 30° 59' 57.66" W 91° 40' 43.14", 2 June, 2011 at 12:41 pm)

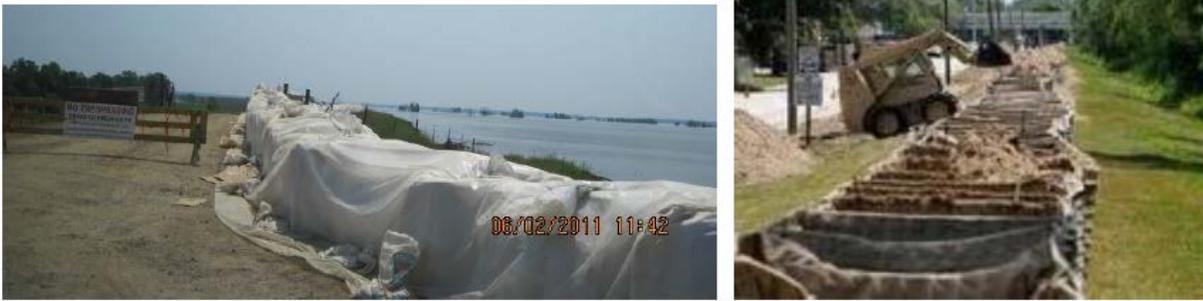
At the time of the GEER Team visit, the Mississippi River level was within three feet of the top of most levees which is the design freeboard. However, in a few locations, the levee height was less than the design freeboard of three feet due to levee settlement or the area had not been raised to provide three feet of free board. In these areas, sand bags or Hesco® baskets were placed to increase the freeboard as shown in Figure 5. Hesco® baskets are about three feet high so the baskets are used in areas where levee height has to be increased significantly. Figure 4.5(a) shows Hesco baskets covered with plastic sheeting being used to increase levee height near the north end of the Morganza Flood Control Structure. Hesco® baskets were also used on the south end of the Morganza Flood Control Structure to increase the levee freeboard. Figure 4.5(b) shows a row of Hesco® baskets being filled by National Guard troops in Louisiana.

Figure 4.5 (a) Hesco baskets used to increase levee height near the north end of the Morganza Flood Control Structure on Mississippi River Right Levee near River Mile 280 (N 30° 46' 33.30" W 91° 37' 09.42", 2 June, 2011 at 11:42 am) and (b) Hesco baskets being filled (photo from communities.washingtontimes.com)

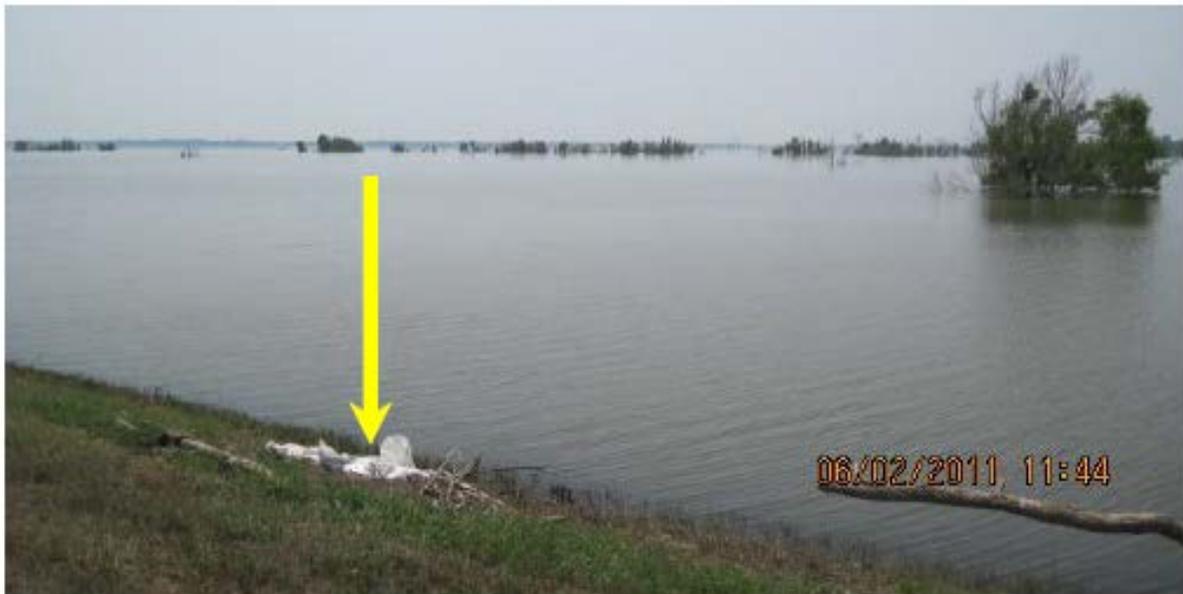
In a number of locations, burrowing and rooting animals and erosion due to river wave action caused damage to a levee. The Corps identified twenty-six (26) Inspection Hot Spots for burrowing animals and eight (8) locations for levee erosion. Sand bags were commonly used to temporarily protect the flood side of the levee in these areas as shown in Figure 4.6.

Figure 4.6 Sand bags being used to control damage due to wave action along the levee approaching the northern end of the Morganza Flood Control Structure on Mississippi River Right Levee near River Mile 280 (N 30° 46' 33.30" W 91° 37' 09.42", 2 June, 2011 at 11:44 am)

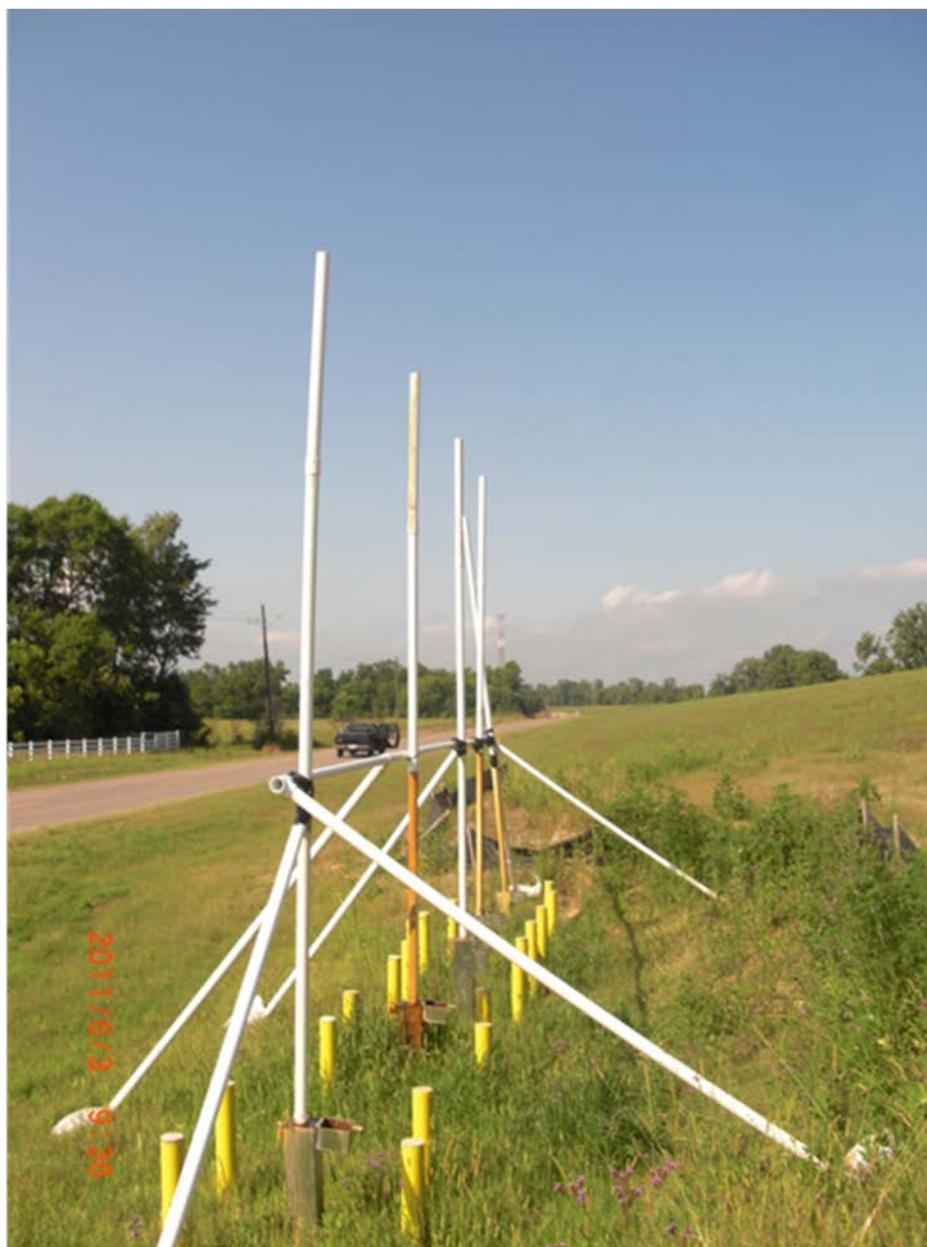
Because Duncan Point is an area of recurring seepage and sand boils, the Corps has heavily investigated this area and also installed piezometers with tip elevations of -5, -35, -80, -150, and -300 feet referenced to the NAVD88 datum. All of the piezometers, except the one with a tip elevation of -300 ft, fluctuate with the Mississippi River level. Figure 4.8 presents a generalized cross-section of the levee and foundation soils at the Duncan Point location. Seepage reoccurs here because the “natural levee” (see Figure 4.8), i.e., the natural fine-grained blanket, is thinner at this location which results in a higher exit gradient and increases the chance for sand boils. The piezometric measurements show a head drop of six to twelve ft across the fine-grained blanket. This head drop is based on a maximum river elevation of 44 ft (levee crest and toe elevations are about 52 and 25 ft as shown in Figure 4.8). The piezometers in Figure 4.9 had to be extended during this flood event from elevation 32 ft to 38 ft because water was pouring out the piezometers onto the levee toe. Extending the piezometers from elevation 32 ft to 38 ft ceased the flow of water indicating that the piezometric level at the downstream toe is between 32 ft and 38 ft, or seven to 13 feet above the levee toe.

Figure 4.9 (a) Overview of five piezometers installed at Duncan Point and temporary standpipe extensions to estimate piezometric head at levee toe on Mississippi River Left Levee at River Mile 225 (N 30° 23' 09.84'' W 91° 12' 53.76'', 3 June, 2011 at 09:36)

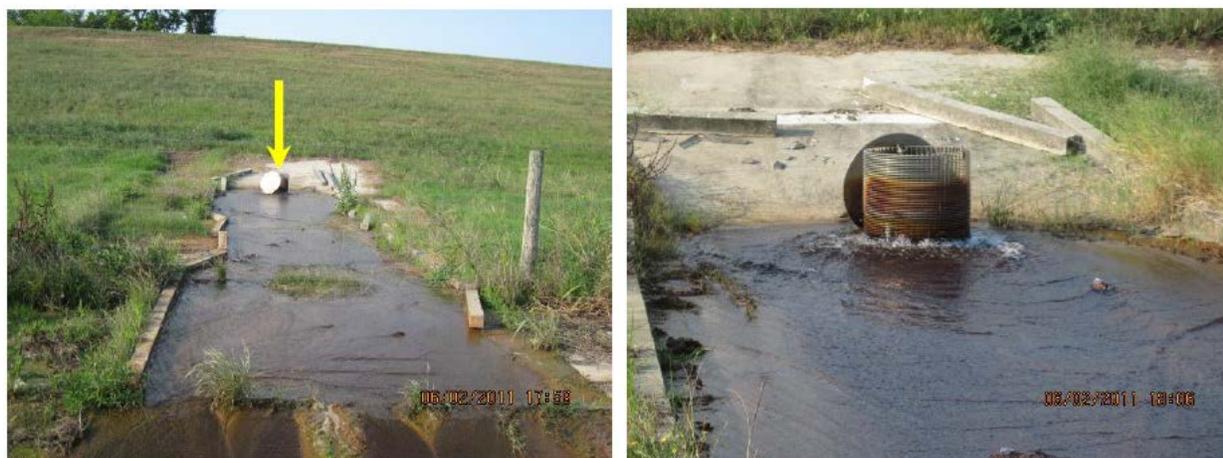
The GEER Team visited two locations where relief wells were installed by the USACE New Orleans District to reduce piezometric heads at the dry side toe to reduce the potential for erosion. At both locations the relief wells were flowing rapidly with no sign of fines in the water. Figure 4.10 presents an overview of one of the flowing relief wells and a close-up that illustrates the active seepage condition.

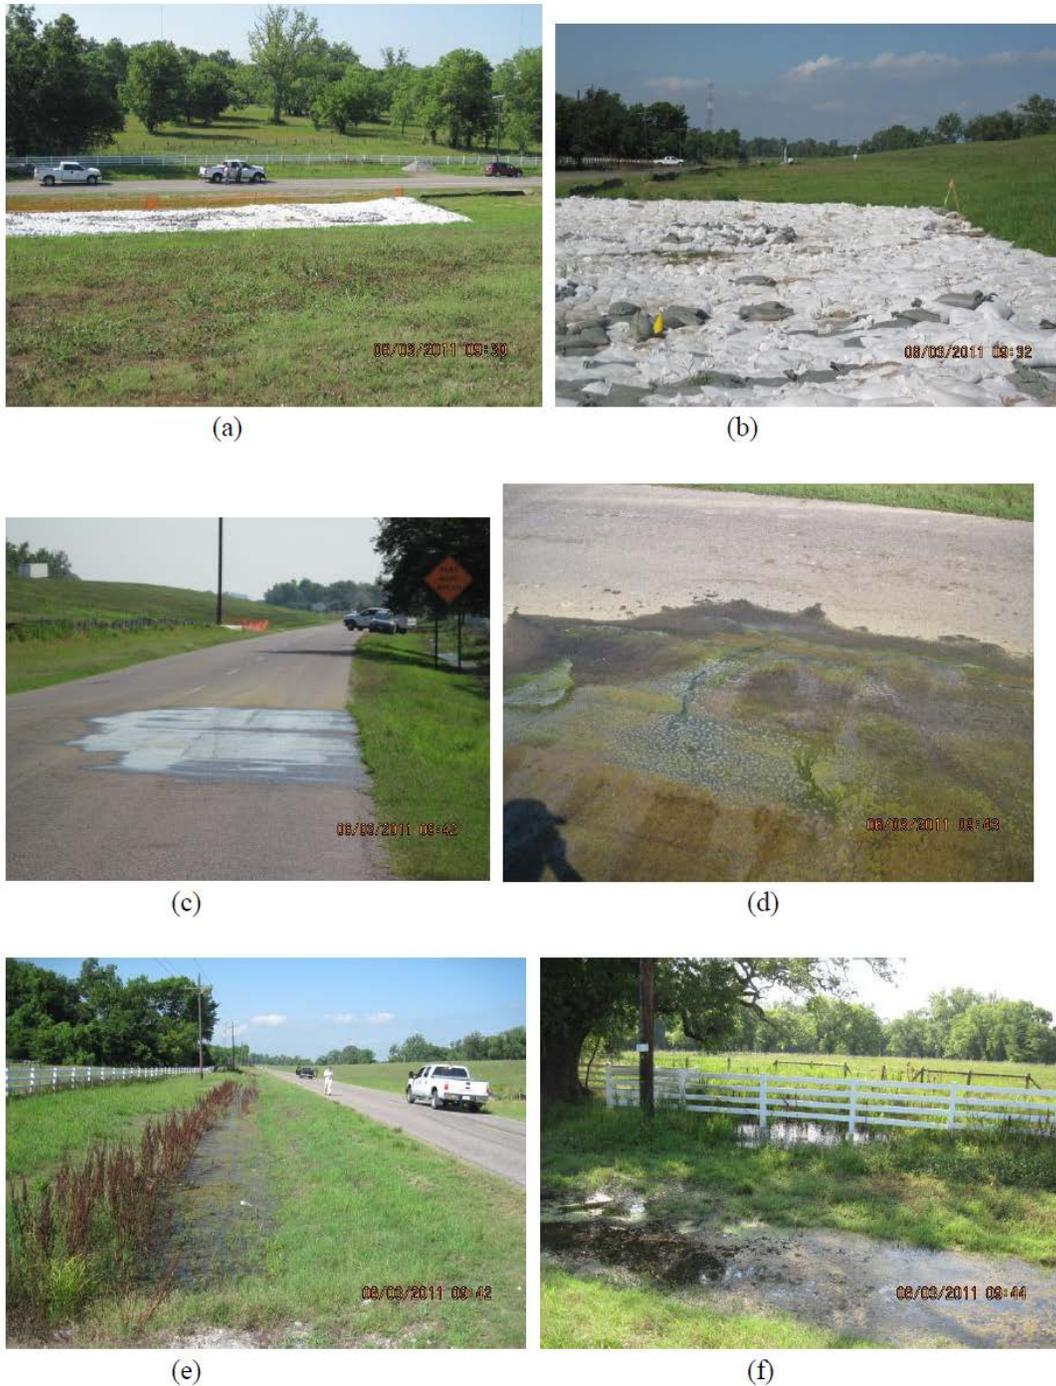
The Duncan Point area is a High Priority Inspection Hot Spot because it is an area of recurring seepage and sand boils. In 2010 an interim stabilization berm was constructed because of continued seepage issues during high water events. A more robust berm is planned to be constructed in the near future. This new seepage berm will be about ten feet higher than the interim berm and extend across the current roadway which is shown in Figure 4.11(a). The roadway will be relocated on top of the higher seepage berm.

Figure 4.11 (a) Overview of seepage berm, (b) close-up of recently placed sand bags to increase the length of the seepage berm because of underseepage on the protected side of the levee, (c) isolated seepage exiting on to roadway pavement through cracks in pavement, (d) close-up of seepage existing through pavement cracks, (e) seepage occurring in ditch on opposite side of roadway from levee, (f) close-up of seepage in adjacent field with roadway ditch at Mississippi River Left Levee at River Mile 225 (N 30° 23' 09.84" W 91° 12' 53.76", 3 June, 2011 at 08:42)

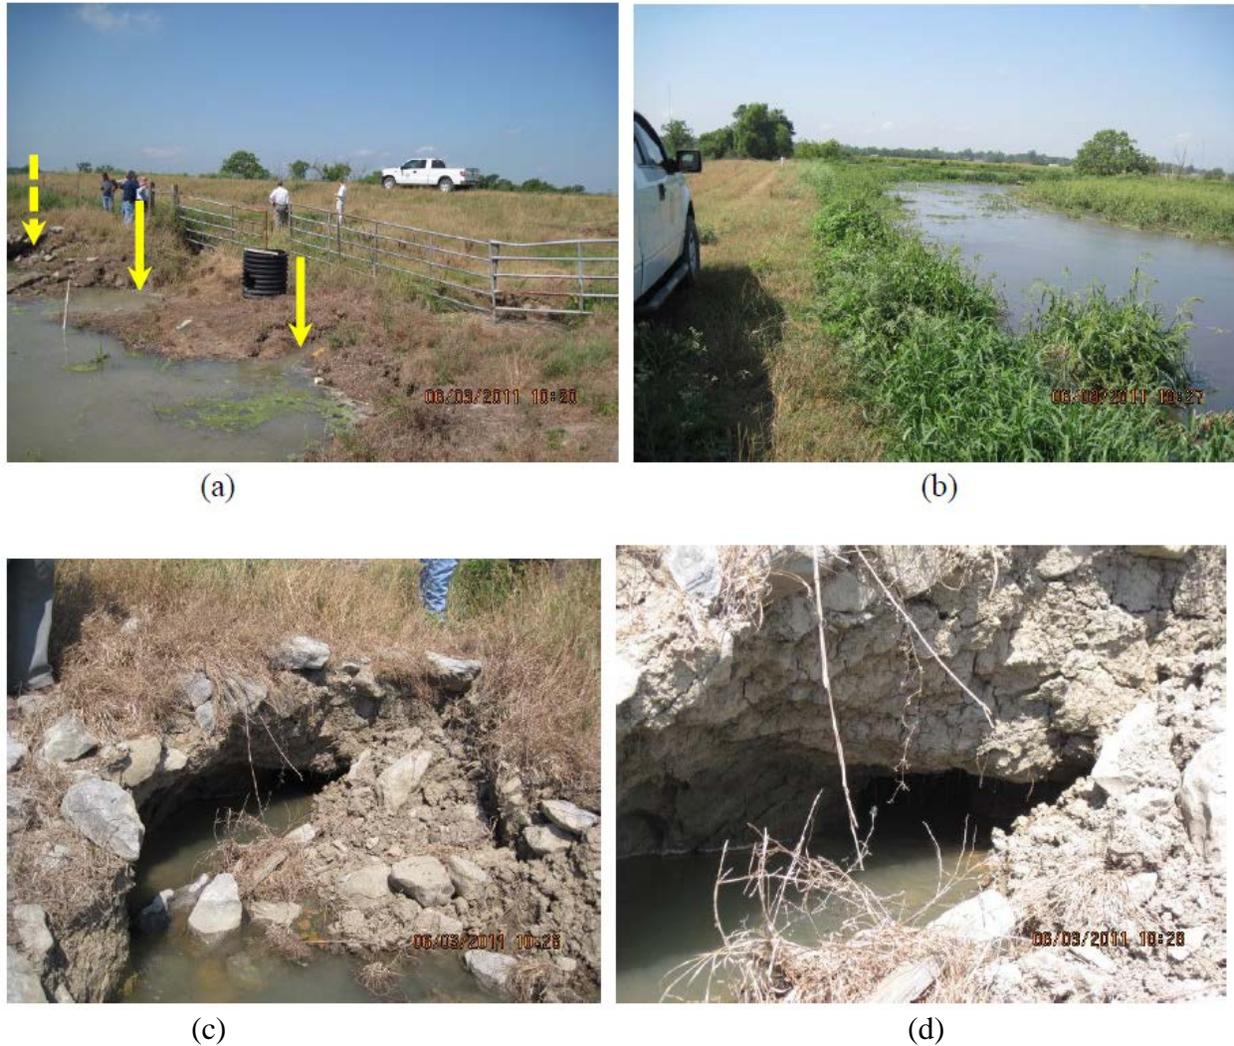
The first distant sand boil location discussed is at the LSU Farms. This site is located about 2,800 from the Mississippi River Levee (MRL). There are five or six well defined sand boils located in the bank of the LSU drainage canal that were flowing clear. Figure 4.12(a) gives an overview of the three largest sand boils. The flow from these sand boils appears to be clear but the cloudy water of the drainage channel makes it difficult to assess the seepage. In addition, there are several small boils in the bottom of the canal that are flowing cloudy water.

An employee of LSU Farm indicated that sand boils have appeared at this site since 2008. The site does not appear to be a threat to the MRL because it is nearly 3,000 feet from the levee. However, at least one of the sand boils had resulted in considerable erosion (see dashed arrow in Figure 4.12(a)) which could undermine the levee for the adjacent LSU oxidation pond which is about 60 ft away (see Figure (b)). The truck shown in Figure 4.12(a) is parked on the crest of the oxidation pond levee. The LSU employee also indicated that the level of the pond had not changed significantly since the sand boils started flowing in 2011 so the seepage is probably due to the Mississippi River and not leakage from the oxidation pond.

Figure 4.12 (a) Overview of three large sand boils in a drainage canal at the LSU Farm site with the dashed arrow indicating the sand boil used for the close up photographs in Figures 12 (c) and (d), (b) close-up of LSU oxidation pond upslope of the drainage canal which gives an indication of pond level, (c) close-up of large sand boil in Figure 12(a), and (d) close-up of sand boil in Figure 12(c) eroding and undermining fine-grained blanket which will eventually collapse into the drainage ditch at Mississippi River Left Levee at River Mile 227 (N 30° 24' 13.68" W 91° 11' 28.14", 3 June, 2011 at 10:20 – 10:27)

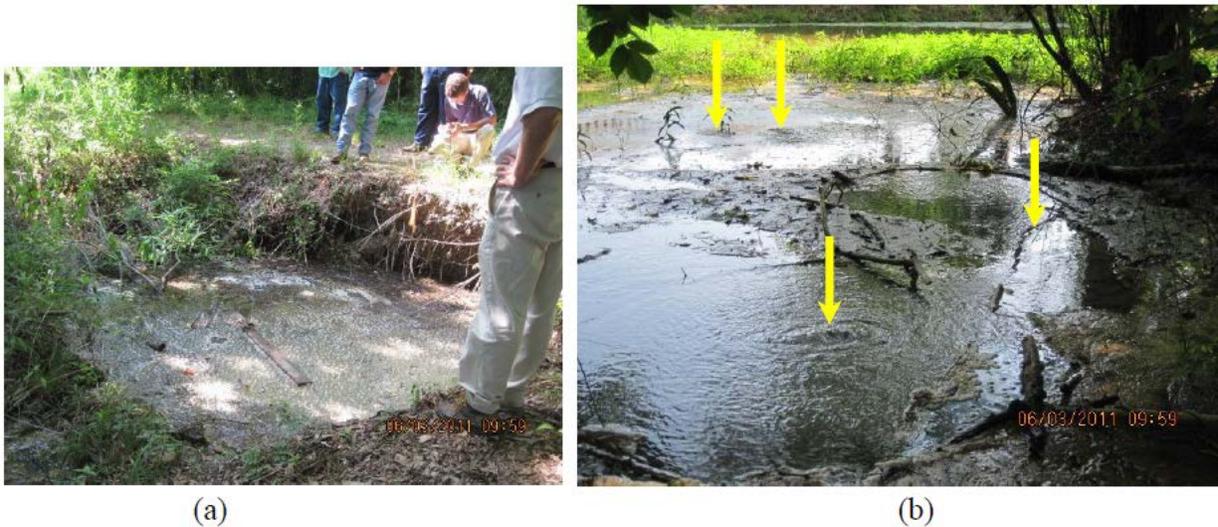
The second distant sand boil location discussed is behind the Farr Park horse training facility near LSU Farms. This site is located about 2,500 from the MRL and numerous flowing sand boils were observed in a drainage ditch behind an adjacent housing development. The largest sand boil is shown in Figure 4.13(a) and appears to be the prior location of a large tree. Many other sand boils were observed flowing in the adjacent drainage channel, some of which are identified in Figure 4.13(b).

Figure 4.13 (a) Overview of large sand boil at Farr Park and (b) close-up of various sand boils in adjacent drainage channel at Mississippi River Left Levee at River Mile 225 (N 30° 23' 0.0702" W 91° 12' 28.4472", 3 June, 2011 at 09:59)

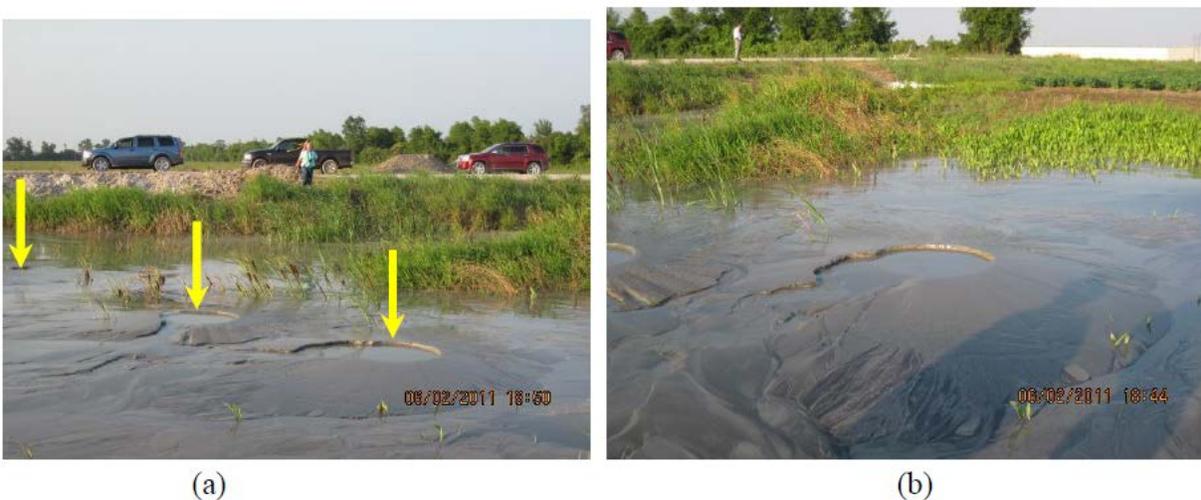
The third and most interesting distant sand boil location observed is on Sun Plus Road, which is located in a farm field nearly 2 miles from the Mississippi River Levee and about 1,500 feet from the spur of a navigation canal (Figure 4.7). At this location, there is a six-foot diameter sand boil eroding fine sand from below the fine-grained blanket which is supporting the farming operation (Figure 4.14). In addition, water was observed existing about 3 inches below the crest of the gravel road in Figure 4.14(a), which is above the level of the sand boil in the foreground. It is possible that the gravel embankment for the road extends below the natural fine-grained blanket and provides a vertical conduit for the underseepage to rise to within three inches of the roadway crest.

Figure 4.14 (a) Overview of large sand boil and (b) closeup of one of large sand boils at Sun Plus Road at Mississippi River Right Levee at River Mile 228 (N 30° 25' 45.18" W 91° 14' 05.64", 2 June, 2011 at 18:50)

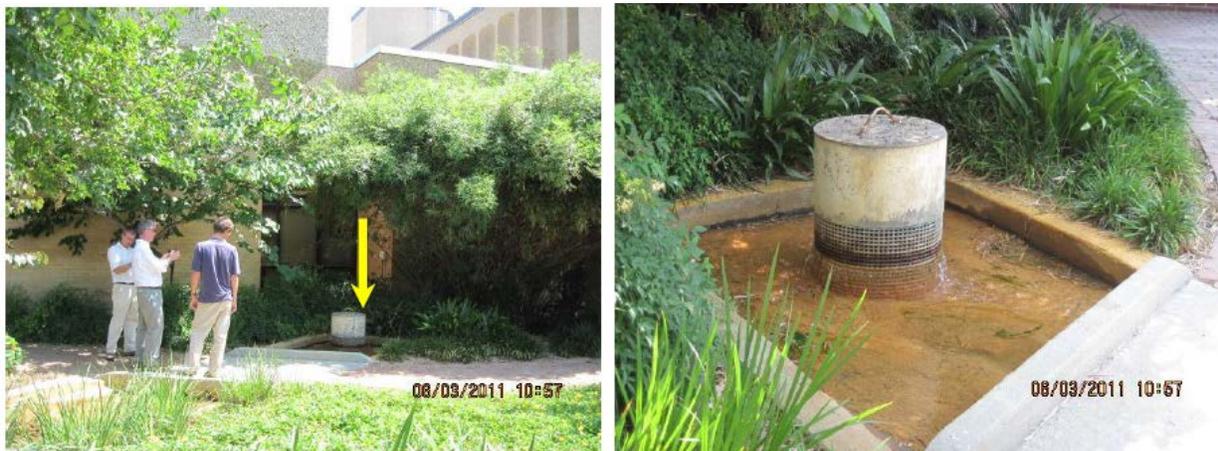
The GEER Team also visited Veterinary Medicine Building on the LSU Campus (see Figure 4.15). This is a non-typical use of relief wells in terms of levees because the relief wells were installed to relieve water pressures on the basement walls of the Veterinary Medicine Building. The Veterinary Medicine Building required a basement that placed its foundation below the natural levee, i.e., fine-grained blanket, so underseepage would be directly impacting the basement walls. To reduce the piezometric pressures and the likelihood of water entering the basement which is being used for the care of large animals, permanent relief were placed around the building. The flow from the well shown in Figure 4.15 is used to create the presence of a creek flowing through the garden area in front of the building and under the entrance sidewalk resulting in a pleasant entrance to the building. At the relief well shown in Figure 4.15(b), steady seepage was occurring with no sign of fines in the flowing water.

Figure 4.15 (a) Overview of LSU Veterinary Medicine Building and relief well adjacent to building and (b) close-up of relief well in Figure 15(a) in front of LSU Veterinary Medicine Building at Mississippi River Left Levee at River Mile 228 (N 30° 24' 47.77", W 91° 11' 38.29", 3 June, 2011 at 10:57)
