the RUMPKE *landslide*

**NEW
INFORMATION**

By W. Douglas Evans and Timothy D. Stark

On March 9, 1996, the largest slope failure in a municipal solid waste (MSW) landfill, based on volume of waste involved, occurred at the Rumpke Sanitary Landfill near Cincinnati. This case history provides many lessons to the solid waste industry, including the importance of operation, expansion, and stability of existing landfill slopes. The original reports of the waste slide appeared in *Waste Age* in April 1996 (p. 8) and July 1996 (p. 8).

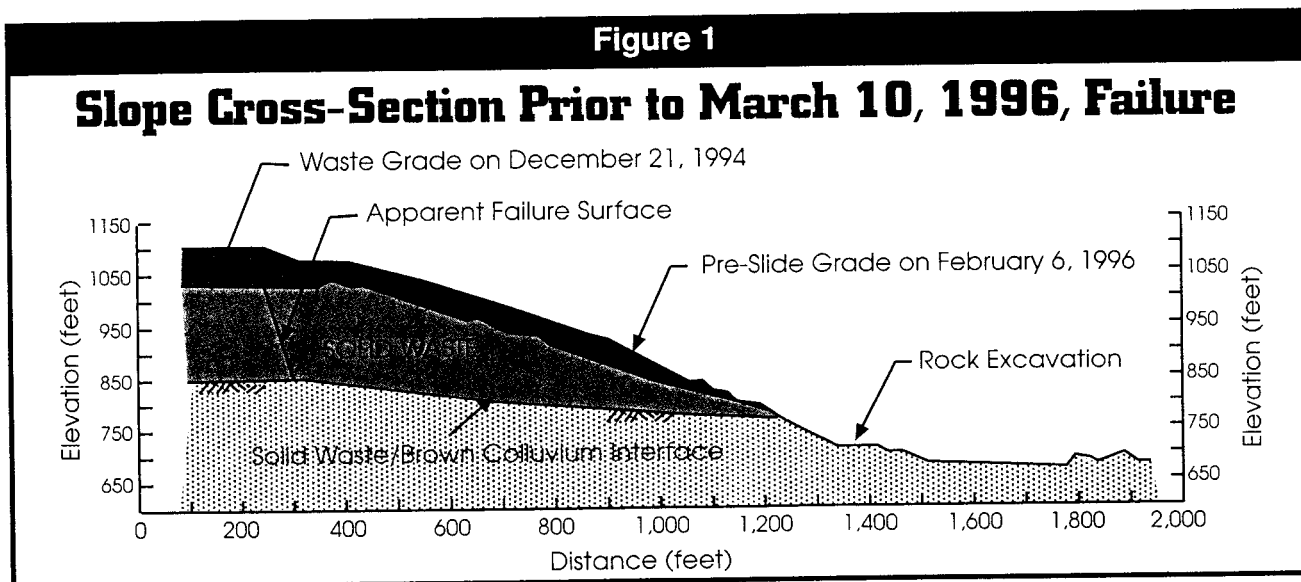
As part of the 1994 expansion permit, the maximum elevation of the landfill was permitted at +1065 feet. From Figure 1 it can be seen that the maximum elevation of the landfill was approximately +1105 feet on Feb. 6, 1996. In addition to exceeding the maximum elevation, the slope of the "grandfathered" area adjacent to the excavation was oversteepened. The average slope was 2.6 horizontal:1 vertical, but some portions of the slope were steeper than 1.85H:1V. In addition, a 15- to 20-foot-high nearly vertical excavation was constructed at the toe of the slope for a composite liner anchor trench and an access road. The impact of this overbuild and oversteepened slope on the stability of the slope are discussed subsequently.

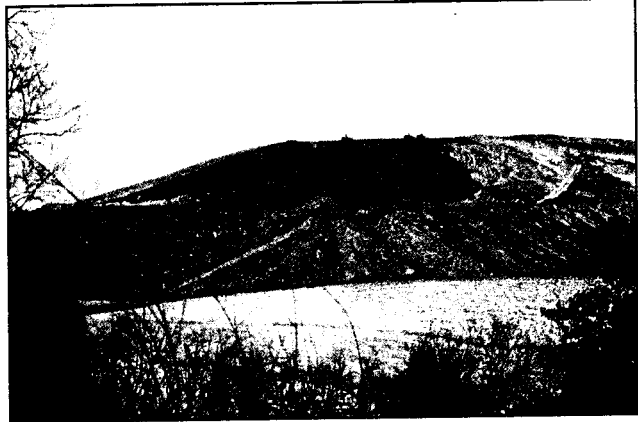
Figure 2

Failed slope and compactors at edge of scarp

on an adjacent slope; and the remainder of the overbuild was spread throughout the site. As a result, the slope that failed was overbuilt by approximately 957,000 cu. yds. Figure 1 presents a cross-section of the slope prior to failure. The two slope grades represent the waste grade on Dec. 21, 1994, (approximately 15 months prior to the slide) and Feb. 6, 1996, (approximately one month prior to the slide). A comparison of these two grades indicates that a large amount of waste was placed on the slope and at the top of the landfill between Dec. 21, 1994, and Feb. 6, 1996. Therefore, it may be concluded that the majority of the approximately 957,000 cu. yds. of overbuild occurred in the 12 to 18 months prior to the failure. In fact, immediately after the slide, three compactors were located at the edge of the scarp (Figure 2). One of these com-

pactors was so close to the scarp that it had to be pulled, instead of driven, away from the edge.

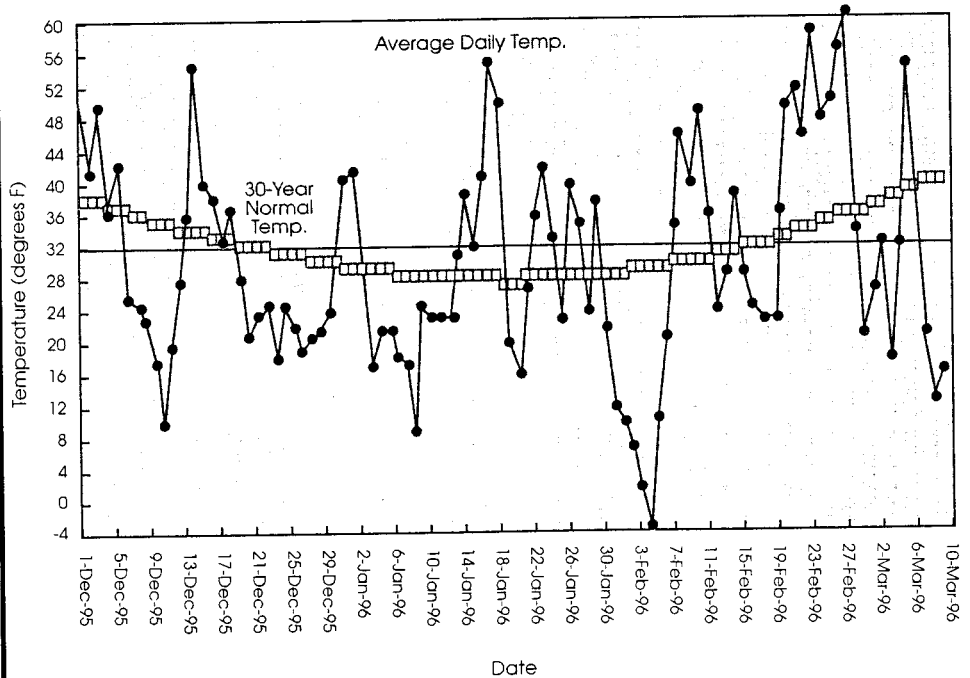
Figure 3 summarizes the weather station data from the Greater Cincinnati airport. It can be seen that between Dec. 1, 1995, and March 9, 1996, each cold period was

Average & Normal Daily Temperatures at the Greater Cincinnati Airport

followed by a warm period. Therefore, there was no extended cold period in the three months prior to the wastelide. In fact, during this three-month period the number of days at or above freezing (32 degrees F) and below freezing were 44 and 55, respectively. In addition, the average daily temperature appears to follow the 30-year normal daily temperature except from Feb. 19 to March 4, 1996. From Feb. 19 to 28, all of the average daily temperatures were above freezing and ranged from 34 to 60 degrees F. On Feb. 26 and 27, approximately 1.1 inches of rainfall occurred in the Cincinnati area. These warm temperatures and rainfall would have reduced and possibly eliminated any frost penetration. From Feb. 29 to March 4, the site experienced subfreezing temperatures between 18 and 32 degrees F. (Cracking was first observed at the top of the landfill on March 4.) Therefore, it appears doubtful that the frost penetration remaining, if any, on Feb. 28 and the frost penetration possibly created from Feb. 29 to March 4, could have blocked a substantial amount of fluid or leachate at the toe of the slope.

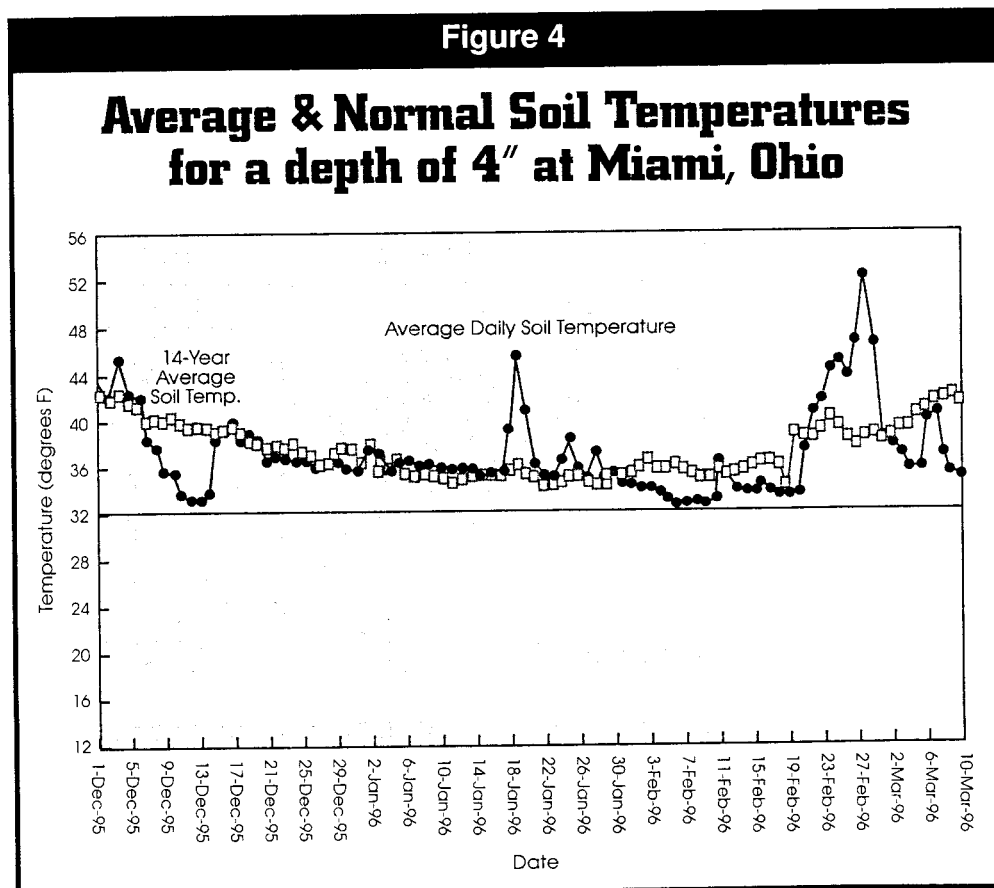
Figures 4 and 5 summarize the soil temperature

data from the Miami, Ohio, recording station that is approximately 17 miles northwest of the Rumpke Sanitary Landfill. Figure 4 presents the soil temperature data at a depth of 4 inches. It can be seen that at no time during the three months prior to the March 9 wastelide did the soil temperature at a depth of 4 inches drop below freezing (32 degrees F). In addition, the soil temperature data appears to follow the 14-year average for this site. Figure 4 presents the soil temperature data at a depth of 2 inches. It can be seen that between Dec. 9 and 12, 1995, and between Feb. 4 and 7, 1996, the average daily soil temperature dropped slightly below freezing. From Feb. 19 to March 9 the soil temperature at a depth of 2 inches was significantly above freezing. In addition, the soil temperature is significantly higher than the 14-year average soil temperature from Feb. 19, 1996, to March 8. The data in Figures 3 through 5 do not support the claim that frost penetration reached a depth of about 1 foot throughout the three months prior to the wastelide.

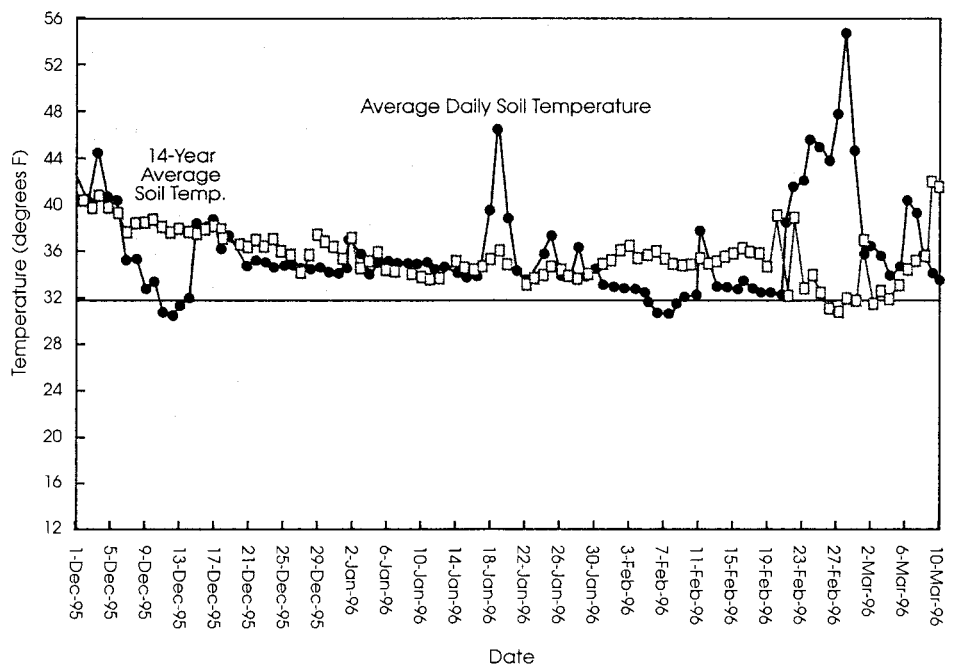
Figure 5
Average & Normal Soil Temperatures for a depth of 2" at Miami, Ohio
