# LESSONS LEARNED FROM AN IMPOUNDMENT SLOPE FAILURE INVOLVING GEOSYNTHETICS

by K.E. Nay, T.D. Stark, and W.D. Evans

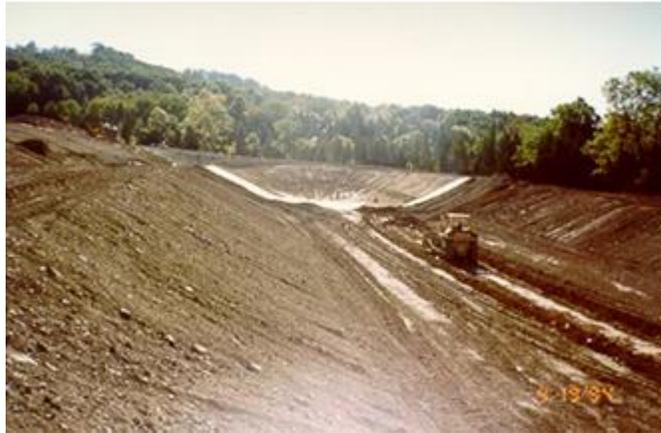
Figure 2 shows a photograph of the failure from across the sedimentation pond. The upper GCL and cover soil are displaced down the slope about 1 to 1.5 m. The failure occurred just below the top of the slope at approximately elevation 247.0 m and about a meter (elevation 245 m) above the maximum water level of elevation 246.1 m (Figure 1). The failure occurred near the center of the north side of the sedimentation pond. The upper GCL, i.e. both geotextiles, was torn over a length of 20 to 25 m. The sedimentation pond had been filled to various levels for approximately three years. The change in vegetation on the side slope in Figure 2 indicates that the long-term pond level before the pond was emptied was about elevation 245.0 m.

Figure 1. View of sedimentation pond and slope failure

The slope failure in the sedimentation pond was remediated by removing all of the GCL and reducing the slope to 1V:3H. Compacted crushed grey shale was placed on the 1V:3H slope instead of a GCL. The sedimentation pond is performing satisfactorily.

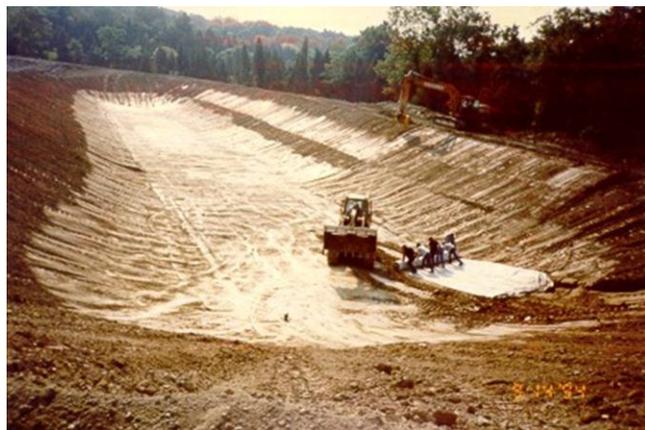
The pond had been emptied (see Figure 2) for approximately one month prior to the failure. This was the first time that the pond had been emptied since being constructed. The reduction in fluid level removed some of the buttressing force on the slope and also may have contributed to the failure.

Figure 2. Different view of sedimentation pond and slope failure

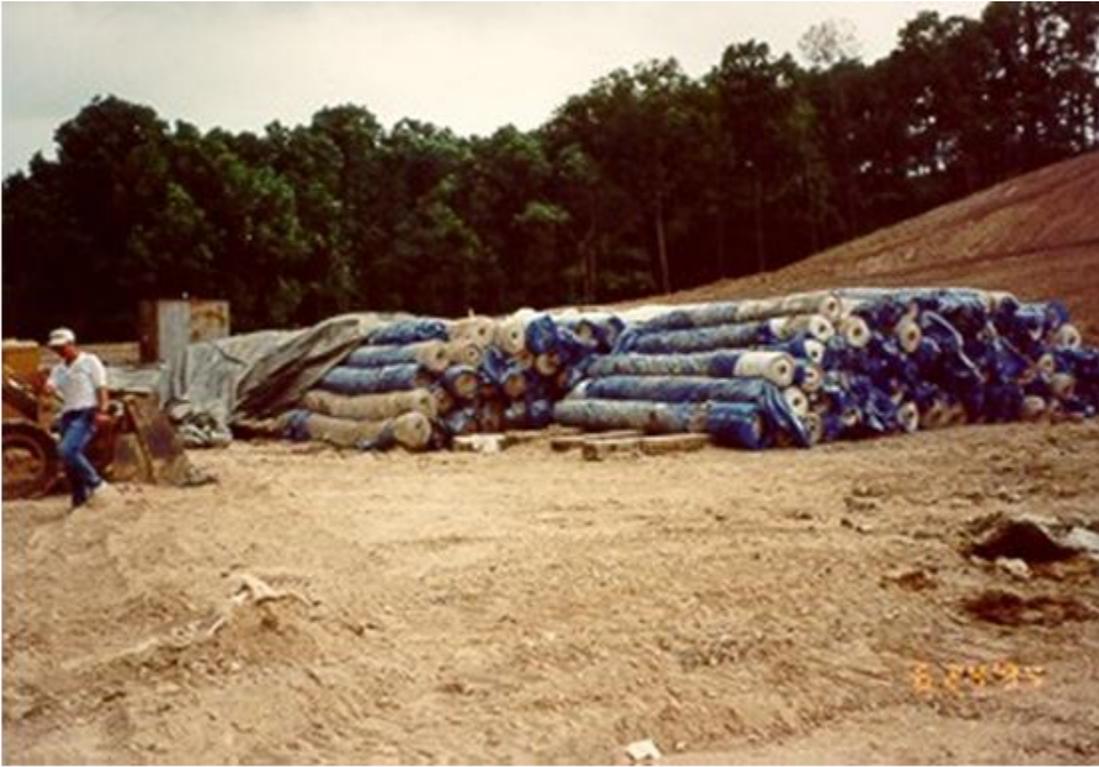
While constructing the final composite cover system for the landfill, which is adjacent to the sedimentation pond, a number of GCL rolls were deemed unsuitable prior to installation. The final landfill cover consisted of a VLDPE geomembrane underlain by a GCL on a 1V:4H slope. The GCLs became unsuitable due to hydration during on-site storage. The manufacturer wrapped each GCL roll in plastic; however, some of the plastic wrapping had unraveled. In addition, the rolls were not covered by a large plastic sheet or stored in a building or shelter. The rolls were stacked directly on 0.3 m by 0.3 m timbers after unloading from a truck. The thick cardboard cores in the middle of the rolls on the bottom of the stack broke or collapsed due to the weight of the overlying GCLs. The cores are used by manufacturers to facilitate rolling up of the GCL after manufacturing and to facilitate installation. The collapse of the cores allowed the GCLs to slump down between the timbers and contact the ground surface in a number of locations. The rolls were stored in an area of surface runoff and water ran underneath the rolls. As a result, it is anticipated that the bentonite hydrated from precipitation, runoff, and/or humidity, which made the majority of the GCLs, especially the bottom rolls, unsuitable for installation. In addition, the collapse of the roll cores made installation of the GCLs with a typical “spreader bar” difficult.

Figure 3. View of GCL stockpile

1. If geosynthetics do not perform satisfactorily, natural materials will replace them.
2. State-of-practice limit equilibrium stability analyses and interface test results could have been used to predict this failure. As a result, it is recommended that state-of-practice testing and analyses and a suitable factor of safety be used when geosynthetics are involved.
3. Storage of GCL rolls at a project site is important to limit the amount of hydration. It is recommended that the manufacturer wrap the GCL rolls in plastic and a large plastic cover be placed over all of the rolls after unloading. It is recommended that the rolls be placed on closely spaced timbers, wooden

- pallets, or other suitable material, to provide adequate support to the roll cores, reduce bentonite migration, and maintain a distance from the ground surface and potential surface runoff. Of course, storage of the GCL rolls in a building or shelter may be more effective in reducing the amount of hydration.

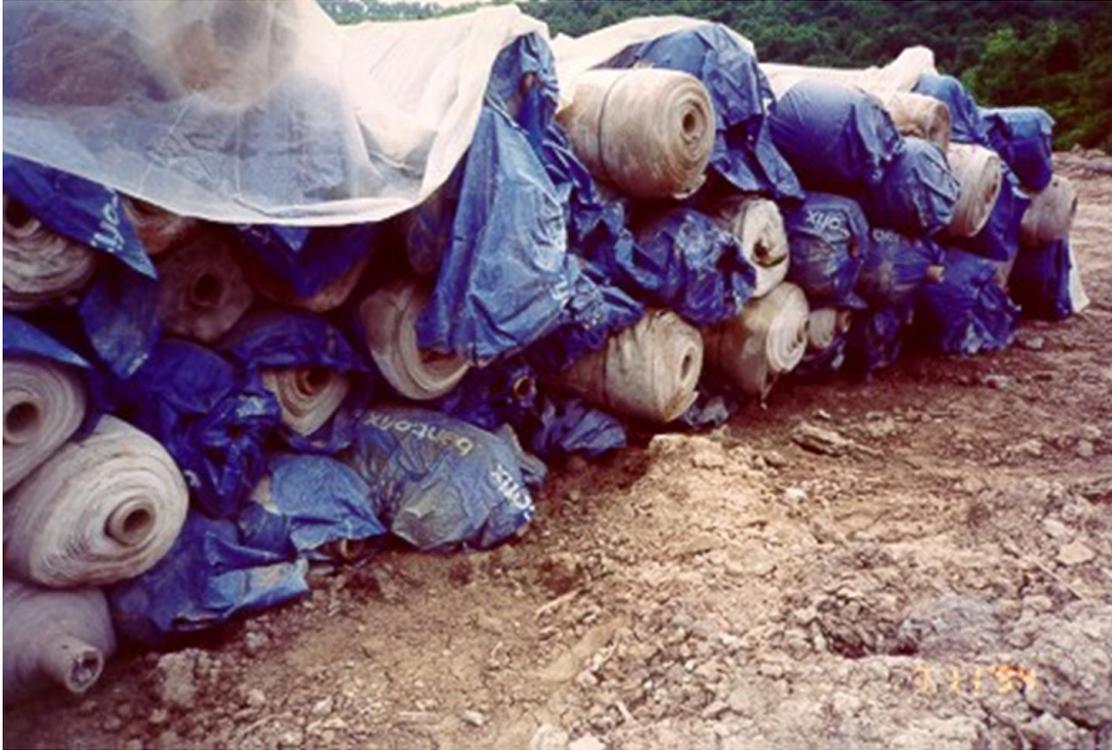
Figure 5. Close up of GCL stockpile
