LEGAL ISSUES ASSOCIATED WITH LANDFILL SLOPES

By: Timothy D. Stark¹ and Paul D. Kerpan²

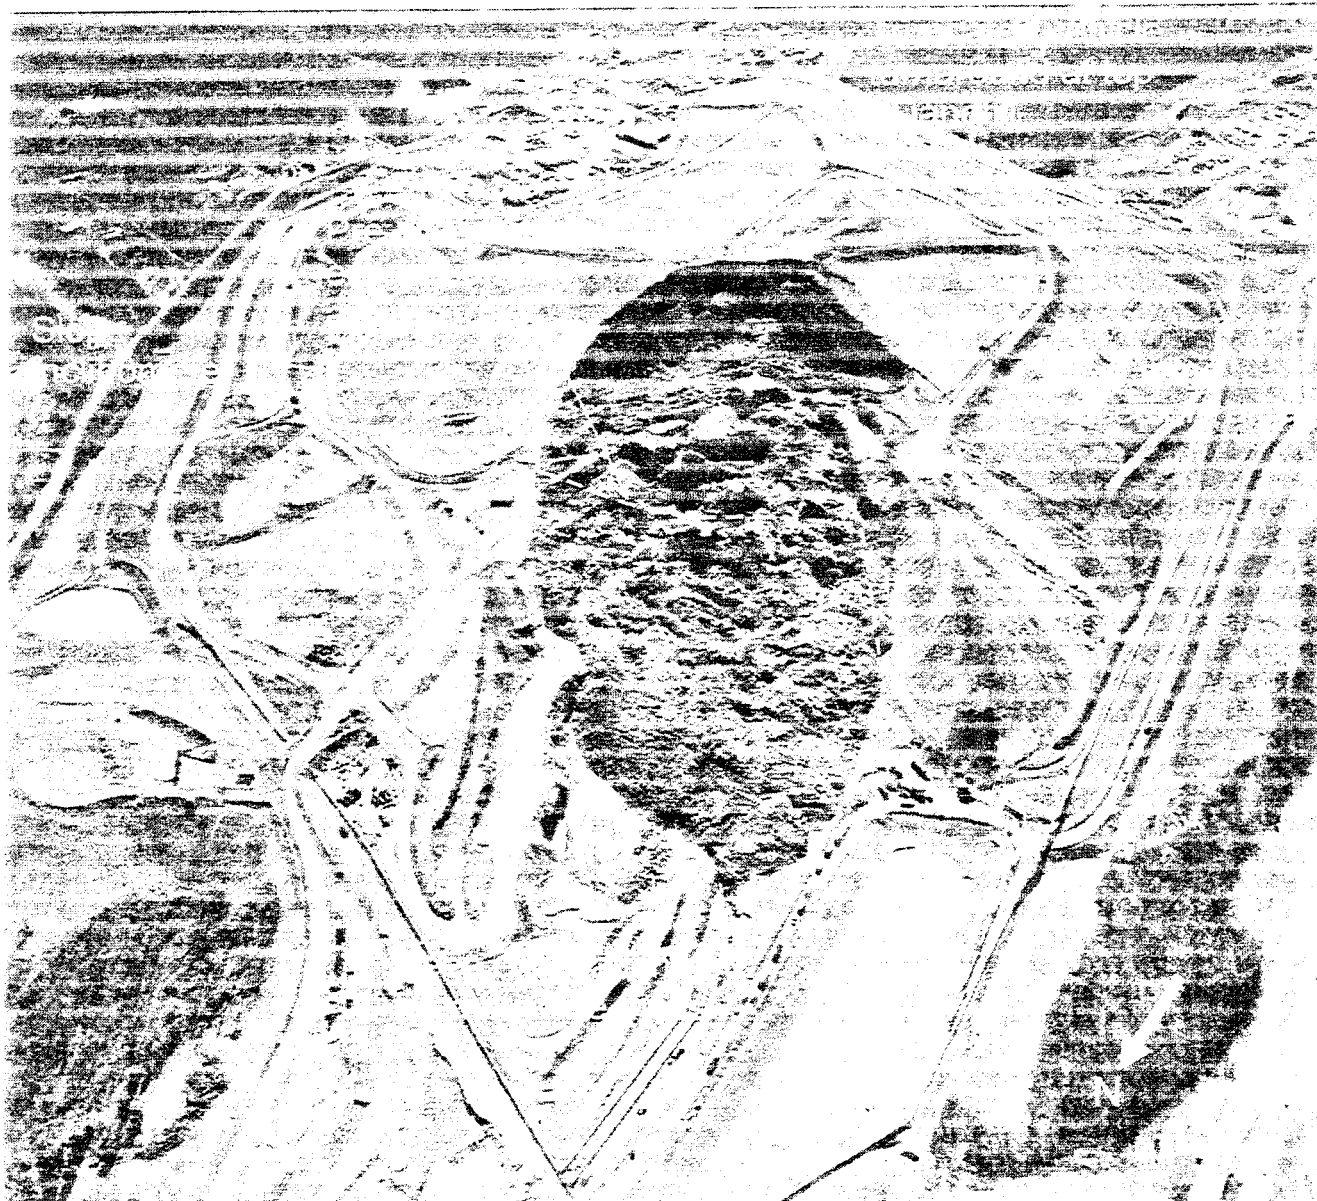
Figure 1. Aerial view of wasteland on March 11, 1996
(two days after wasteland).

scarp that resulted from the wasteslide (note truncated vehicle turnaround at top of landfill in Figure 1) and thus delineated the extent of the slide mass. Owner/operator personnel reviewed the entire slope including the toe below the cracking to determine if the cracks were an indication of slope instability. No other cracks or other indications of slope movement were identified on the slope or at the toe on March 4. Consequently, the owner/operator concluded that the cracks were caused by landfill settlement and ongoing visual monitoring and covering the area with soil to control infiltration was deemed appropriate. As a result, waste placement continued at the top of the landfill until the failure occurred and blasting in the excavation resumed on March 5.

The appearance of substantial cracking initially at the top of the slope and formation of a large slide block, graben, and nearly vertical scarp (Figure 1) are characteristic of a translational failure. In addition, observations at the slope toe and slope inclinometer readings after the slide suggest that the failure was translational and occurred through the weak brown native soil underlying the MSW. Based on field observations and the results of a subsurface investigation, the failure surface was estimated to have passed through the solid waste at a steep inclination to the underlying weak, saturated brown native soil (Figure 4). The failure surface continued along the brown native soil until it daylighted at the vertical excavation at the slope toe, which exposed the MSW and soil.

A three-dimensional (3-D) back-analysis of the wasteslide was conducted to investigate the shear behavior of the brown native soil. A 3-D analysis was used to account for the complex geometry of the scarp (Figure 1), slide mass, original ground surface, e.g., the presence of a ravine under the MSW, landfill geometry, and piezometric level that varied due to the underlying topography. In addition, a 3-D analysis was used to account for the end effects (i.e., shear forces along the sides of the slide mass) and thus yield a back-calculated shear strength that is in agreement with the field or mobilized strength. Two-dimensional (2-D) analyses do not account for the 3-D end effects and thus yield estimates of the mobilized shear strength that are too high, or unconservative (Stark and Eid 1998). Janbu's simplified method of slices (Janbu 1968) was used to conduct the 3-D limit equilibrium back analysis. Janbu's simplified method was extended to three-dimensions and coded in the microcomputer program CLARA 2.31 (Hungry 1988). The 3-D geometry of the slide mass and piezometric level were described using eighteen 2-D cross-sections. (Stark et al. 2000 and Eid et al. 2000 provide additional details of the back analysis and case history, respectively.)

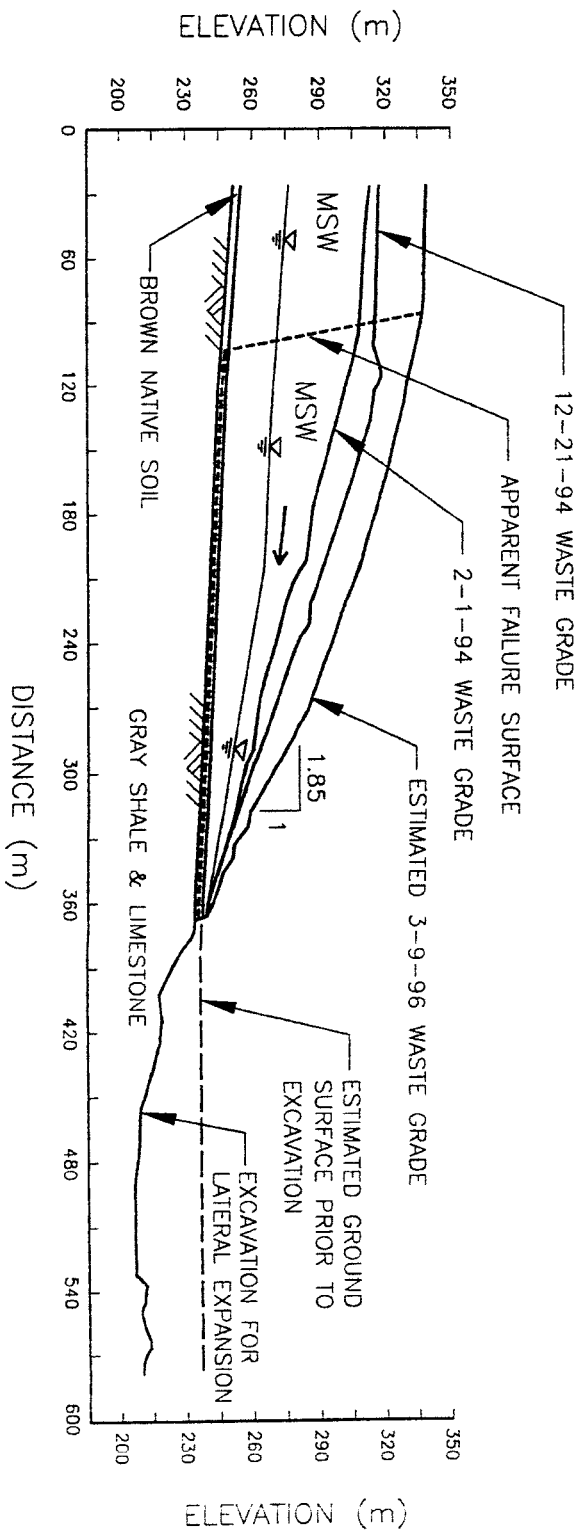
As part of the 1994 expansion permit, the maximum allowable elevation of waste placement was increased from +317.2 to +324.8 m (1040 to 1065 feet). As a result, the top of the landfill exceeded the permitted elevation by 13 to 15 m (45 to 50 feet) at the time of the failure. Figure 3 shows the waste grades from the owner/operator's annual aerial surveys dated February 1, 1994, December 21, 1994, and February 6, 1996. (Cross-section B-B' in Figure 3 passes through the arrow indicating the vehicle turnaround in Figure 2 and the furthest northward movement of the slide mass, see dashed line, where two conveyors are shown.) It can be seen that the slope inclination increased from February 1, 1994 to December 21, 1994, but the maximum elevation did not increase significantly. However, from December 21, 1994 to March 9, 1996, both the slope inclination and maximum elevation increased significantly. In fact a 9 to 20 m (30 to 65 feet) thick layer of waste was placed over the majority of the slope between December 21, 1994 and March 9, 1996. This resulted in a significant increase in slope height and inclination. In addition to waste placement, the owner/operator stockpiled processed soil at the top of the landfill for daily cover operations. The secant slope inclination, i.e., inclination of a straight line from the toe to the crest, was 2.6H:1V. However, the slope inclination near the toe of the slope was 1.85H:1V (Figure 3) and at the toe the slope was at or near vertical after construction of the access road. Figure 3 also shows the ground surface at the toe of the landfill prior to construction of the deep excavation estimated from a 1955 U.S.G.S. Quadrangle sheet and daylighting of the brown native soil underlying the waste.

Figure 3. Slope Cross-Section B-B' Showing Recent Waste Placement

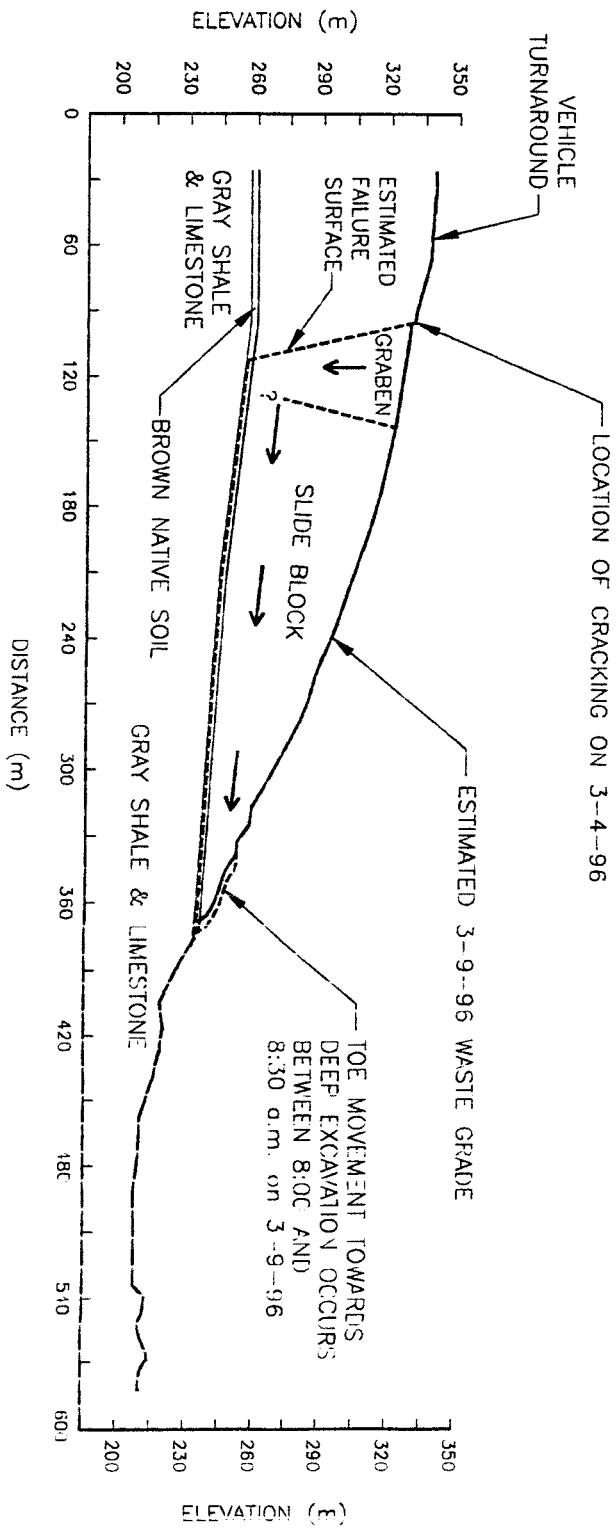
Figure 4. Cracking and Translational Movement of Waste Slope Along Cross-Section A-A'
