CONSTRUCTION CONSIDERATIONS FOR GEOSYNTHETIC LINER SYSTEM STABILITY

By: Pedro Amaya, Timothy D. Stark, and Brian Queen

ABSTRACT: Construction conditions experienced during the installation of a landfill geocomposite liner system lead to two slides of a 3H:1V internal slope being developed for final disposal of Flue Gas Desulfurization byproduct material (FGD). The approved geocomposite liner consisted of 18-inches of compacted clay, a 30-mil thick PVC geomembrane, 12-inches of drainage sand, and 24-inches of FGD used as protective cover material. A stability improvement program featuring the use of geosynthetics to reinforce the 3H:1V slopes was implemented and no re-occurring or additional slides have occurred at the site.

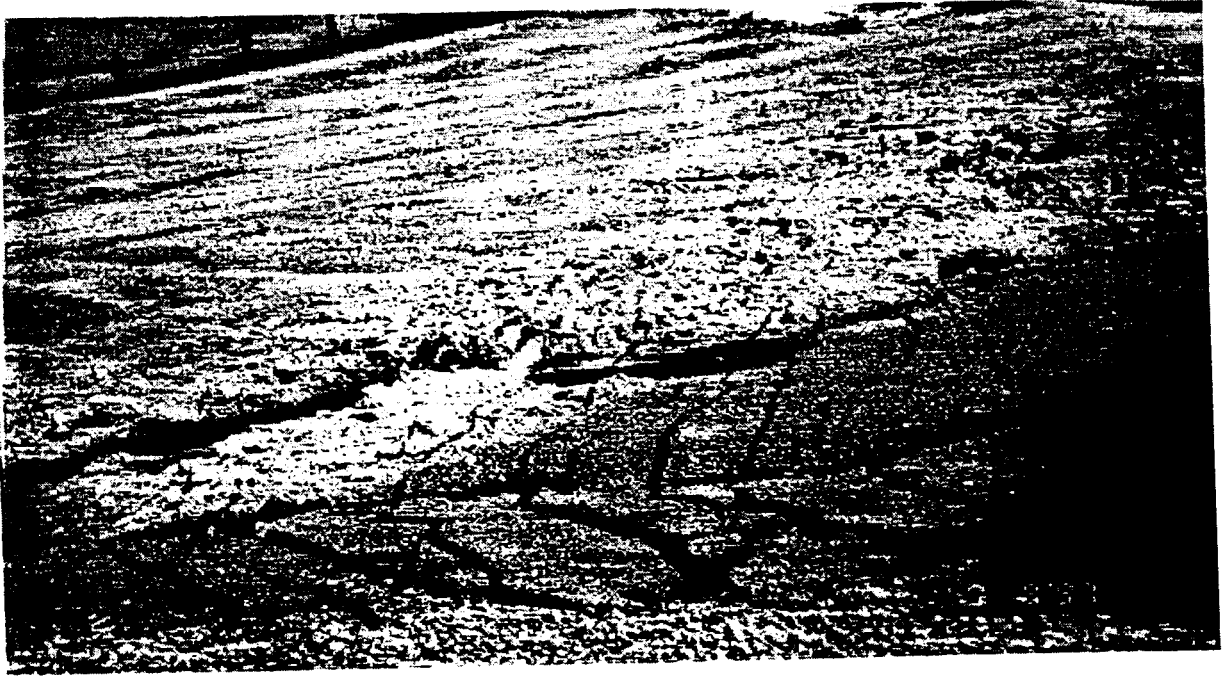
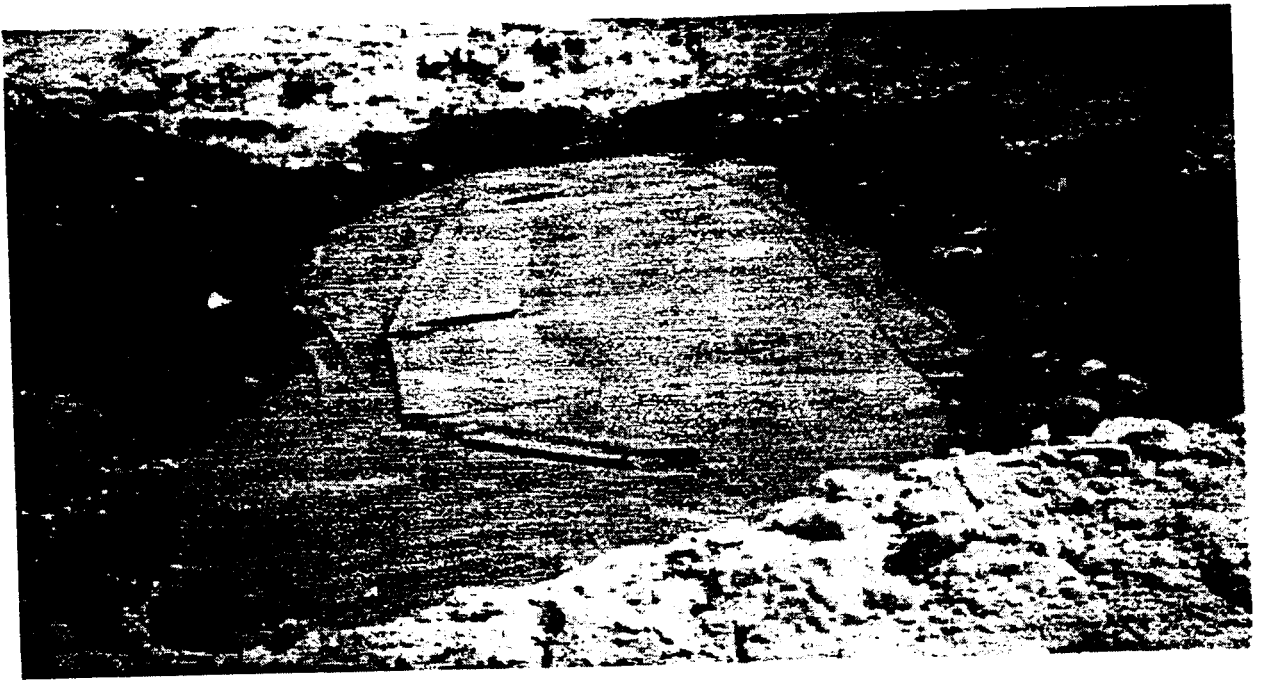
In June 1997, another section of 3H:1V slope in Phase B became unstable and slid. Figure 3 illustrates the condition of the PVC geomembrane in the June 1997 slide area.

Construction records indicate that the clay in this area had been compacted to an average moisture content of approximately 19.5% or about the optimum moisture content. The PVC geomembrane was placed over the compacted clay and the moisture content of the clay was monitored before the drainage sand was placed. The moisture content was monitored with the PVC geomembrane in place by cutting a square section of the PVC geomembrane at a few locations and patching it after a sample of the clay liner was obtained for moisture content testing. No significant change in the moisture content was measured prior to placement of the drainage sand. The FGD protective cover was placed following placement of the drainage sand. The liner system was completed and stable for a period of two weeks. After two weeks, three temporary haul roads were constructed on the 3H:1V slope. The three haul roads were equally spaced along the 304 ft (92.7 m) long slope with one road constructed at the toe of the 3H:1V slope and one being constructed within approximately 15.2 m (50 ft) of the slope crest. A few days after the haul roads were put into service, the June 1997 slide occurred. As a result, it is anticipated that the shear stress induced by traffic on these roads contributed to the 1997 failure. The observed network of cracking was similar to the network observed for the October 1996 slide. The parallel cracks extended across the slope and from the crest of the slope approximately 50 feet (15 m) down the slope. The width of the cracks ranged from 0.5 to 5 inches (12 mm to 125 mm) but did not show any significant vertical offset. A significant finding during the failure investigation was that the average moisture content of the compacted clay liner at the geomembrane interface was 22.5%. This corresponds to an increase in moisture content of approximately 3% during placement of both the sand drainage layer and the protective FGD cover material.

Based on field observations, the slope failures occurred due to sliding at the PVC geomembrane/CCL interface. This caused tension in the PVC geomembrane and allowed the drainage sand layer and protective cover material to translate down slope. In some locations the geomembrane tore resulting in the failure surface migrating up through the drainage sand and protective cover material. The failures were translational in nature due to the compacted and stiff nature of the underlying compacted clay liner and existing terrain.

Figure 3. (a) Slope cracking and (b) tear observed in PVC geomembrane after June 1997 slide

With the implementation of these two remedial measures (careful monitoring of the CCL moisture and installation of tensile geosynthetics), the two slide areas were successfully repaired. These same measures were implemented on the remaining interior slopes of the landfill that were steeper than 4H:1V in all of the landfill phases. No signs of slippage or large deformation have been observed since June 1997. During construction of Phase C in Valley 3, blasting operations were performed approximately 30 m (100 feet) from the edge of the 3H:1V slope in Phase B a few weeks after placement of the protective cover material. Peak horizontal ground surface accelerations at the edge of the slope were determined to be as high as 0.13g. No signs of distress or large strains were observed on this or any of the slopes in Phase B, Valley 2. This is significant because Stark et al. (2000) conclude that blasting can have an adverse impact on the stability of marginally stable slopes. Therefore, it may be concluded that the slope was not marginally stable because the blasting did not have an adverse impact on stability.
