# **AN INTERIM SLOPE FAILURE INVOLVING LEACHATE RECIRCULATION**

Paper Submitted to:  
**Municipal and Industrial Solid Waste Disposal Technology  
Waste Tech '2000  
March 6-8, 2000  
Orlando, Florida**

January 12, 2000

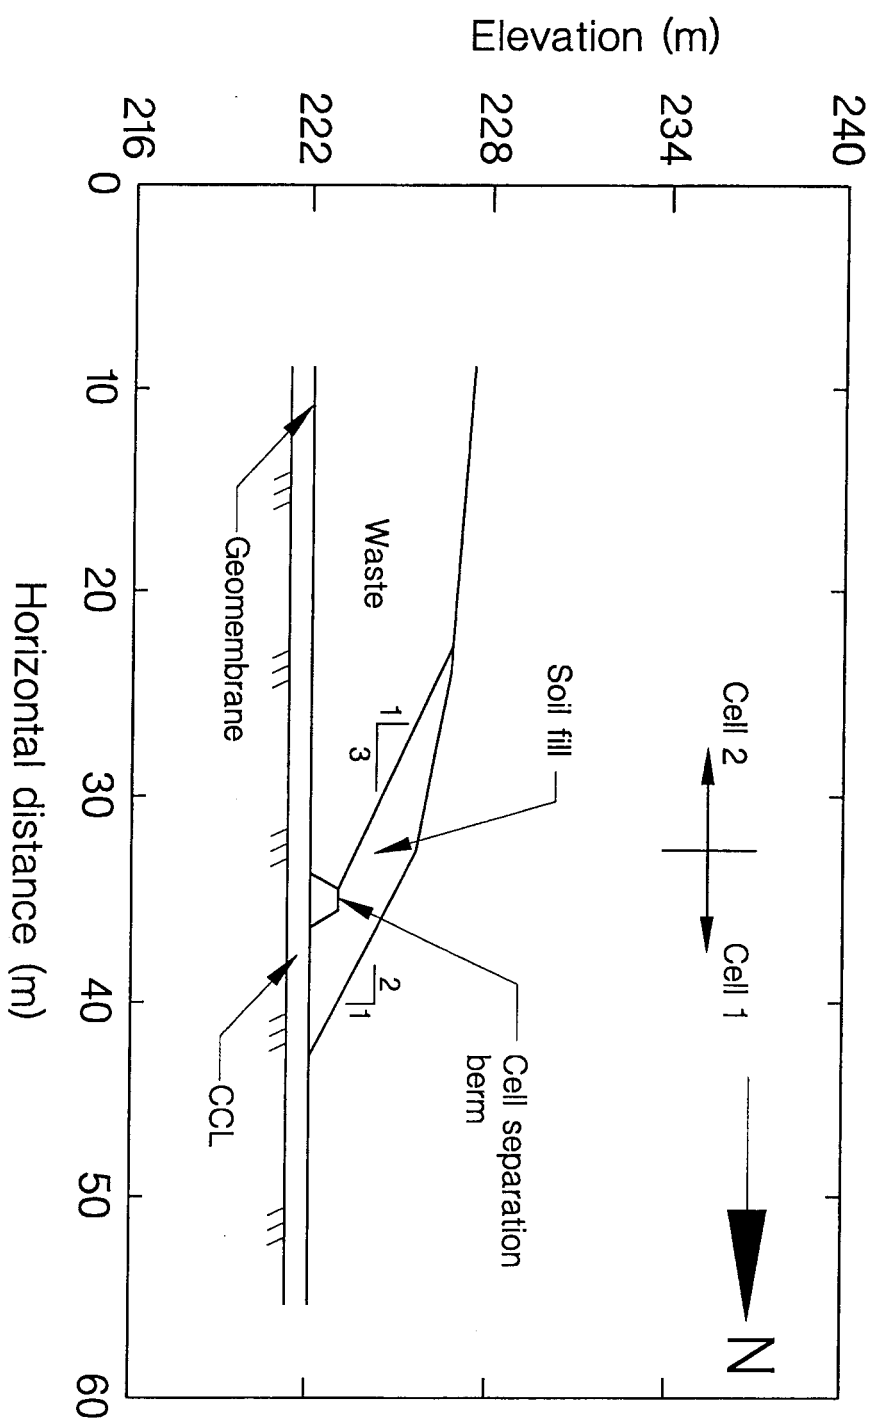
Figure 3 presents a detailed cross-section at the intersection between Cells 1 and 2 just prior to the failure. It is important to note that the soil fill shown in Figure 3 was placed on the 1V:3H waste slope in an effort to control the continual leachate outbreaks that occurred along the toe of the waste slope. Initially, a 0.6 m (2 ft) thick lift of soil was placed over the slope toe in an unsuccessful attempt to control the leachate outbreaks. Several subsequent 0.6 m (2 ft) thick lifts of soil were also placed in unsuccessful attempts to control the leachate outbreaks. Finally, an approximately 3 m (10 ft) thick lift of soil was placed over the toe. The soil fill then extended into Cell 1 the distance shown by the line at approximately a 1V:2H slope. The abundance and magnitude of the outbreaks were probably attributable to leachate recirculation, surface water infiltration, and the lowest portion of the cell being along the toe of the interim waste slope. In addition, the permanent sump is located at the northeastern end of the cell separation berm (see Figure 1) and thus a large distance away from the location of cross-section B-B'. Therefore, it was concluded that leachate was building up behind the low permeability cell separation berm and causing the leachate outbreaks.

Figure 3. Cross-section B-B' in toe area showing soil fill to reduce leachate outbreaks

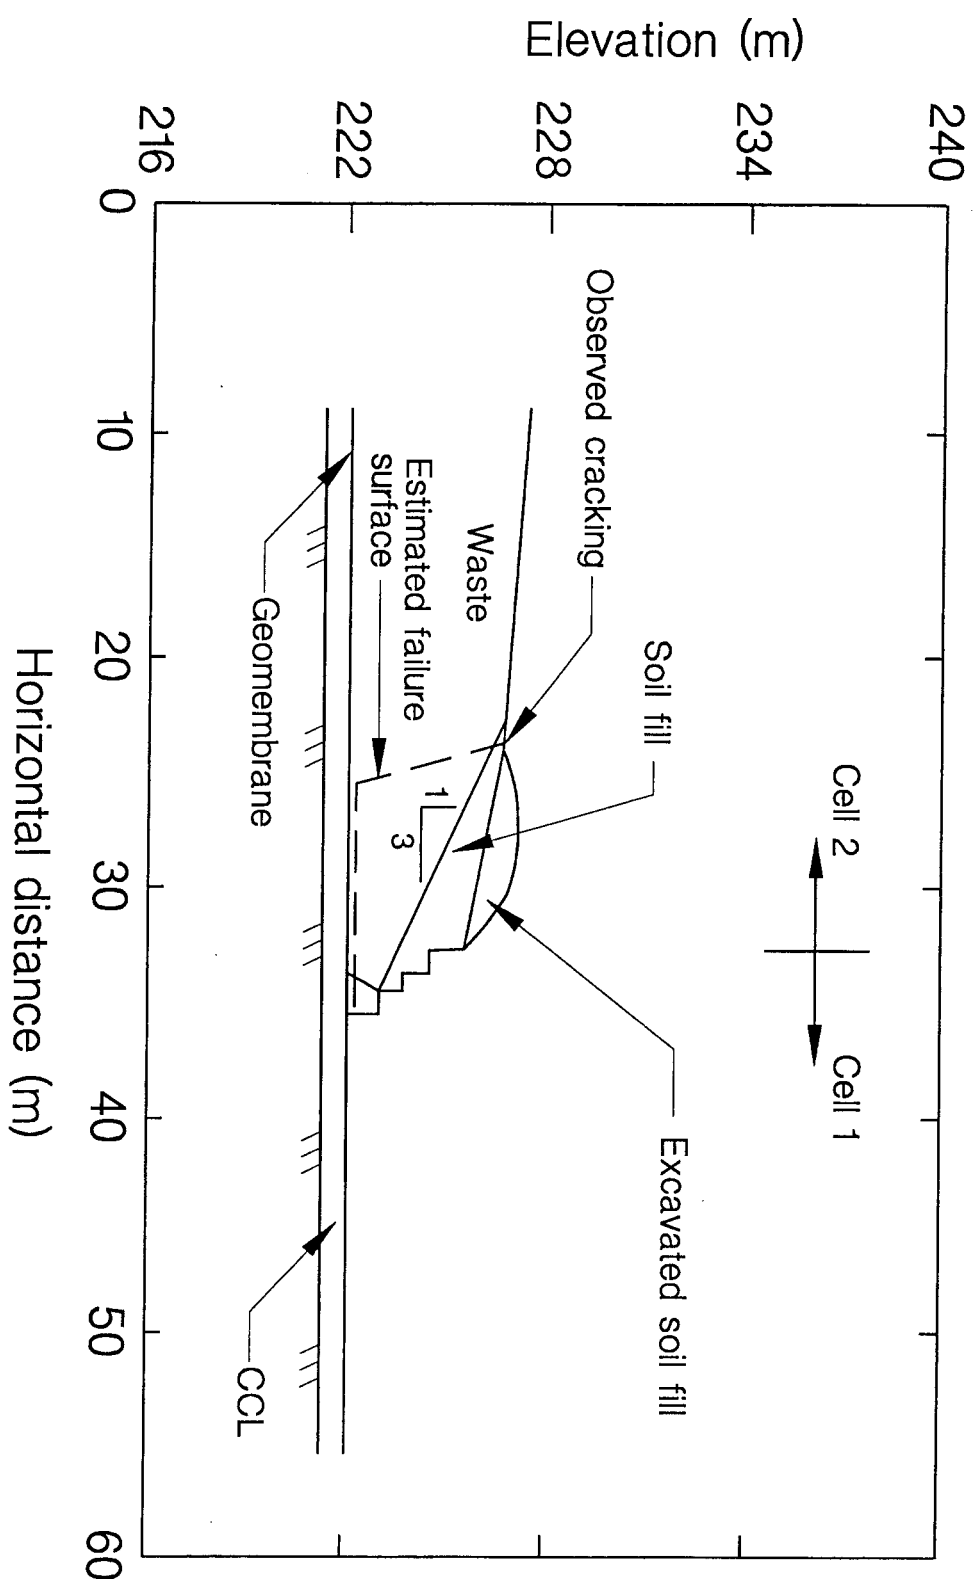
Figure 5. Cross-section B-B' at toe berm showing estimated failure surface

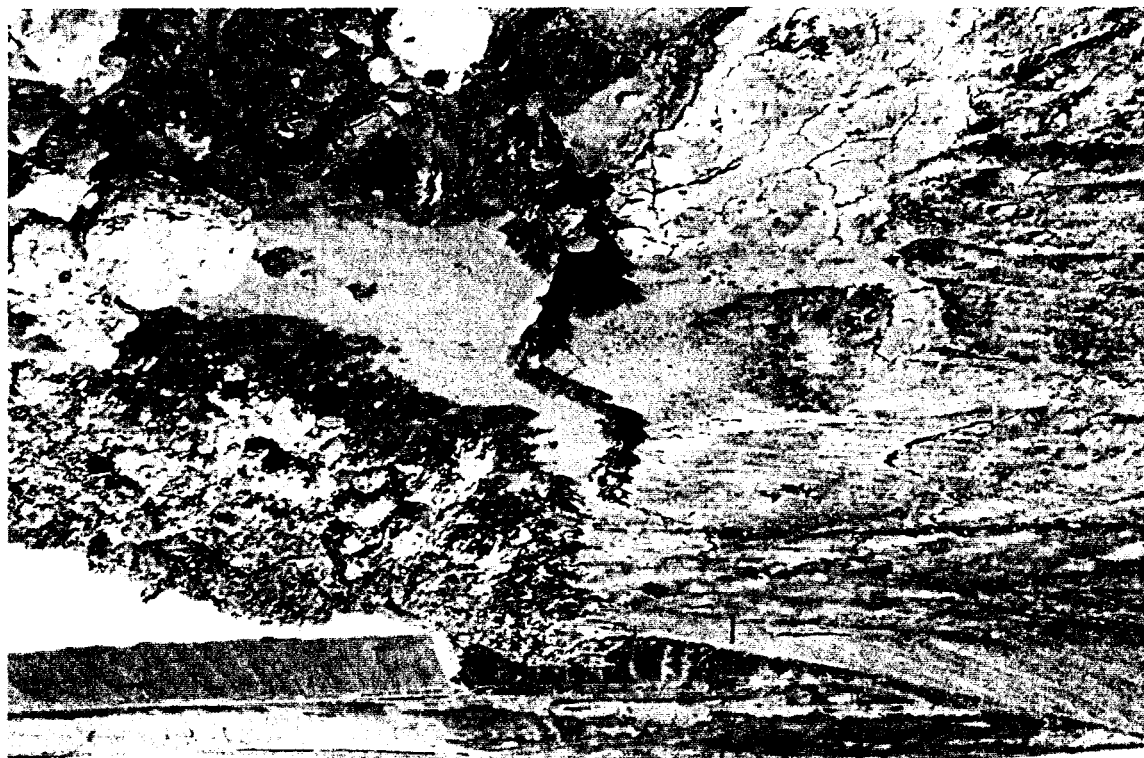
Between the close of business on 17 August 1997 and the start of business on 18 August 1997 a block of the soil fill, some waste, and the temporary cell separation berm from Cell 2 translated laterally 4 to 6 m (15 to 20 feet) into Cell 1. The sump for Cell 1 near the intersection of the two cells can be seen in the foreground of Figure 7. The sump for Cell 2 is located near the tires in the foreground but hidden by the overlying waste. The access area/road for the landfill is evident by the vehicles in the background of Figure

7 and is shown in Figure 1 on the west side of Cells 1 and 2. Figure 7 also shows the cohesionless drainage layer being placed in Cell 1, the displaced soil/waste from Cell 2, and the damaged geomembrane at the toe of the failed slope. The slope failure is approximately 92 m (300 feet) long, 6 m (20 feet) high, and involved about 91,680 m<sup>3</sup> (120,000 cubic yards).

Figure 8. Overview of interim slope. Note: The photograph was taken from the top of the east slope, slightly south of the leachate riser pipes (see Figure 1). Cell 2 is on the left of the photograph and Cell 1 is on the center-right part of the photograph
