Waste Age®

February 2001

Avoiding the Slippery Slope

By V.L. Wilson, W.D. Evans and T.D. Stark

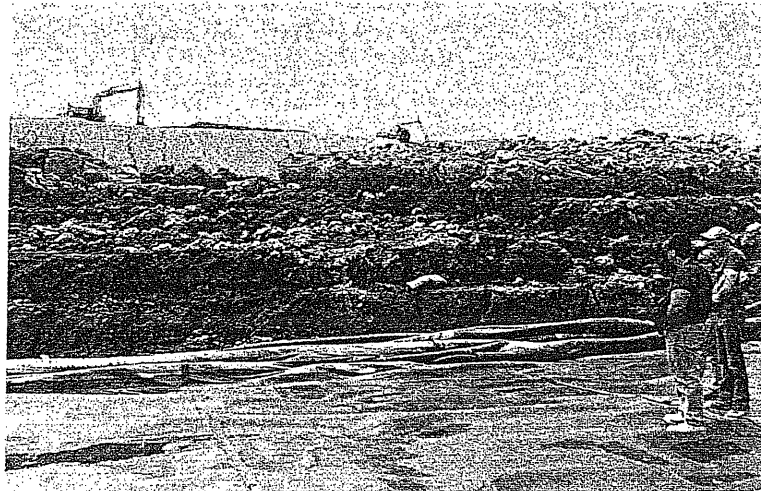
Workers examine terraces in the soil fill, the excavated soil placed at the top of slope and the damaged geomembrane at the slope's toe.

To "tie-in" the composite liner systems in both cells, it became necessary to remove a substantial portion of the soil fill that extended into Cell 1 and remove some of the cell separation berm. Cell 2's geomembrane, located under the cell separation berm, had to be exposed prior to welding the two cells' geomembranes. As a result, the soil fill was excavated so that the northern portion of the cell separation berm could be excavated to expose Cell 2's geomembrane. The slope above the cell separation berm was excavated in 3- to 5-foot-high terraces. Removing the soil fill from Cell 1 decreased the buttressing affect provided to the soil fill at the slope toe.

slope. This soil loaded the slope with additional driving force and effectively dammed or trapped some surface water runoff at the terraced slope's top.

To investigate the potential for damage to the composite liner system a significant portion of the soil fill was excavated. Wrinkled and torn geomembrane was discovered in the portions of the liner system outside of the active cell area indicating that the failure plane occurred within the cover soil in the active cells. The sliding occurred at the interface between the compacted clay liner and the smooth geomembrane in the active and developing cell. However, operators also suspected that some of the damage was due to the saturated soil fill slumping or bulging into Cell 1.

To repair the facility, operators had to remove the soil fill, waste and damaged geomembrane, then replace the composite liner system's damaged portions.

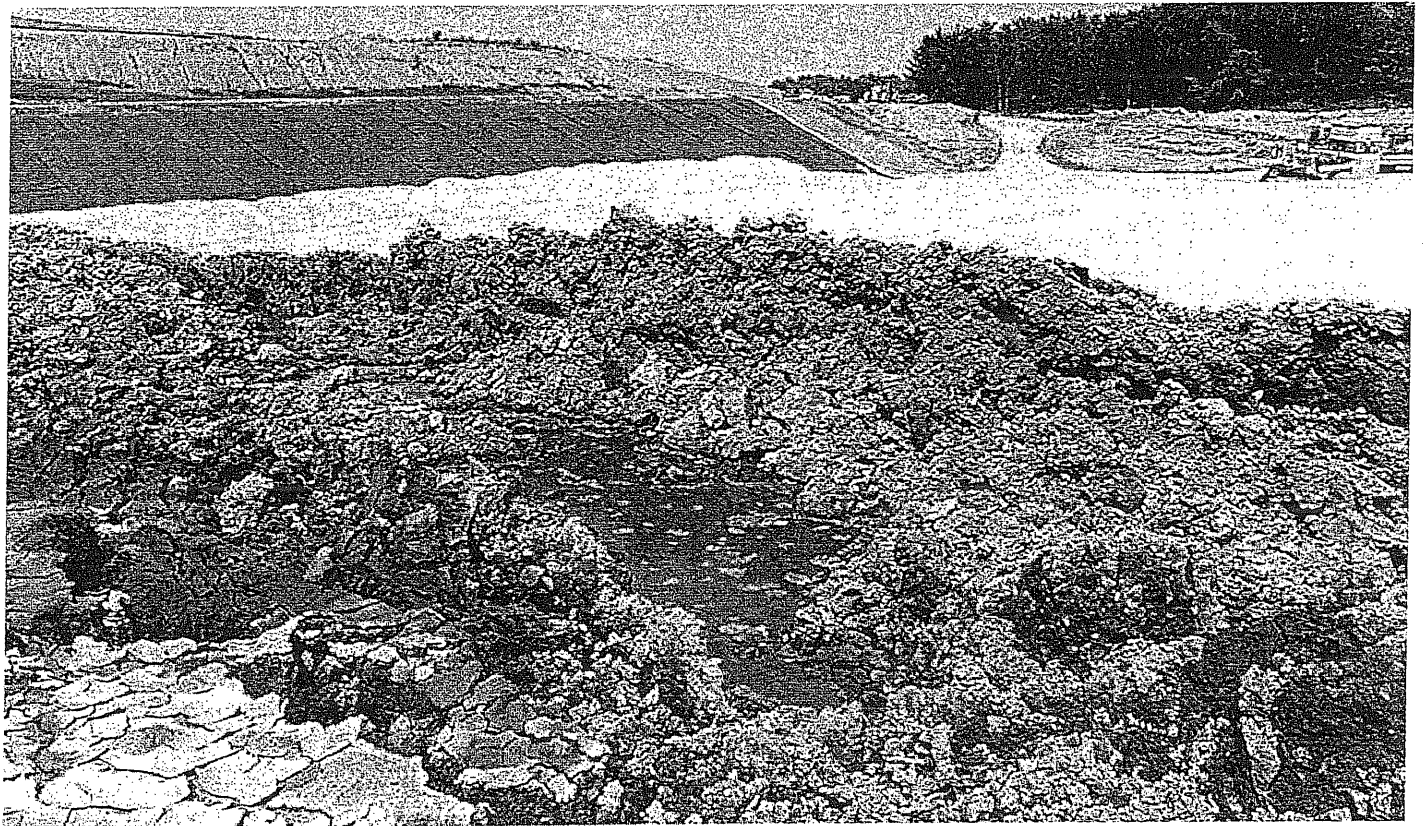
It was assumed the outbreak's abundance and magnitude resulted from leachate recirculation, surface water infiltration and the lowest portion of the cell being along the toe of the interim waste slope. Additionally, the permanent sump was located at the northeastern end of the cell separation berm. It was concluded that leachate was building up behind the low-permeability cell separation berm causing the outbreaks.

With leachate appearing at ground surface, excavated soil fill was placed at the top of the slope.
