LEGAL ASPECTS OF A LANDSLIDE CASE

Timothy D. Stark¹, Gregory de la Pena² and Erik J. Newman³

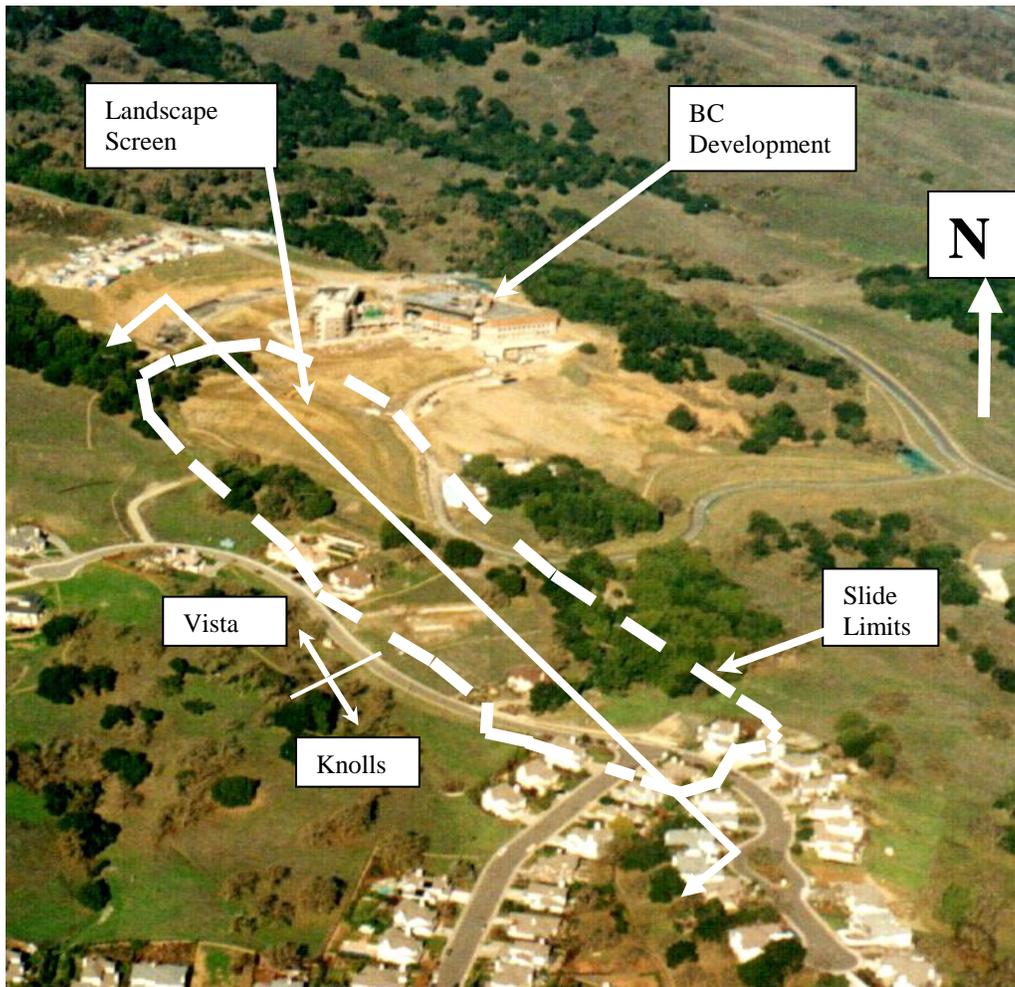
Between 1988 and 1989, a housing development with about 50 units (the Knolls) was completed on an undeveloped hillside in California (Figure 1). An 11 unit housing development was subsequently constructed upslope of the Knolls (the Vista development) (Figure 1). Neither housing development experienced any complaints from the residents until September 1996. In June 1996, a large fill was started by development upslope of the Vista development. The main purpose of the large fill was to create a visual barrier between the BC Development and the Vista development (Figure 1) and is referred to as the landscape screen herein. Fill placement for the landscape screen ceased in late December 1996 even though the fill had not reached full height because of the onset of homeowner's complaints of damage to their homes. The surface area of the landscape screen in December 1996

Figure 1. Aerial view of BC Development, downslope housing developments, cross-section location, and an outline of the slide mass (photograph by Cotton, Shires & Associates, Incorporated.)

section. This is in agreement with distress being first reported in the homes in the western portion of the landslide toe and the western portion of the Vista development. Therefore, it was concluded that shear movement started along the western portion of the slide mass, which induced movement along the eastern portion to create the slide limits shown in Figure 1.

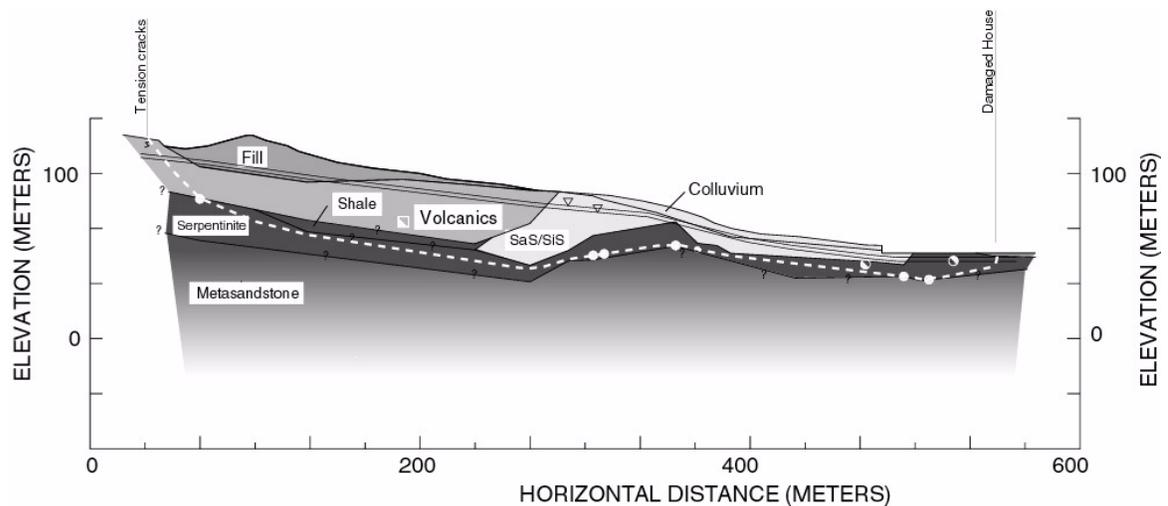
The fully shaded circles in Figure 2 correspond to inclinometers that show a distinct shear movement and are within 30 m of the cross-section. Thus, the estimated failure surface passes through these dots. The partially shaded symbols correspond to inclinometers that are greater than a horizontal distance of 30 m from the cross-section. Partially-shaded circles correspond to the depth of movement in inclinometers installed deep enough to experience movement while the partially-shaded squares in Figure 2 correspond to the maximum depth of inclinometers that are too shallow to record movement. The failure surface is shown in Figure 2 by the dashed line and was estimated from the surficial movements and the inclinometer data.

Figure 2: Cross-section through the western portion of the landslide after surficial grading and placement of the landscape screen

Figure 2 shows the estimated failure surface passes through the Tertiary Volcanics upslope of the landscape screen at a steep inclination to the underlying weak and saturated serpentinite. The failure surface continues along the serpentinite layer until the depth of overburden allows it to daylight in the Knolls housing development. The landslide also damaged the homes in the Vista development that are at or near the western edge of the slide mass.

Back-analysis of the four cross-sections that extend the length of the slide mass was conducted to locate the weakest portion of the hill or the area most susceptible to sliding. The largest back-calculated friction angle was obtained for the cross-section shown in Figure 2, which indicates that this cross-section is the critical cross-section or the weakest portion of the hillside. The two cross-sections in the eastern portion of the slide mass yielded lower back-calculated friction angles, 7.3 to 7.9 degrees, than the two cross-sections in the western portion, 9.5 to 9.9 degrees. Thus, failure did not initiate in the eastern portion of the slide. The cross-section in Figure 2 yielded the highest back-calculated friction angle of 9.9 degrees and thus is the critical cross-

In summary, the back-analysis identified the critical cross-section (Figure 2) as being located along the western portion of the slide mass (Figure 1) and the mobilized friction angle of the serpentinite to be 9.9 degrees.

Thus, it was concluded that the landscape screen triggered the slide movement along the western portion of the slide mass and the surficial grading did not significantly reduce the stability of the slope. The jury agreed with this conclusion and the case settled shortly thereafter.
