DESIGNING AND SPECIFYING LANDFILL COVERS

By: Timothy D. Stark,¹ Erik J. Newman,² and Kenneth R. Binnix³
Submitted for Review and Possible Publication in the **Geotechnical Fabrics Report (GFR)**
September 12, 2005

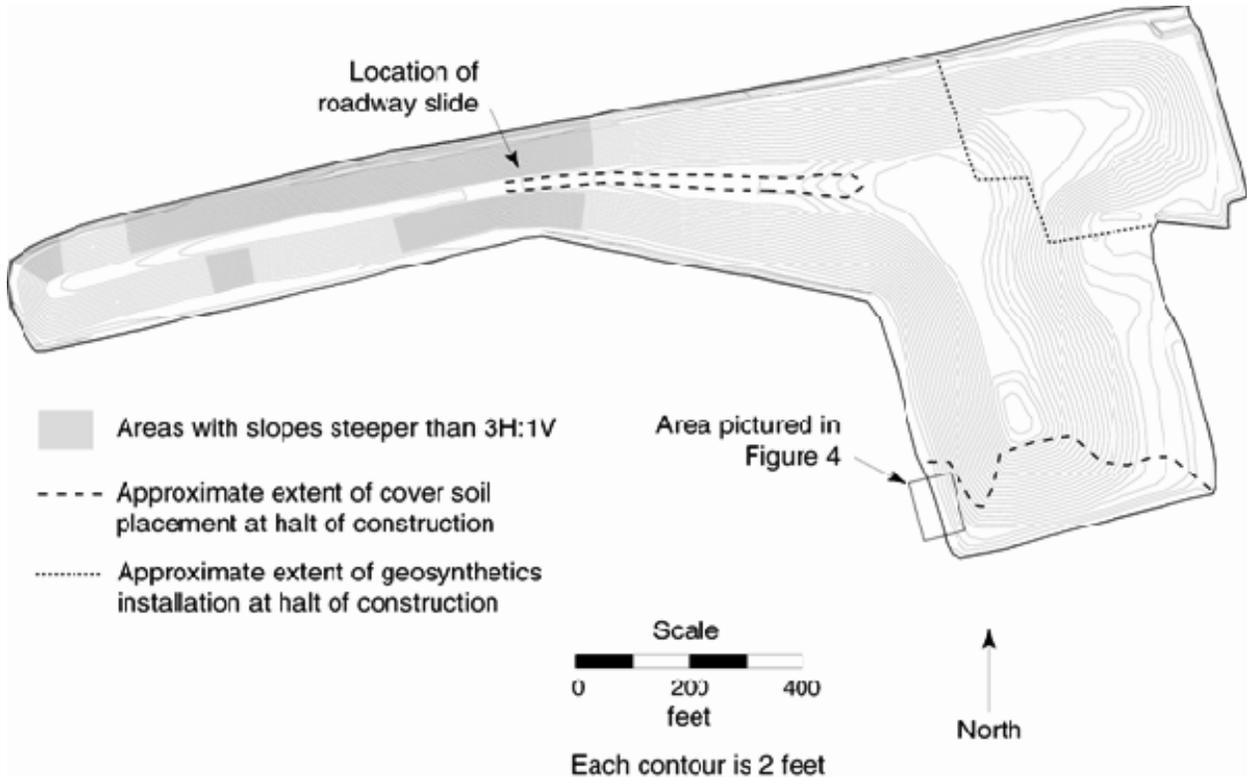
Before final cover construction commenced, MDE identified areas of the landfill that did not possess the required 24 in. of interim soil cover. To comply with MDE's request for 24 in. of interim soil cover, Somerset County personnel placed additional soil cover which resulted in the slopes being even steeper. The landfill is shaped like a sauce pan with a long handle. The oversteepened portions of the landfill are located along the panhandle as shown in Figure 1. As placement of soil cover was occurring by Somerset County, MES prepared the final design based on a slope inclination of 3H:1V. Thus, the design did not reflect field conditions from the beginning.

Figure 1: Plan view of landfill slopes steeper than 3H:1V after placement of additional soil by Somerset County to achieve the required 24 in. thickness of intermediate soil cover

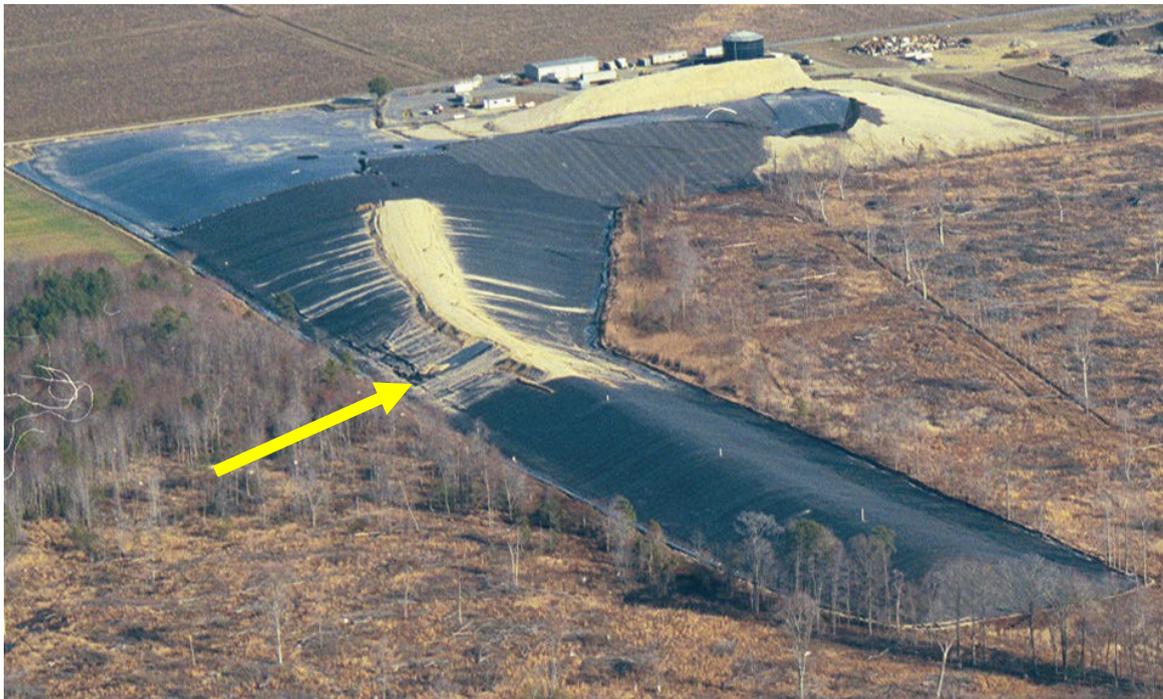
Because access along the north side of the panhandle prevented creation of an access road, the contractor started placing vegetative cover soil over the drainage composite on the crest of the panhandle from the east towards the west (see Figure 2). Geosynthetic placement started at

the drainage composite started pulling apart (see Figure 2). Afterwards, soil placement and the anchor trench detail were started along the west side of the pan. Before construction was halted, soil was placed a distance of about 30 to 40 feet west from the southern corner. The soil placement proceeded slightly ahead of the anchor trench detail only for the last portion of the west side constructed. This resulted in the access road on the west side not being continuously supported by the tire chips. However, the vegetative cover was being placed parallel to the slope toe first and not up the west slope yet.

Figure 2: Aerial view of panhandle and southern slope

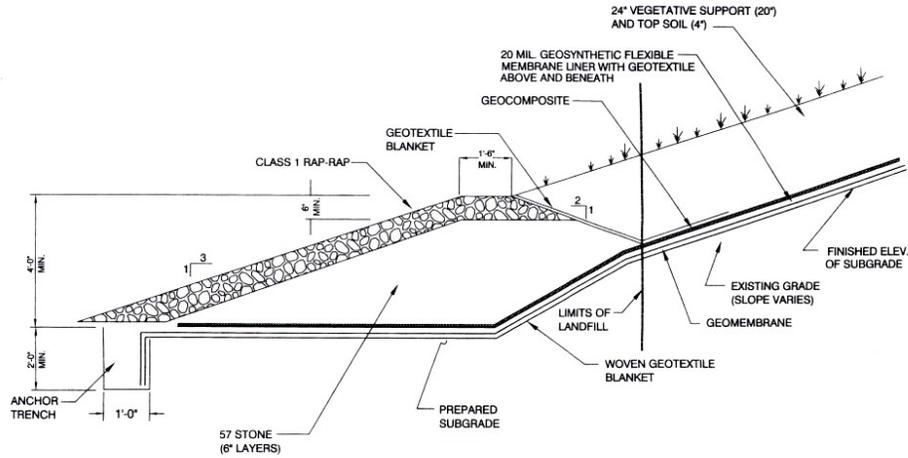
Figure 3: Sideslope Anchor Detail prepared by MES

The construction contract included a pay item for "closure excavation" of 1,000 cubic yards and a budget of \$8,250. Clearly, this small volume and budget was not intended for the contractor to remove the recently placed interim soil cover, remove waste to flatten the slope to 3H:1V, dispose of the waste, and replace the interim soil cover to achieve a 3H:1V slope in the oversteepened areas. In fact, the remediation did not involve any slope flattening. The slope toe could not be moved outward to reduce slope inclination because adjacent properties are within 1 to 5 feet of the geosynthetics anchor trench. MES sought a variance for the 24 in. thickness of

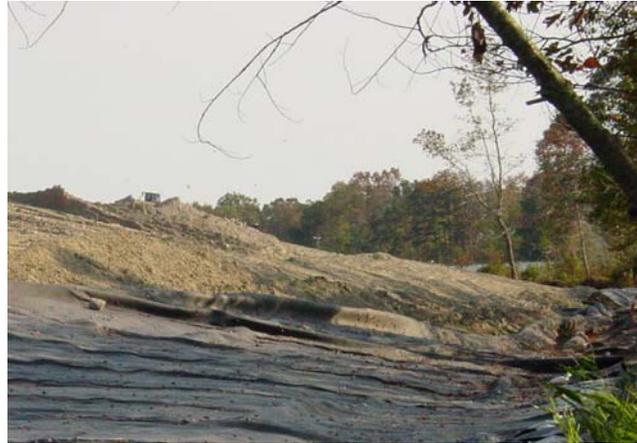
As construction progressed from the southwest corner towards the steepest portion of the west slope (see Figure 1), wrinkles started developing in the single-sided drainage composite at the slope toe (see Figure 4) and plastic ties along the top of the western slope started failing. Movement was again occurring at the geonet/PVC geomembrane interface which suggested a design problem to the contractor. Minor wrinkling of the single-sided drainage composite started before the end of work on a Friday and the majority of the wrinkles occurred over the subsequent weekend when no construction equipment was present. The photograph in Figure 4 was taken on the following Monday morning. Therefore, the majority of the slope movement was not caused by vehicle loading; instead it appears that progressive failure over the weekend contributed to the magnitude of observed movement. The potential for progressive failure is enhanced when the interface friction (16.0 degrees) is less than the average slope inclination (18.0 degrees) (Stark and Poeppel 1994). It is recommended subsequently that the interface friction angle should always exceed the slope angle even with the presence of a toe buttress. The slide on the panhandle occurred quickly and thus progressive failure was not a large factor because the slope angle (22 to 23⁰) significantly exceeds the back-calculated friction angle for the geonet/PVC geomembrane interface, i.e., 16⁰. In addition, the laboratory direct shear testing (ASTM D5321) of the geonet/PVC geomembrane interface conducted after problems developed

show a peak geonet/PVC geomembrane interface friction angle of 18 degrees. Thus, the design assumption of a geonet/PVC geomembrane interface friction angle of 23 degrees from a seminar presentation is the main issue leading to the failure of the cover system.

Figure 4: Toe of west slope showing wrinkles in single-sided drainage composite that developed over weekend

The geocomposite material necessary to create the wrinkling shown in Figure 4 was derived from the separation of butt-seams at the top of the west slope over the weekend and/or elongation of the geonet and geotextile due to the tensile forces induced along the slope. The separation of butt-seams at the top of the west slope also identified that sliding was occurring on the geonet/PVC geomembrane interface along the entire west slope length. The observed failure mode is representative of a global failure, not a localized failure such as might be induced by a heavy piece of equipment on the slope. The observed failure mode also illustrates the ramifications of installing a weak interface on a steep slope, which is that every material above that weak interface can move downslope, even if the overlying material exhibits high shear strength. In short, the good material will simply be “along for the ride” and thus a careful evaluation of the interface strengths should be undertaken prior to construction.

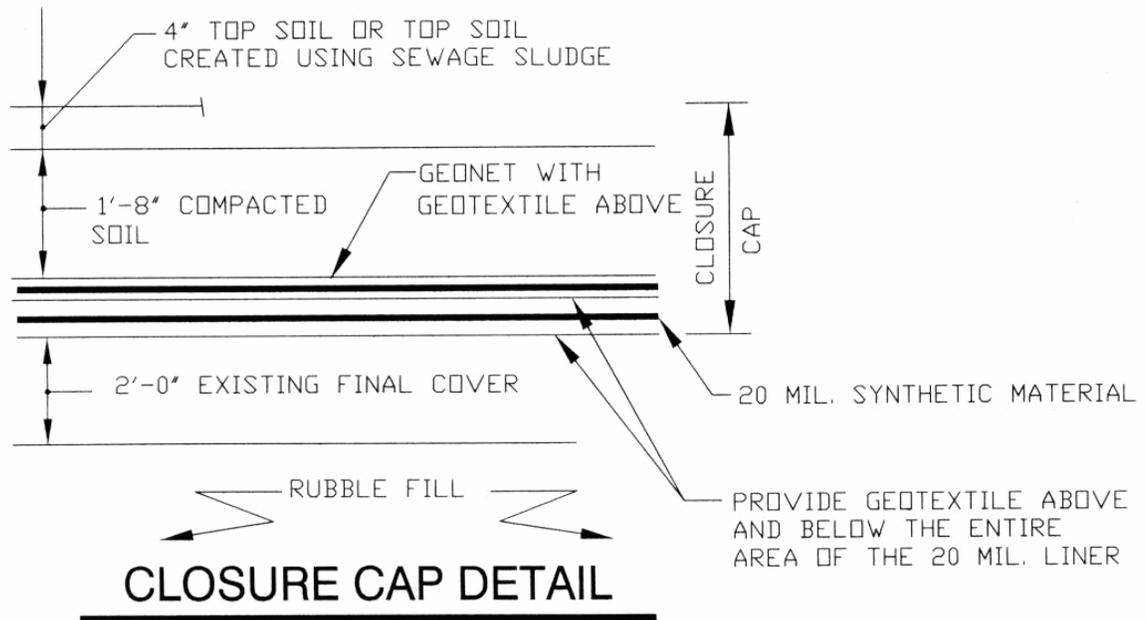
The original MES design includes two unbounded nonwoven geotextiles, a 20 mil PVC geomembrane, and a single-sided drainage composite as shown in Plan Sheet C-9 in Figure 5. The unbonded geotextiles are designed to provide cushion between the geomembrane and the interim soil cover and the overlying geonet, respectively. The presence of an unbonded, non-woven geotextile between the geonet and the PVC geomembrane gives the appearance of a double-sided drainage composite, but it is not, as is shown in Figure 5. The design consists of a single-sided drainage composite, two unbonded geotextiles, and a PVC geomembrane. Fortunately the unbonded non-woven geotextile underlying the geonet was removed from the design in the first addendum to the contract bid package dated April 27, 2001 because a pay item was not included for this geotextile. The inclusion of this unbounded geotextile/geonet interface would have resulted in an even lower interface friction angle than the geonet/PVC geomembrane because the geonet cannot embed in the geotextile as it can into the PVC geomembrane. The inclusion of this unbounded geotextile/geonet interface, the lack of a pay item for the unbonded non-woven geotextile, and the subsequent deletion of this unbonded geotextile suggests that the strength of various interfaces was not well understood. It is possible that the design was just adapted from another site that probably did not have the extreme site access and oversteepened slope problems present at this site. This is reinforced by the following project chronology: (1) Construction Drawings dated April 4, 2001, (2) letter soliciting bids dated April 10, 2001, (3)

slope stability design calculations dated April 19, 2001, and (4) first Contract Bid Addendum dated April 27, 2001. Therefore, the slope stability calculations were conducted AFTER the construction drawings were prepared and bids were solicited. In addition, the slope stability analyses were performed before the Bid Addendum removed the unbonded geotextile below the geonet but the stability analyses do not consider the geonet/unbonded geotextile interface.

Figure 5: Original final cover system design from Plan Sheet C-9 with unbonded nonwoven geotextile below the drainage net.

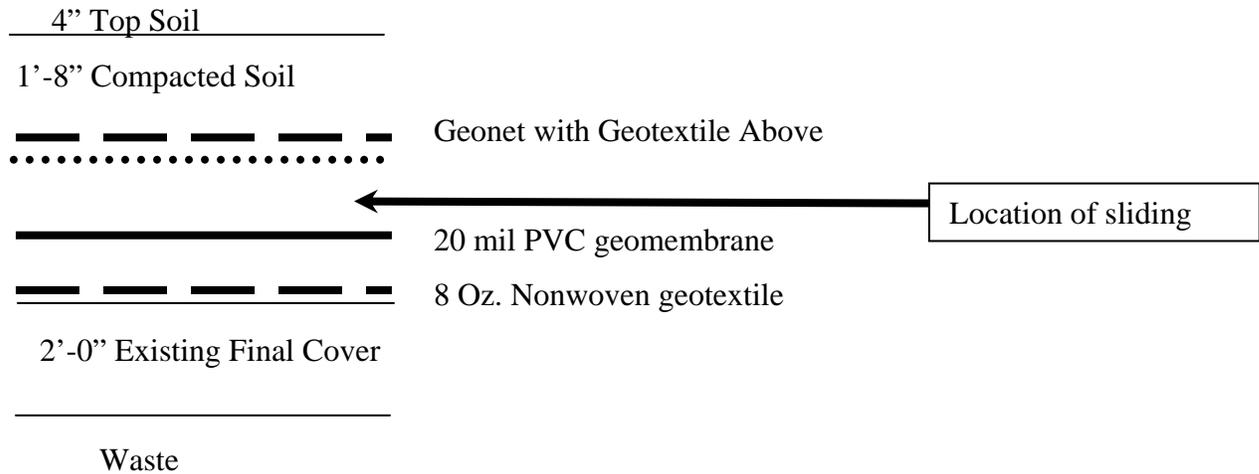
The cover system actually bid and initially attempted to be constructed by the contractor is shown in Figure 6. Figure 6 shows the unbonded, nonwoven geotextile removed from below the geonet with all other components shown in Figure 5 remaining the same. Figure 6 shows that sliding occurred on the geonet/PVC geomembrane interface.

Figure 6: Final cover system bid by contractor
