LANDSLIDE STABILIZATION USING GEOFOAM

G. MANN, P. E., President, Creative Engineering Options, Inc., 5418 159th Place NE, Redmond, WA 98052, (425) 883-6889; engineeringgm@comcast.net

T. D. STARK, Professor of Civil and Environmental Engrg., University of Illinois, Newmark Civil Engineering Laboratory, 205 N. Mathews Avenue., Urbana, IL, 61801-2352, (217) 333-7394; tstark@uiuc.edu

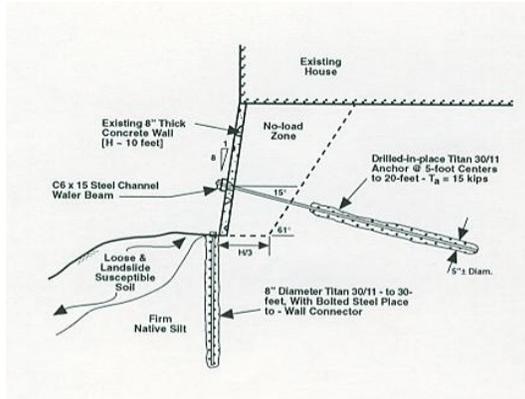
The first remedial step was to drill a series of Titan 30/11 anchors through the concrete panel to pin it in-place. Concurrently a series of vertical Titan 30/11 piers was drilled along the base of the concrete wall to provide vertical support. These Titan piers were structurally connected to the concrete panel wall with bolted-in-place steel brackets which were subsequently encased in concrete. This pinned the concrete panel firmly to the upper face of the western slope, and prevented the soil beneath the structure and the house foundation from future vertical or lateral movement.

Figure 1: Schematic of underpinning and anchorage of existing concrete wall.

The original deck supporting piers are connected to the existing concrete wall by “truss-like” grade beams. The loss of soil support around these piers had begun to initiate settlement, and a large portion of the deck load was transferred into the grade beams. This load transfer caused the distorting grade beams to impose an increasing lateral and vertical load on the concrete panel wall and this was beginning to pull the wall off the slope face. This was one of the primary reasons for providing supplemental vertical and lateral wall support.

The tie-back anchors were drilled to a depth of 6.1 m on 1.5 m centers at an angle of about 20 degrees. Anchor

resistance, determined to be 239.5 kPa/m, was achieved in the firm and competent native silt. After grout set up the anchors were locked off by hand against a C6x15 steel C channel which acts as a waler beam. Figure 1 shows a schematic of this system.

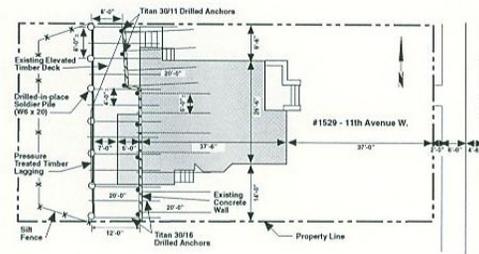
The second retaining structure, the anchored soldier pile and lagging wall, is constructed about 3.7 m downslope of the above-described concrete wall. This retaining structure is to re-support the timber deck and recreate some usable

flat back yard area. This retaining structure consists of 0.61 m diameter drilled soldier piles with timber lagging. W6x20 wide flange steel piles were inserted into each hole and provided a means of “retaining” the timber lagging. The pile holes were backfilled with 34,500 kPa concrete. Geofoam blocks are used to help reduce the vertical and lateral stresses on the retaining structure. Approximately 6.1 m long Titan 30/11 drilled anchors provide lateral restraint and extend into the firm and competent native silt soils. This installation is depicted in figure 2.

Figure 2: Plan view of the house, the two retaining structures, and the anchors.

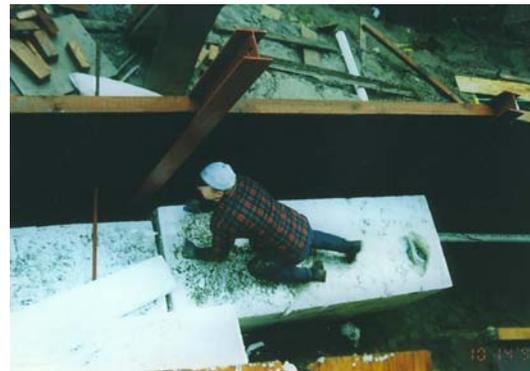
The geofoam used here is an XPS-VII manufactured by Big Sky Insulation of Belgrade, Montana. The compressive strength at less than 2 percent axial strain is 310 kPa and the unit weight is 0.35 kN/m^3 . The original Geofoam blocks were 2.4 m long, 1.2 m wide and 1.2 m thick. This thickness made the blocks difficult to handle, particularly in moderate to high wind conditions. To facilitate handling the contractor cut the blocks in half with a hot wire cutter. This size reduction allowed a single workman to lift, carry and place the individual blocks with ease [see Figure 3].

Figure 3. Geofoam block field installation.

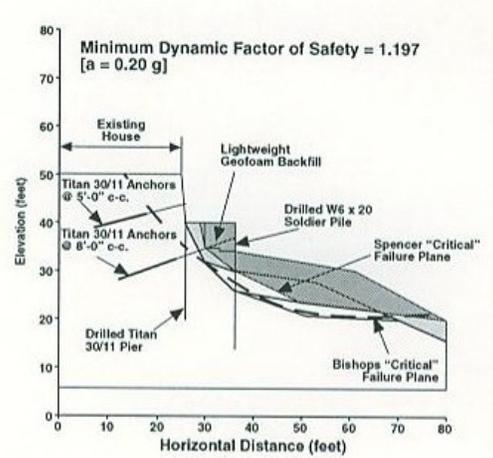
The cross-section in Figure 4 depicts the geometry and materials considered in the stability analyses. Using the soil parameters in Table 1, the cross-section in Figure 4 and the software and search routines in SLOPE/W, the minimum computed static and dynamic factors of safety are 2.1 and 1.3, respectively. The critical static and dynamic failure surfaces are shown in Figure 4. The pseudo-static (dynamic) analysis was conducted using a 0.2g horizontal seismic acceleration.

Figure 4. Slope section for stability analyses showing retaining structures, geofoam, and geologic materials.
