## **BACK-ANALYSES OF LANDFILL SLOPE FAILURES**

**Nejan Huvaj-Sarihan**

**Timothy D. Stark**

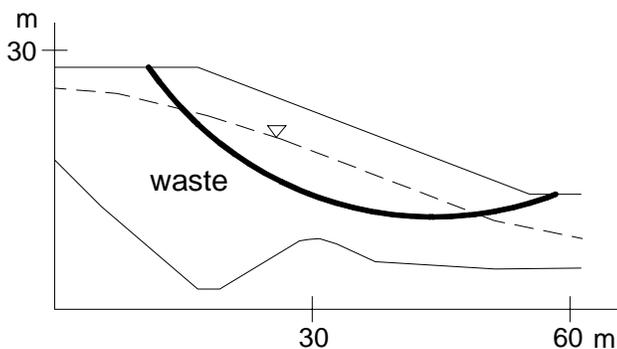
Based on piezometer records the groundwater/leachate level was found to be 3 to 5 meters below ground surface (Fig.1). No geosynthetic liner system was installed prior to waste placement and thus the waste is in contact with native materials and groundwater. The slope did not experience a large slide but tension cracks developed in buildings on top of the landfill indicating the onset of sliding. Some of the observed building cracks may be caused by waste settlement rather than slope movement but tension cracks were observed indicating the onset of slope instability. Because the slope did experience some movement, the Factor of Safety (F.S.) was assumed to be near unity for the back-analysis. To back-calculate an effective stress friction angle, the MSW was assumed to exhibit a cohesion intercept ( $c'$ ) of 0 kPa. The back-calculated friction angle ( $\phi'$ ) of the WF is 21°. The back calculated friction angle is reasonable considering the age of the waste. The landfill is estimated to be 300 years old. Therefore, the back-calculated shear strength of MSW would be expected to be close to the shear strength of a cohesive soil even though the WF is the newest of the waste layers. The average effective normal stress on the observed failure surface through the waste is 106 kPa and the corresponding back-calculated shear strength is 40.7 kPa.

Fig.1 Approximate slope profile of Gnojna Grora landfill in Warsaw, Poland (from Bouzza and Wojnarowicz 2000)

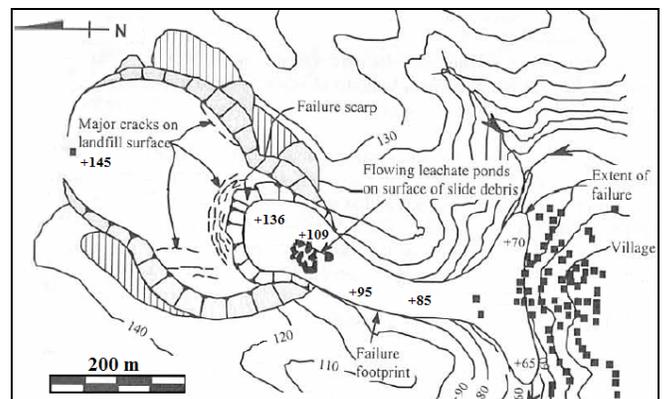
The catastrophic slope failure occurred on April 28, 1993 and resulted in 27 casualties and involved approximately 500,000 m<sup>3</sup> to more than 1,000,000 m<sup>3</sup> of waste (Fig. 2 shows a site plan view after the failure). Before the slide, 3 to 5 m of demolition debris and soil was placed on top of the uncompacted waste starting in mid-1992 to provide cover for the waste and to increase income obtained from the fees of dumping of demolition debris. Fires were known to be burning on the surface of the waste at several places during most of the year before the slide (Figs. 3 and Fig. 4 are photos from the landfill).

Fig. 2. Site plan view after slope failure (modified from Koerner and Soong 2000)

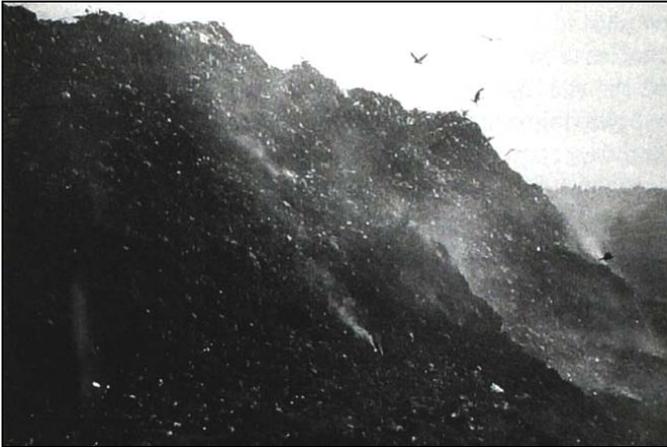
Fig. 3. Front slope of the MSW before slope failure showing surface fires and steep slope of the MSW (Kocasoy and Curi 1995).

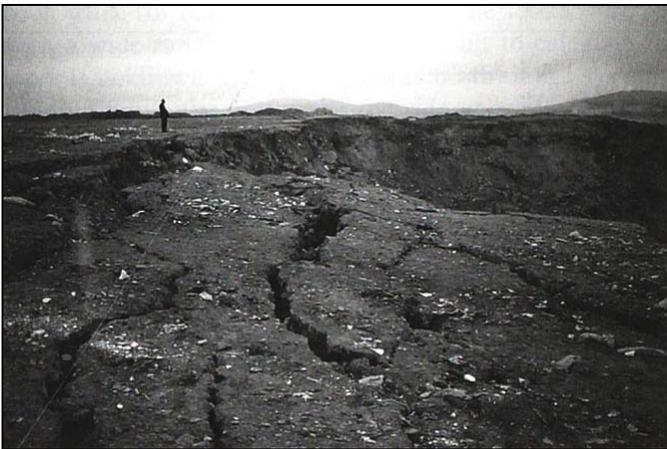
Fig. 4. Tension cracks on top of landfill and steep backscarp in MSW after slope failure (Kocasoy and Curi 1995)

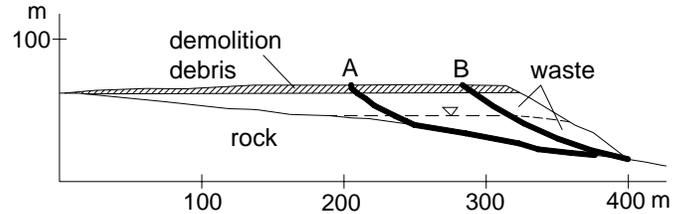
The approximate cross section of the landfill and the leachate level is shown in Fig. 5. The location of the actual failure surface in the field is not known. Search for the critical failure surface passing through the slope toe was performed and it is failure surface B in Fig. 5. This search resulted in a failure surface closer to the one described by Kocasoy and Curi (1995) than Koerner and Soong (2000). The figure in Kocasoy and Curi (1995) study didn't include a scale therefore the failure surface couldn't be used for this study. It is assumed

that their failure surface is the most reliable because it is based on based on their observations at the site and data they obtained from the municipality of Istanbul. A noncircular failure surface is assumed by Koerner and Soong (2000) and shown as failure surface A in Fig. 5. Water level from Koerner and Soong (2000) is at about 21 m below the top of the waste. Fires and explosion are not modeled in the slope stability analyses.

Fig. 5. Approximate cross-section of landfill and estimated slip surfaces (modified from Koerner and Soong 2000)

Because the observed failure surface at the time of failure is not known, both failure surfaces (A and B) in Fig. 5 are considered in the analyses. Weighted average values of the back-calculated average effective normal and shear stress pairs along the base of the failure surface are  $(\sigma'_n, \tau) = (170, 62 \text{ kPa})$  and  $(76, 68 \text{ kPa})$  for failure surfaces of A and B respectively. A circular failure surface (B) passing through the slope toe results in lower factors of safety than the noncircular failure surface (A) if one uses the same shear strength parameters for both cases. If a higher leachate level (leachate level at about 10 m below the top of the waste surface, not shown in Fig. 5) would be assumed (Kocasoy and Curi 1995, Koerner and Soong 2000), the corresponding backcalculated pair is  $(54, 77 \text{ kPa})$ . High leachate levels are believed to be more representative of the field conditions, therefore an average value of the two circular analyses  $(\sigma'_n, \tau) = (65, 72.5 \text{ kPa})$  is listed in Table 1.

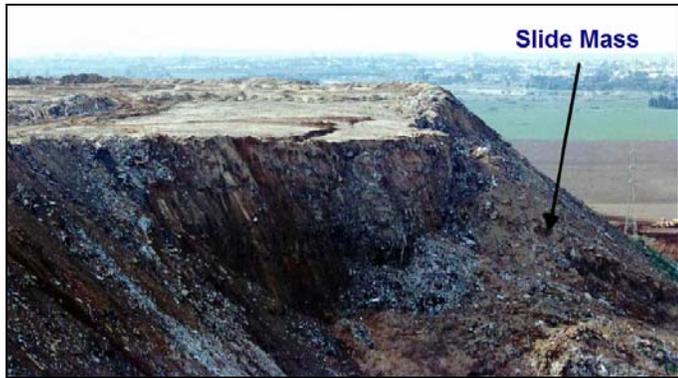
Side slopes of Hiriya landfill range from 1.3H:1V to 1.6H:1V with an average 1.44H:1V. The slopes are covered with a thin irregular soil cover, with waste exposed in some areas. Slope heights range from 43 to 64 meters, averaging 56 meters as measured above surrounding level terrain. As a result of the steep slopes, the lack of vegetation, drainage and erosion controls, the landfill has experienced small and large instability problems. In the winter of 1997-98 a major slope failure (Figures 6 and 7) occurred in the northern face of the dump, following a period of heavy rain, and the Ayalon River was blocked for some days.

Fig. 6. 1997 Hiriya landfill slope failure (Isenberg, 2003)

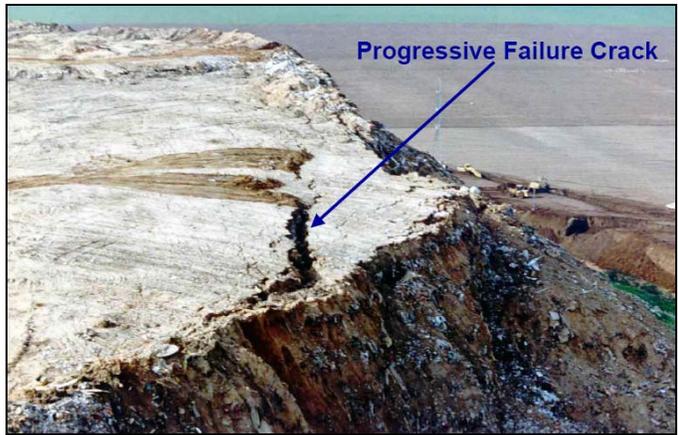
Fig.7. Top of Hiriya landfill after slope movement (Isenberg 2003)

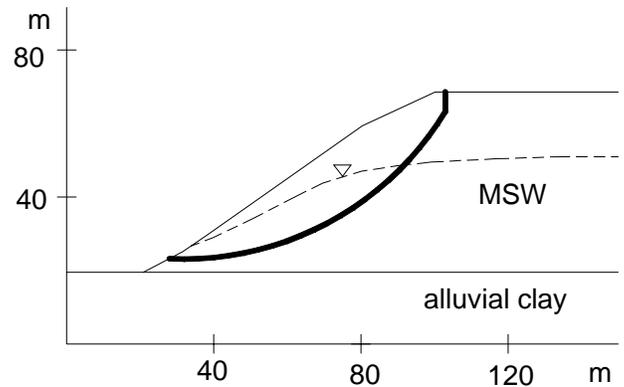
Figure 8 shows the cross section of Hiriya landfill, and the results of the back-analysis are presented in Table 1.

Fig. 8. Cross section of the Hiriya landfill (modified from Isenberg 2003)

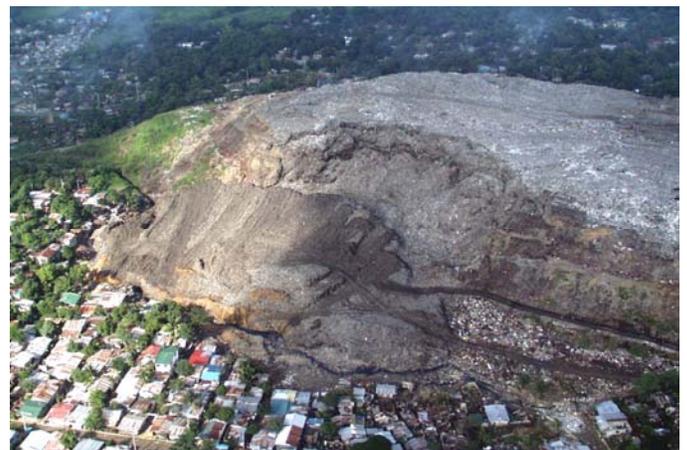
Fig. 9. Payatas landfill slope failure in 2000. (Kolsch and Ziehmman, 2004)

The picture of the observed failure in the field is shown in Fig. 9. Although the exact location of the failure surface is not

known, looking at the near vertical scarp, the thickness and movement of the displaced waste mass, and no sign of bulging at the toe to indicate a deeper seated failure surface through the underlying clay, the failure surface in the field seems to be shallower and mostly through the waste than failure surface A in Fig. 9. Therefore a critical circular failure surface was found using UTEXAS3 (shown as failure surface B in Fig. 11). This failure surface, together with unit weights of MSW from Merry et al. (2005), were used in a back-analysis. The weighted average effective normal stress along the failure surface is 45 kPa and the corresponding shear strength is 35 kPa.

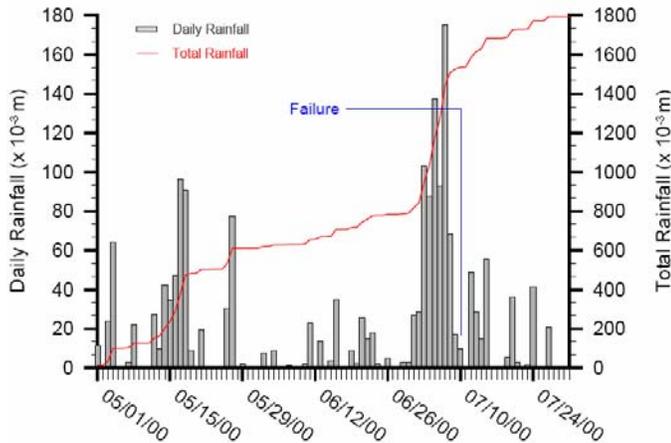
The exact mechanism of failure is not clear, but several factors probably contributed to the failure. These include heavy rains (68 cm rainfall caused by two typhoons that occurred in the area in the two weeks prior to the failure, see Fig.10) leading to the likely saturation of the entire waste mass; building up of waste that caused the side slopes to be steeper than recommended (1.5H:1V at the time of failure); ponding of water on the top of the slope; the construction of drainage trenches at the top of the slope to drain this ponding water; construction of a 2 to 3 m deep drainage ditch at the toe of the slope; and the potential build-up of landfill gas (Merry et al. 2005).

Fig.10. Precipitation record at Quezon City Weather Station in Philippines during May thru July 2000 (Merry et al. 2005).

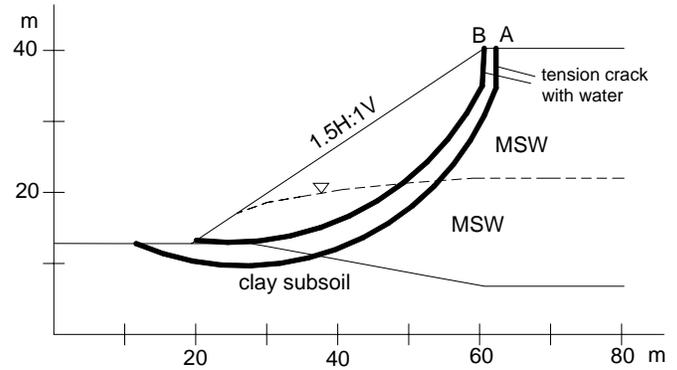
Merry et al. (2005) assume that the failure surface passes through the waste and the underlying natural clay (failure surface A in Fig. 11). In this study, using the failure surface A in Fig. 11, and using the unit weights of MSW and clay substrata, and shear strength of clay substrata given by Merry et al. (2005), a cohesion of 20 kPa, and a friction angle of 32 degrees are back-calculated for the MSW. The back-analysis is correct if the location of the failure surface used in the analysis represents the observed failure surface in the field, and the shear strength of the underlying clay strata is known. The weighted average effective normal stress along the portion of the failure surface that passes through the waste is 62 kPa and the corresponding shear strength is 59 kPa. Although Merry et al. (2005) did not back-calculate the shear strength of the MSW, they suggest using a cohesion of 19 kPa

and a friction angle of 28 degrees based on Geosyntec (1998) and Kavazanjian (2001). These parameters lead to an average effective normal stress along the failure surface through the MSW of 62 kPa and a shear stress of about 52 kPa, which is in agreement with the back-calculated shear strength parameters in this study.

Fig. 11 Cross section of Payatas landfill slope failure (modified from Merry et al. 2005)

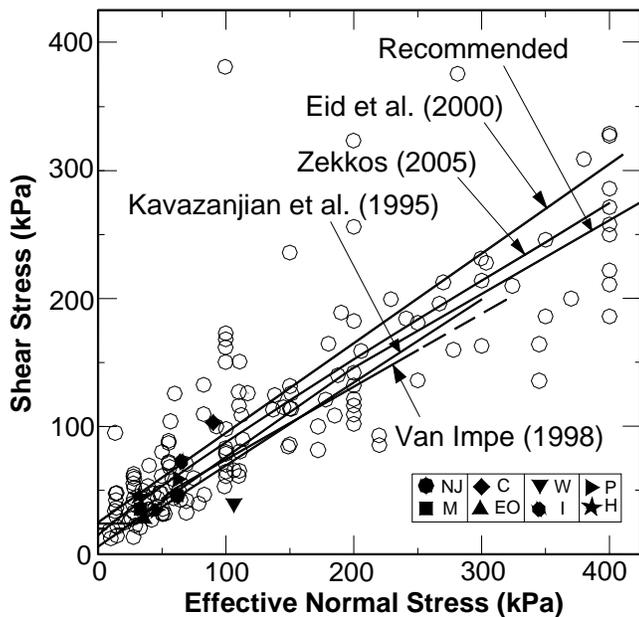
Figure 12 shows a summary of back-calculated MSW shear strengths given in Table 1, together with other four landfill slope failures back-analyzed and reported by Stark et al. (2000) and Eid et al. (2000). These previously analyzed cases are located in New Jersey (NJ), Maine (M), Cincinnati (C) and Eastern Ohio (EO) landfills. Also in Fig. 12 various published shear strength envelopes for MSW are presented. A recommended strength envelope is developed by Stark et al. (2007) based on an extensive literature review on the laboratory and field measurements of shear strength of MSW, which are shown as open circles in Fig. 12. The cases analyzed in the current study have low effective normal stress range. It would be interesting to look at cases where the effective normal stress on the failure surface along the MSW is large. This would aid in determining the MSW shear strength at large effective stresses. The interest in mega-landfills with effective stresses in the waste up to more than 1,000 kPa is necessitating MSW shear strength parameters at high effective stresses.

Fig.12. Summary of back-calculated MSW shear strength shown with four other landfill slope failures, and published failure envelopes (modified from Stark et al. 2007)

More case history analyses and laboratory and field testing of shear strength is needed on fresh waste and degraded (old) waste to better understand its mechanical behavior and shear strength. In the interim, a bilinear shear strength envelope is recommended based on Stark et al. (2007) and this study. The recommended bilinear envelope is,  $c' = 6$  kPa and  $\phi' = 35^\circ$  degrees for effective normal stresses less than 200 kPa, and  $c' = 30$  kPa and  $\phi' = 30^\circ$  degrees for effective normal stresses more than 200 kPa.
