LANDSLIDE IN AN URBAN ENVIRONMENT

By: Timothy D. Stark and Erik J. Newman

ABSTRACT: The causation of distress in two housing developments located downslope of a large development is discussed. The investigation shows that distress in the housing developments was caused by a large, deep bedrock landslide triggered by upslope fill placement. A large fill was placed to create a visual barrier between the existing housing developments and the large upslope structure and to balance the cut and fill quantities of the upslope development. This case history illustrates some of the ramifications of fill placement on natural slopes surrounded by urban areas such as, overstressing underlying weak bedrock material that may exist below the depth of subsurface investigations that are typically conducted for single family residences, the importance of surface and subsurface information in complicated geologic settings, and the effect of natural and man-made changes to a slope, such as rainfall, surficial grading, home construction, and fill placement, on slope stability. This case history also illustrates the importance of locating the critical cross-section before construction and designing th

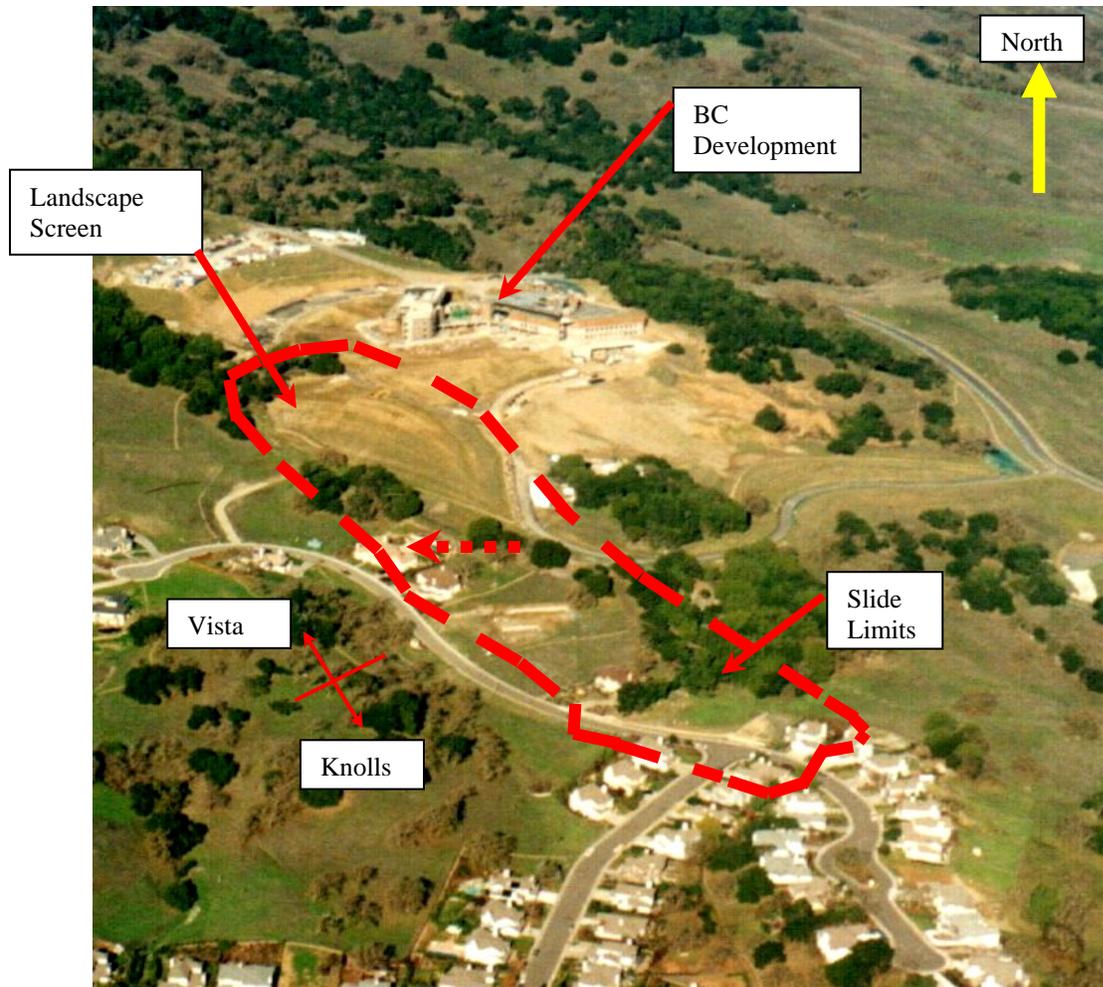
referred to as the BC Development, and an outline of the slide mass. Only a portion of the housing units in the Knolls and Vista development are shown in Figure 1.

Fig. 1. Aerial view of housing developments, BC Development, and an outline of the slide mass

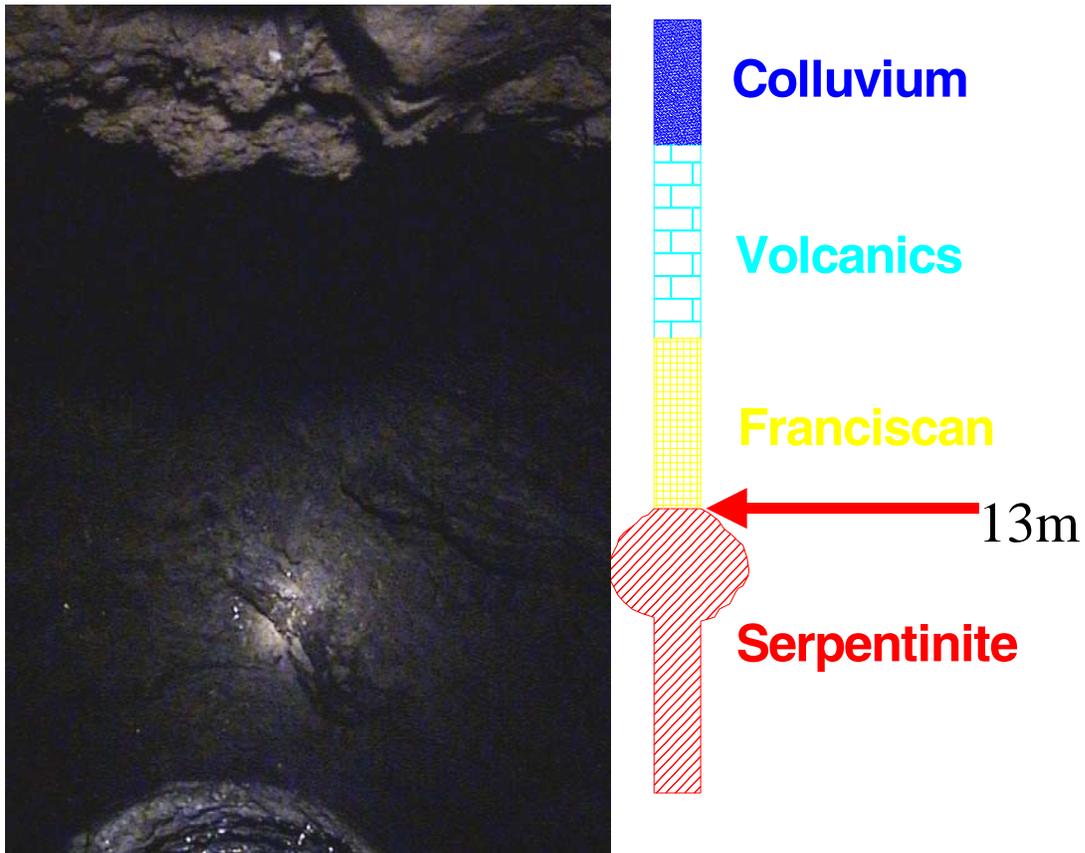
The first important observation from Figure 2 is that the serpentinite caved in and thus the clay matrix in the serpentinite could not support the blocky material in the open boring. As a result, frequent splashes from serpentinite entering the water filled bottom of the boring could be heard. The serpentinite caved in such that a 2.0 to 2.5 m of material from the edge of the boring was removed as shown in the diagram to the right of the photograph in Figure 2. Also shown in the photograph in Figure 2 is the diameter of the boring returned to about 0.6 m after the 4 to 5 m thick zone of caving serpentinite. This is in agreement with sliding being observed through this zone of serpentinite in the adjacent slope inclinometer. Because the serpentinite caved in 2.0 to 2.5 m from the edge of the boring, samples of this serpentinite could not be obtained. As a result, the testing described previously was conducted on grab samples from the auger while the

two 0.6m diameter borings progressed through this layer and on grab samples obtained from previous 0.6 m diameter borings. Above the location shown in Figure 2, the soil materials were able to support themselves and the boring maintained a diameter of about 0.6 m. This is in agreement with the adjacent inclinometer indicating a well defined movement plane below these stronger materials that overlie the serpentinite.

Fig. 2. View of caving serpentinite at a depth of 13 to 15 m in a 0.6 m diameter boring

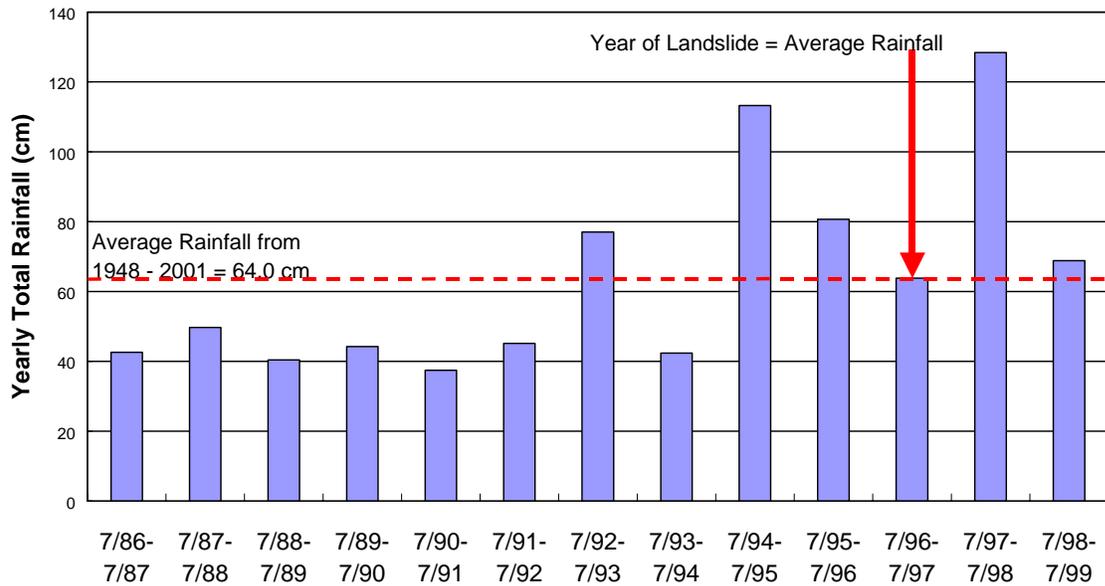
In general, the depth to groundwater is related to the amount of precipitation. High levels of precipitation usually result in higher levels of groundwater and vice versa. Thus, it is important to compare rainfall records prior to and during the year that movement is first reported to determine if rainfall is the trigger of the landsliding. To investigate the impact of rainfall on the causation of the landslide, the rainfall records from the nearby Petaluma Fire Station are summarized in Figure 3. Petaluma is the next town north of Novato, California. The yearly rainfall total from July 1 to June 30 of each year is presented in Figure 3. The Knolls housing development, which suffered the most damage, was completed between 1988 and 1989. Between 1989 and 1992-1993 rainy season, the area received below average rainfall. The fifty-three year average rainfall for the Petaluma Fire Station from 1948 to 2001 is 64.0 cm. In the 1992-1993 rainy season, 77 cm of rainfall or 13 cm above average rainfall occurred. The area also experienced above average rainfall in the 1994-1995 (113.2 cm) and 1995-1996 (80.7 cm) rainy seasons without any reports of distress even though the 1994-1995 rainfall exceeded the 53 year average by 49.2 cm. The reports of distress started in late December 1996 during a year of essentially average rainfall (63.8 cm) see Figure 3.

In summary, prior to the reported distress in late December 1996, more rainfall occurred in three prior years and no landslide occurred. The major difference between these years and 1996-1997 when landsliding did occur is the landscape screen had not been constructed. In the 1996-1997 rainy season, less rainfall occurred than in several previous years and a landslide occurred. As a result, it can be concluded that rainfall alone did not trigger this landslide and thus the investigation focused on the third factor, driving force.

Fig. 3. Annual rainfall data from nearby fire station

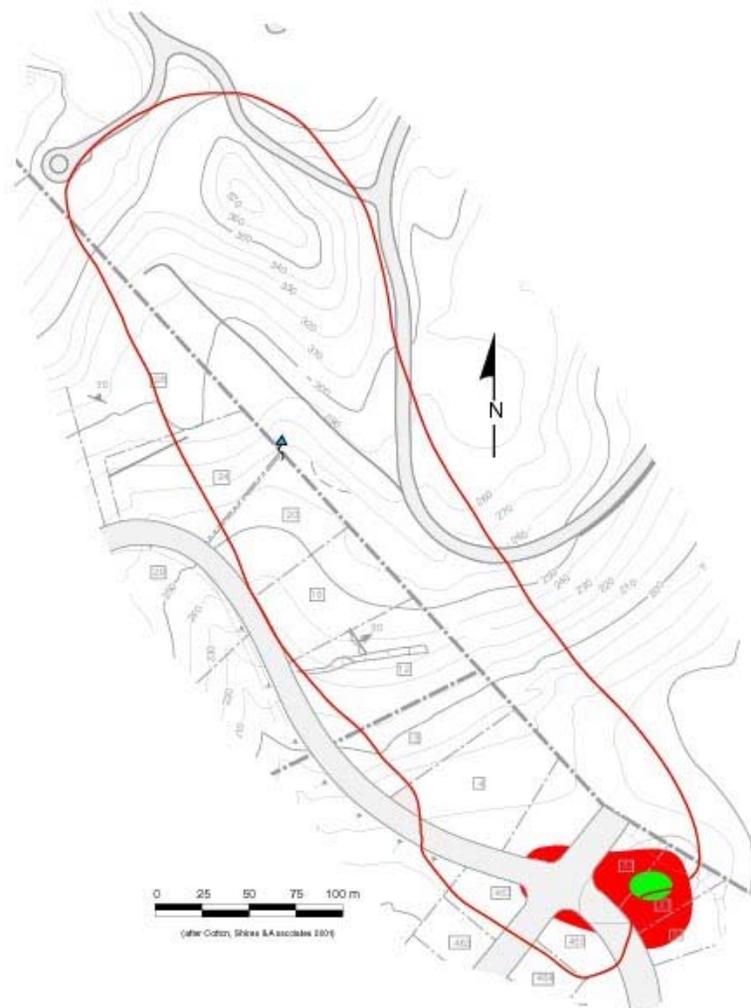
Figure 4 presents a plan view of the landslide area with the slide limits from Figure 1 superimposed. In the eastern portion of the landslide toe the maximum depth of material removed during the surficial grading is approximately 6.5 m. The area corresponding to a removal of more than 6.1 m of material is indicated by the small ellipsoidal area in the eastern portion of the landslide toe. This maximum depth of excavation is due to a small hill that was situated at that location and had to be removed to create a level building pad for the house that would be constructed on the pad. Figure 4 also shows a larger area that corresponds to a depth of excavation exceeding 3.5 m. This area again is in the eastern portion of the landslide toe which is significant because subsequent stability analyses will show that the critical cross-section is located in the western portion of the landslide toe and outside both shaded areas in Figure 4. If the removal of the small hill had caused the landslide by reducing the buttressing effect and lowering the normal stress, most, if not all, of the landslide toe would have occurred through the point of maximum excavation. However, Figure 4 shows that a large portion of the landslide toe is the western portion where the removal of material is less than 2.5m. The maximum depth of excavation to create building lots in the western portion of the slide is about 2.5 m.

In summary, the surficial grading conducted to facilitate the construction of the Knolls development did not trigger the landslide in 1996 because (1) the landslide occurred 7 to 8 years after the surficial grading and after several years of significantly above average rainfall, (2) the maximum amount of excavation did not occur in the critical portion of the slope and thus did not impact the triggering of the landslide, (3) a large portion of the landslide toe occurs outside of the area of the largest surficial grading and if grading did destabilize the slope the landslide toe would be concentrated at the point of the deepest excavation, and (4) the maximum depth of excavation is 6.5 m and is insignificant compared to a depth of landsliding of 36 m measured in two slope inclinometers because shallow excavations usually do not trigger deep bedrock landslides.

Fig. 4. Plan view illustrating the areas of greater than 3.5 m and 6.1 m (ellipsoidal area) of surface grading

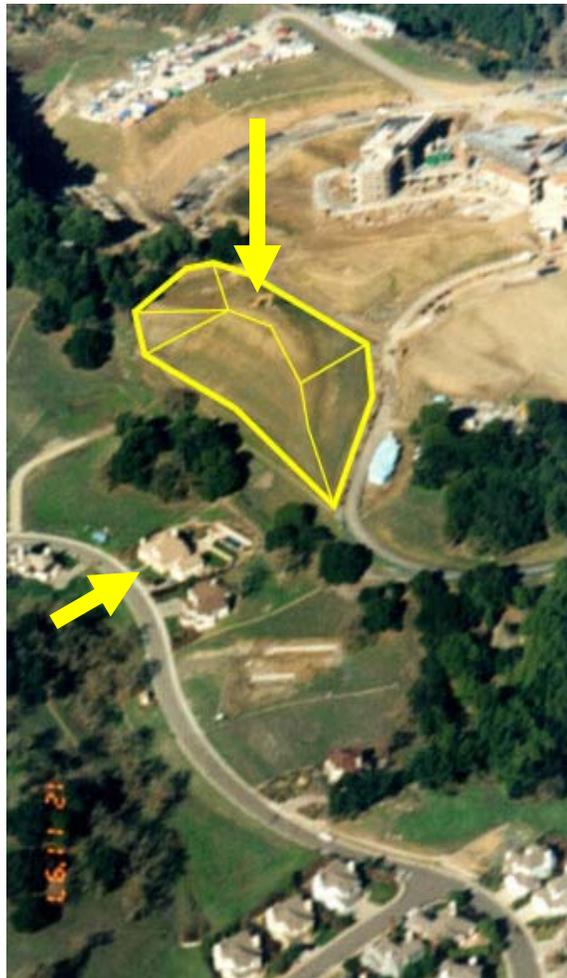
The other change in the driving forces acting on the slope is the placement of the landscape screen. Figure 5 provides a comparison of the landscape screen to the homes in the Vista development. The landscape screen has a height of at least 22 m above the adjacent natural terrain and has a length and width of about 165 and 80 meters, respectively. The volume of the landscape screen when fill placement ceased is approximately 76,600 cubic meters, which corresponds to about 147 million kg of soil assuming a soil unit weight of 18.8 kN/m³.

Fig. 5. Aerial illustrating size of landscape screen in relation to a 375 m² single family residence (see arrow) and an excavator on the top of the landscape screen (see arrow)

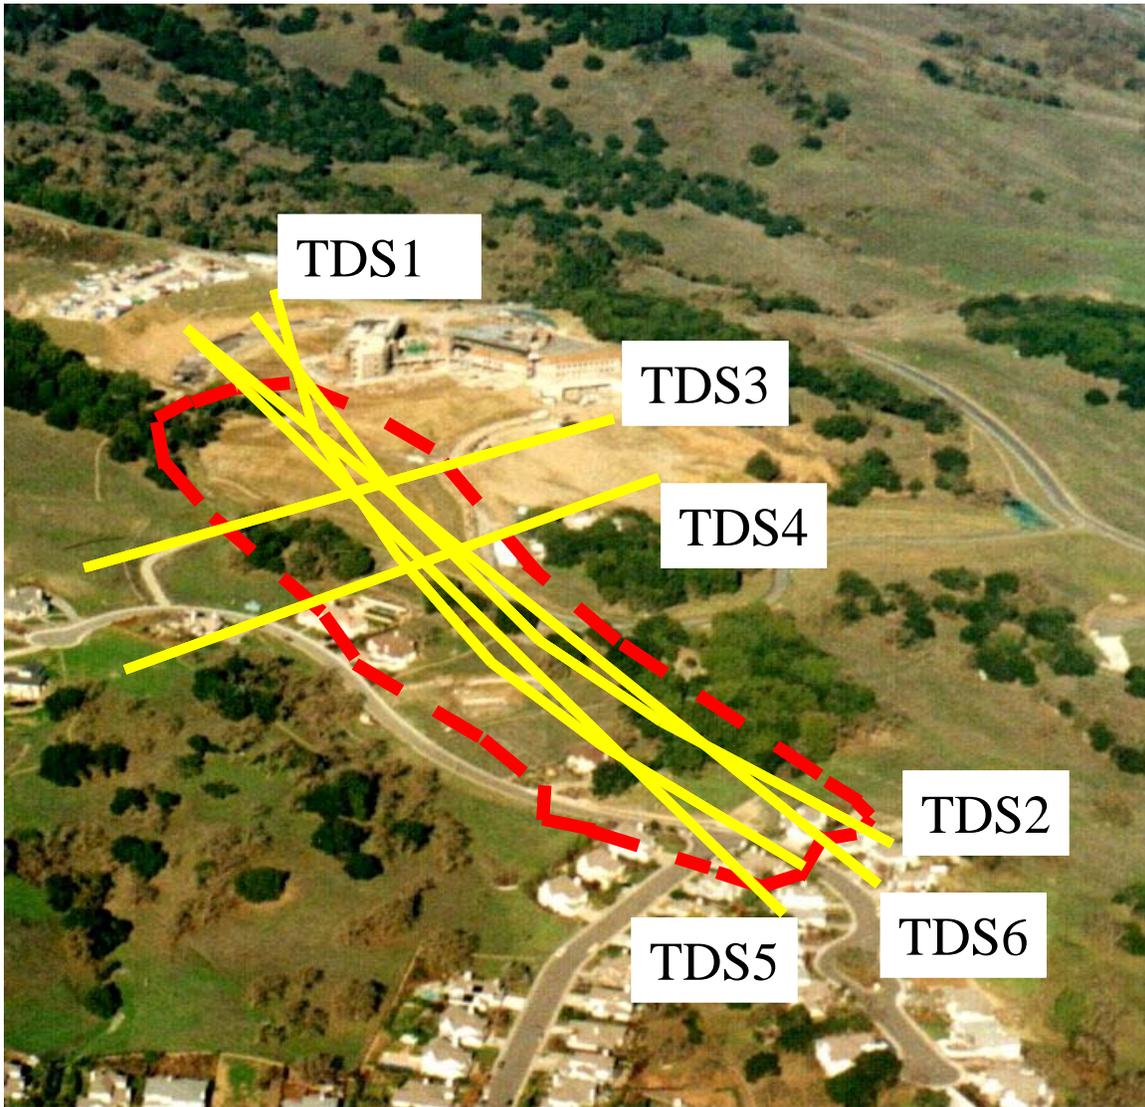
Knowing that the landslide is underlain by the highly variable Franciscan Complex, six cross-sections were drawn to gain an understanding of the materials present, the variability of the materials, and the presence of unusual and varying subsurface features, such as the buried sandstone ridge under the eastern portion of the slide mass. These six cross-sections are shown in Figure 6 and not only extend the length of the slide mass but also traverse the slide mass to determine material variability and distribution of the weak layer. The cross-sections are labeled TDS1 through TDS6 and stability analyses were performed on all of the cross-sections that extend the length of the slide mass, i.e., are in the direction of sliding. Cross-sections TDS1 and TDS5 (see Figure 6) extend through the western portion of the landslide toe while TDS2 and TDS6 extend through the eastern portion of the landslide toe. The stability analyses reveal that TDS5 and TDS6 are the critical cross-sections, i.e., yield the lowest factors of safety, for the western and eastern portions of the landslide toe, respectively. As a result, the forensic analysis described subsequently provides a comparison of the results obtained using cross-sections TDS5 and TDS6. However, drawing of the six cross-sections provided an invaluable insight to the subsurface conditions underlying the landslide especially cross-sections TDS3 and TDS4 which traverse the slide mass. These cross-sections reveal the presence of a buried sandstone ridge that increases from a depth of about 40m on the western portion of the slide mass to a depth of about only 18m on the eastern portion of the slide mass in the vicinity of TDS4.

Fig. 6: Aerial view of the landslide illustrating the six cross-sections considered in the forensic study.

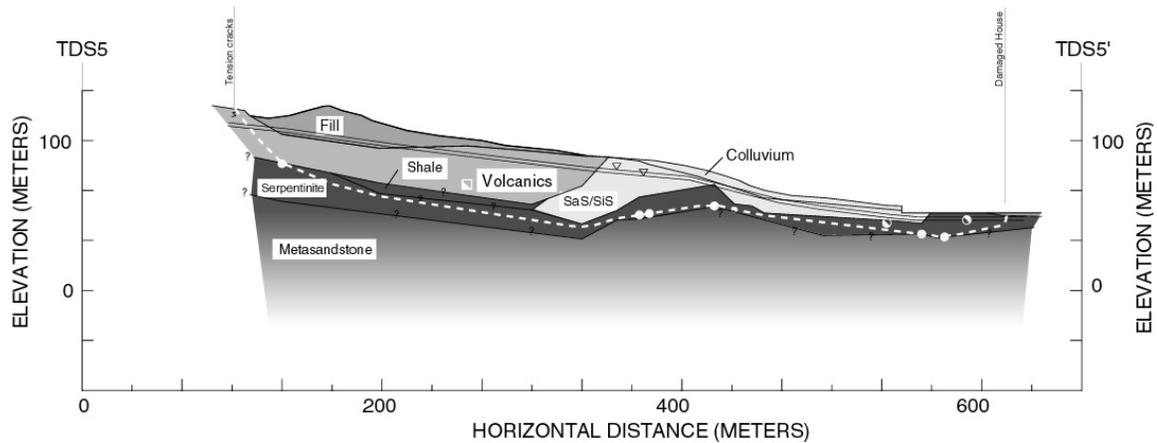
Nine of the fifteen slope inclinometers installed after the initial report of distress provide useful information but the other six are either too shallow or outside the slide limits shown in Figure 1 and do not provide direct information on shear movement of the slide. Each of the nine useful inclinometers show only one slide plane at depths ranging from 5 m near the landslide toe to 40 m near the middle of the slide mass. The depth of movement from the inclinometers is plotted on cross-section TDS5 in Figure 7.

Fig. 7: Cross-section TDS 5 through the western portion of the landslide after surficial grading and placement of the landscape screen

Figure 7 presents the depth of movement or the total depth of the inclinometer in the fifteen inclinometers with various data symbols. The solid circle corresponds to an inclinometer that is within 30 m of cross-section TDS5 and distinct shear displacement is observed. The partially shaded circle corresponds to an inclinometer that that is not within 30 m of TDS5 but shear displacement is present, and a partially shaded square corresponds to an inclinometer that is not

within 30 m of TDS5 and the inclinometer is too shallow and thus the failure surface should pass below this inclinometer. The failure surface shown in Figure 7 (see dashed line) was developed by connecting the location of shear movement in the inclinometers, following the various material types, and passing the failure surface through the cracks observed at the top of the landslide and the housing distress observed at the landslide toe.

Based on field observations, slope inclinometer results, and the stratigraphy developed from the results of the subsurface investigation, the failure surface passes through the Tertiary Volcanics upslope of the landscape screen at a steep inclination to the underlying weak and saturated serpentinite (Figure 7). The failure surface continues along the serpentinite layer until the depth of overburden allows it to daylight in the Knolls housing development and destroy four homes at the landslide toe. The landslide also damaged the homes in the Vista development that are at or near the western edge of the slide mass. The other homes did not show substantial landslide damage because they are located inside of the slide boundaries and are essentially “along for the ride”.

In summary, the failure surface shown in Figure 7 corresponds to a translational failure mechanism although it is somewhat atypical in that it passes up and over a sandstone ridge near the middle of the cross-section.

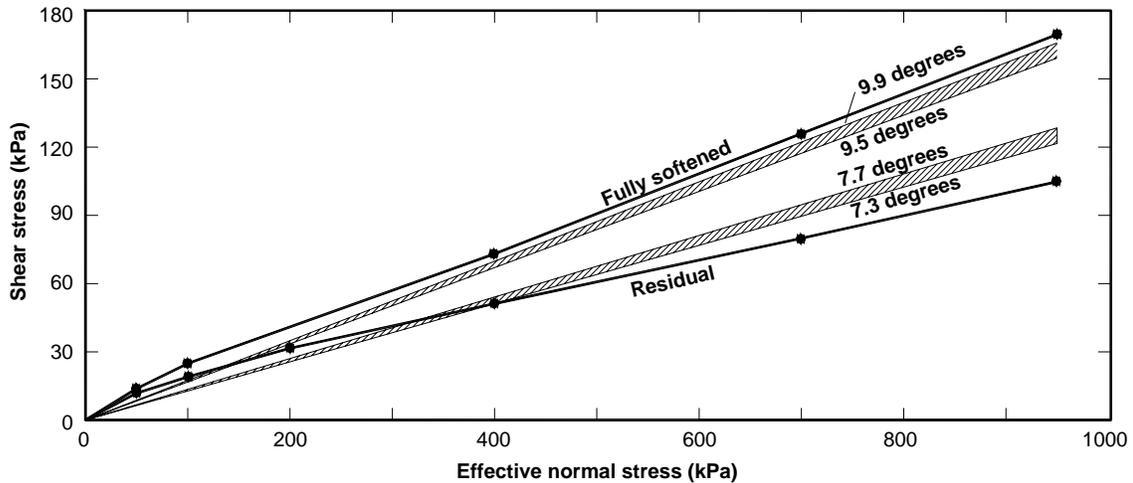
The serpentinite has undergone shearing over geologic time but there is no evidence of prior landsliding along the failure surface shown in Figure 7 and thus a residual strength condition is probably not applicable to the observed failure surface for the causation of the landslide. However, a residual condition may be applicable for the design of remedial measures. In addition, if a residual strength condition had been mobilized along the failure surface shown in Figure 7 a small increase in the driving force or reduction in resistance, e.g., surficial grading, would have caused a reactivation of movement. The landscape screen is a large increase in driving force and the movements were increasing when the removal of screen commenced indicating the onset of post-peak behavior.

Fig. 8. Serpentinite failure envelopes derived from torsional ring shear tests and back-analyses
