Title of Paper (maximum eight words): The 10 July 2000 Payatas Landfill Slope Failure

The 10 July 2000 Payatas Landfill Slope Failure

ABSTRACT: *This paper presents an investigation of the slope failure in the Payatas landfill in Quezon City, Philippines. This failure occurred 10 July 2000, after two weeks of heavy rain from two typhoons and killed at least 278 people. Slope stability analyses indicate that the raised leachate level, existence of landfill gas created by natural aerobic and anaerobic degradation, and a significantly over steepened slope contributed to the slope failure. The Hydrologic Evaluation of Landfill Performance (HELP) model was used to predict the location of the leachate level in the waste at the time of the slope failure for analysis purposes. This paper presents a description of the geological and environmental conditions, identification of the critical failure surface, and a slope stability analysis to better understand the failure to present recommendations for other landfills in tropical areas. In addition, this case history is used to evaluate uncertainty in parameters used in back-analysis of a landfill slope failure.*

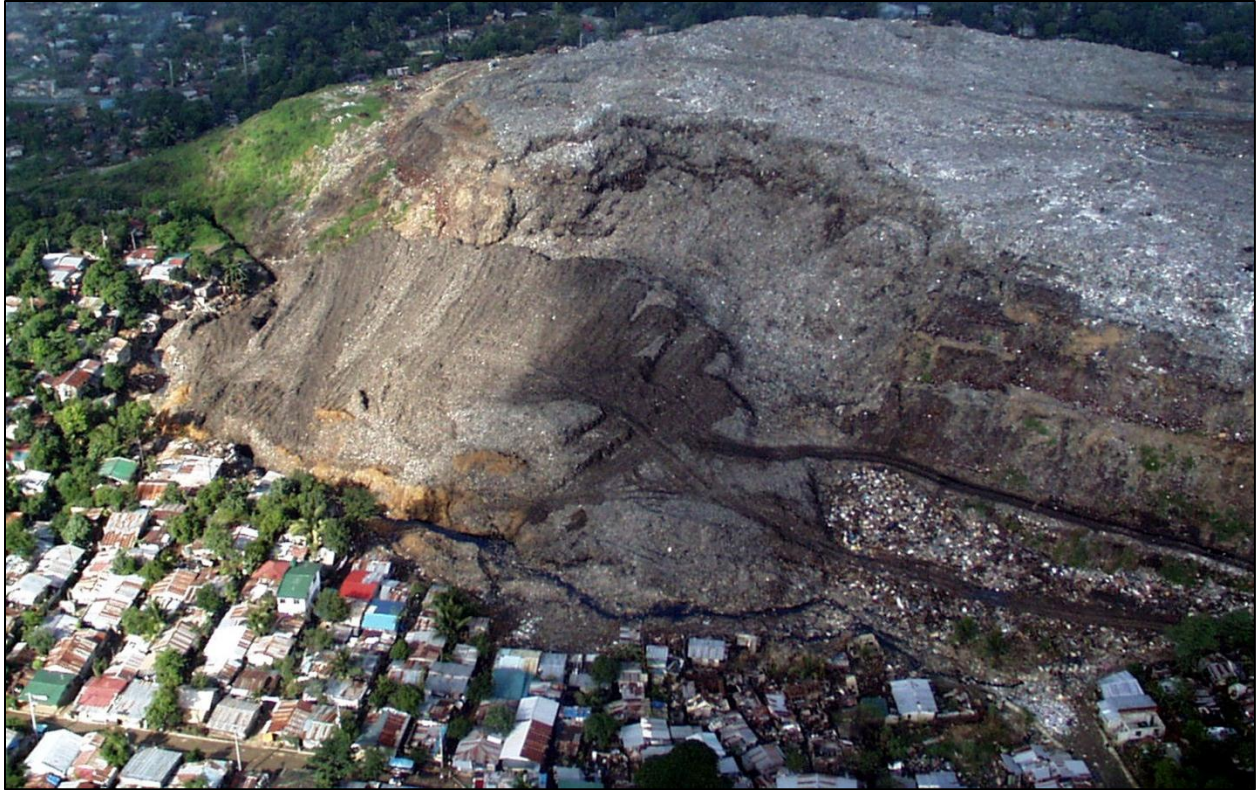
Figure 2. Aerial view of 12.7 hectare Payatas Landfill with slope failure and homes visible in foreground (photo by S.M. Merry).

Each of the above-referenced shear strength recommendations were developed for MSW below its field capacity. When fine-grained materials are intermixed with partially saturated MSW, negative pore pressures may exist in the partially saturated media. If the negative pore pressures are ignored, the total and effective stresses are equal and the shear strength envelopes may be directly compared. The MSW strength envelopes have generally resulted in progressively higher shear strengths, although recent work (e.g., Stark et al. 2009 and Bray et al. 2010) tends to reduce the shear strength at higher normal stresses due to the stress dependent nature of MSW. MSW strengths for effective normal stresses of 500 kPa or less are considered herein because of the shallow nature of the Payatas slope failure suggested by Figure 2.

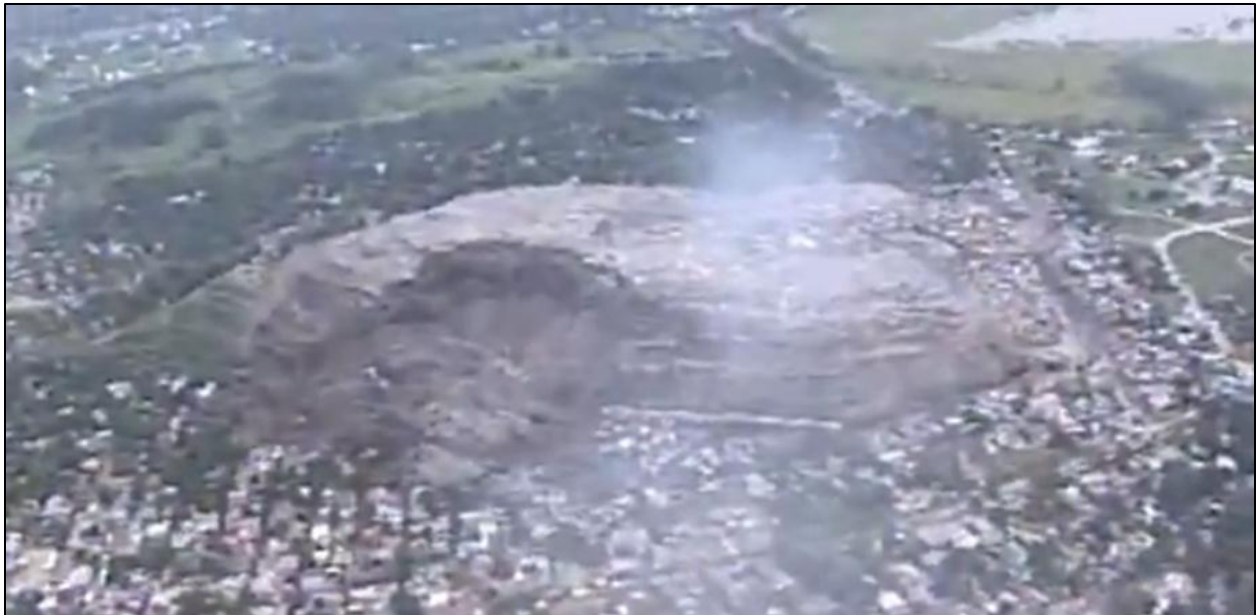
Figure. 3 Aerial view of waste slide from news video before regrading of slide mass (<http://www.abs-cbnnews.com/>).

The failure surfaces shown in Figure 11 were estimated from photographs in Figures 2, 3, 5, and 6 and consist of a shallow circular and shallow planar failure surface through only the MSW. From Figure 3, the authors surmise that the failure

surface is shallow in nature, and the waste mass slid down the side slope as a mass, i.e., a slab or sliver slide. Subsequently, ledges developed along the main scarp formed from vertical blocks toppling over or sliding down, see Figure 3. Therefore, it was concluded that the failure surface passed from the crest of the slope through the MSW, and exited at the slope toe and did not enter the underlying brown native clayey silt.

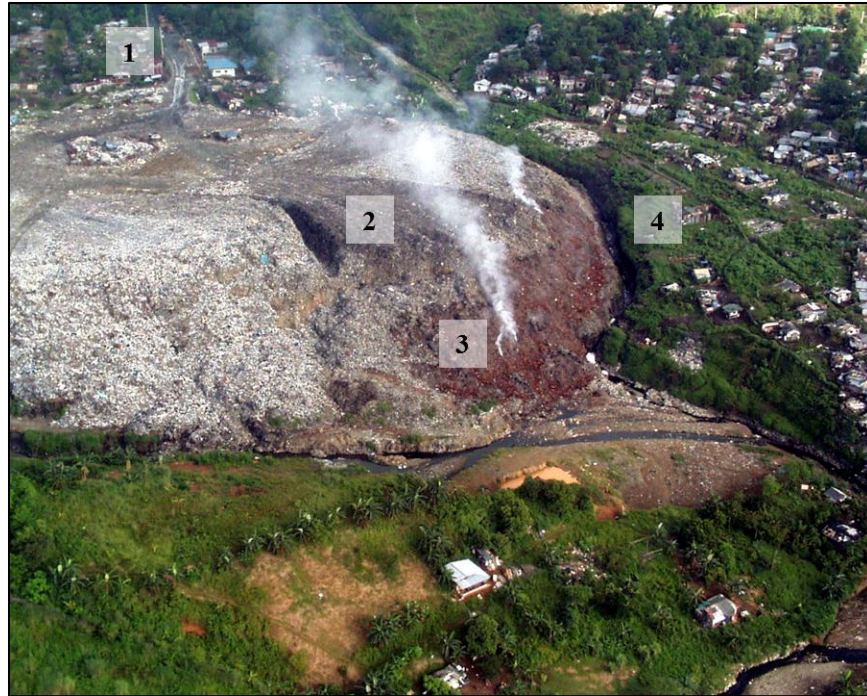
This section describes observations of a smaller landfill immediately southeast of the waste failure that helps interpret the waste slide. These observations are based on both site reconnaissance and photos. Figure 4 shows the slopes at this smaller landfill, which did not fail after both typhoon events although both facilities followed the same landfill operation procedures. The following bulleted sections discuss in numerical order the labels shown in Figure 4:

2. A deep, man-made trench at the slope crest was excavated to collect and channel surface precipitation. Although this trench did not result in slope failure, a similar trench was observed near the failed waste mass. The trench is believed to have acted as a water-filled tension crack, where the failure plane intersects the bottom of the crack. The tension crack depth increased with frequency of precipitation and subsequent waste erosion. Also, the trench provides a direct conduit of water to lower depths of the landfill, thereby decreasing effective stress in the waste. This landfill, like the landfill with the slope failure, did not have a soil cover on the top of the facility, which allowed for faster infiltrate of precipitation over a large area of the landfill;

3. A combination of steam or smoke is emanating from the slope in the foreground. It is common for steam or smoke to be present because of the large area of uncovered MSW that can result in spontaneous combustion. Residents living downslope of the failure heard a loud explosion before the waste failure (Merry et al. 2005). The explosion may have been facilitated by elevated gas pressures due to MSW degradation and steam or smoke due to spontaneous combustion of the exposed MSW;

4. A leachate collection trench surrounds the landfill periphery and is used to collect and remove leachate seeping from the waste pile.

Figure 4. Stable landfill south of landfill with waste slide showing smoke plumes (photo by S.M. Merry).

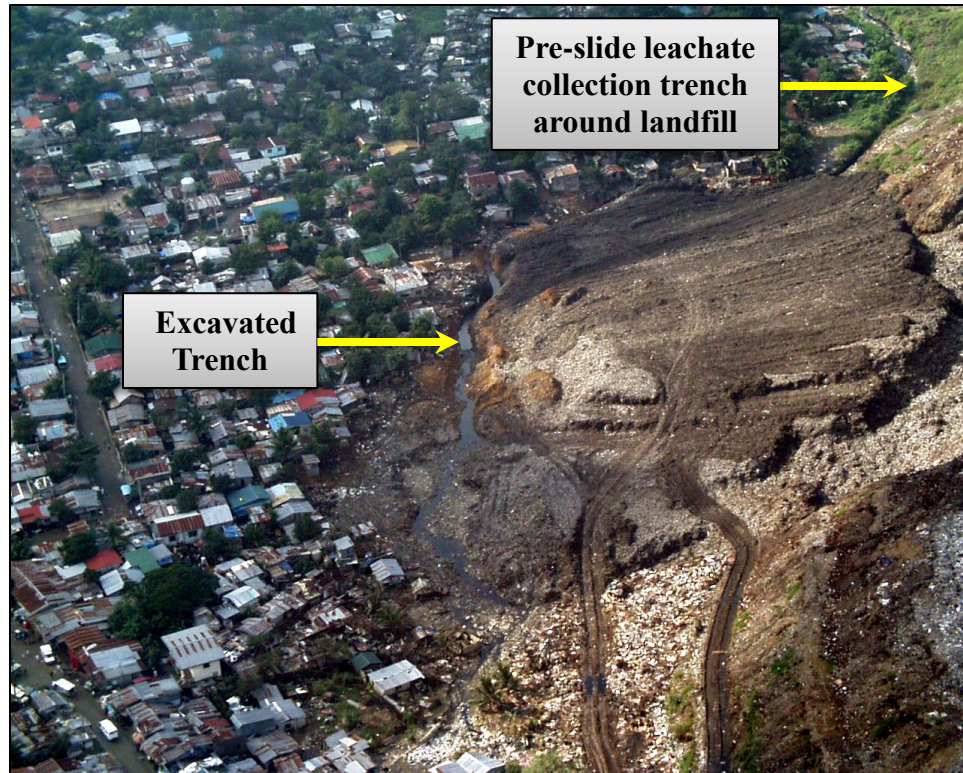
Figure 5 shows a close-up of the slope failure area and scarp in Payatas Landfill. Regrading of the slide mass had started shortly after the failure and can be seen in Figure 5. A leachate collection trench was excavated along the toe of the slide mass and is highlighted by the arrow and text box in Figure 5. The native brown soil underlying the waste and residential area is visible along the toe and sides of this excavated leachate collection trench. Leachate seepage existed prior to and shortly after the slope failure; however, the exact leachate level in the landfill just prior to failure is not known. A smaller landfill leachate collection trench was present along the slope toe prior to the slide and was similar to the trench shown in Figure 4. The prior leachate collection trench is not visible in Figure 5 because the slide mass covered the pre-slide location of the trench. Evidence of the pre-slide leachate collection trench around the landfill is visible at the top of Figure 5, where a small trench separates homes from the landfill toe and is highlighted by an arrow and text box. In summary, Figure 5 indicates that the leachate trench in front of the slide mass was constructed after the slide to collect leachate exiting the slide mass and a considerable volume of leachate existed in the landfill prior to failure but the exact leachate level at failure is not known.

Figure 5. Slope failure showing new and existing leachate trenches along slope toe (photo by S.M. Merry).

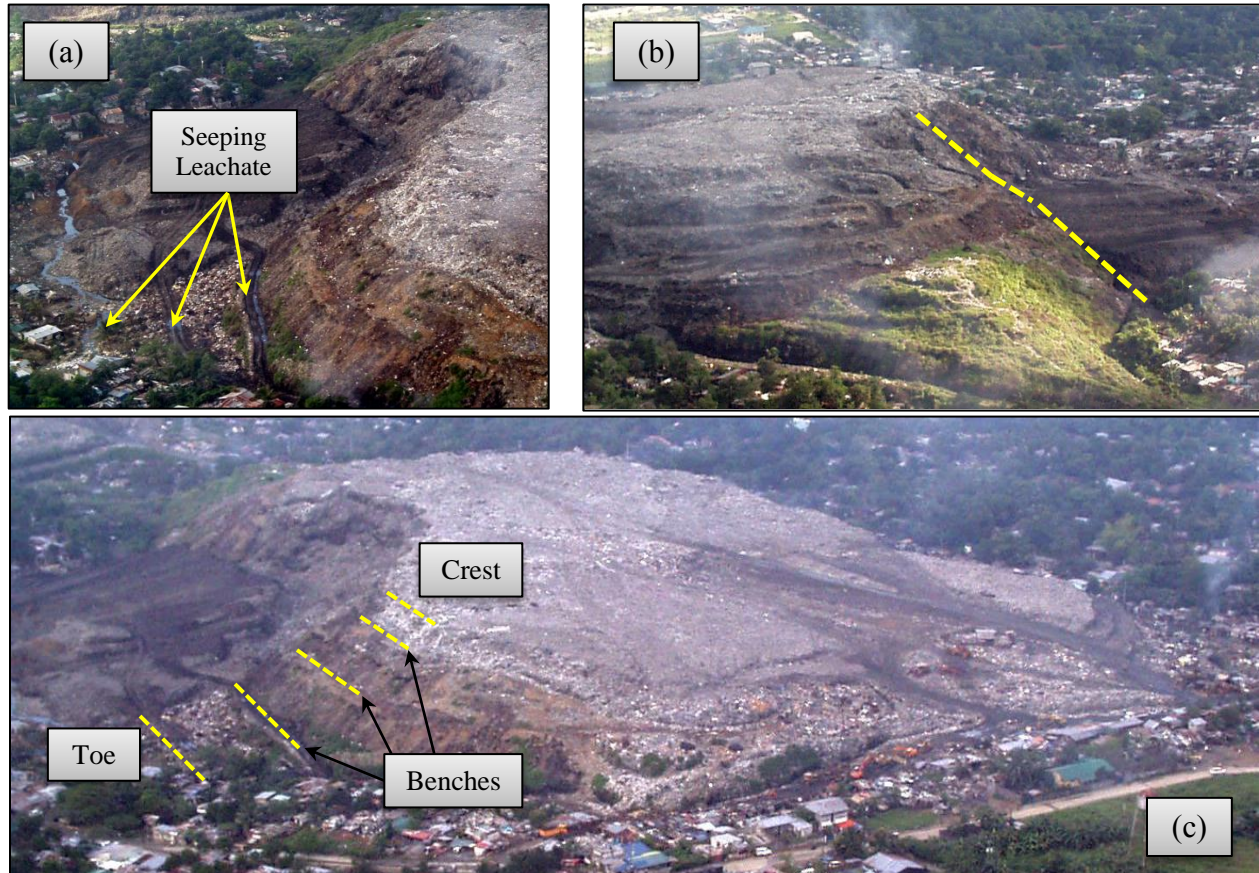
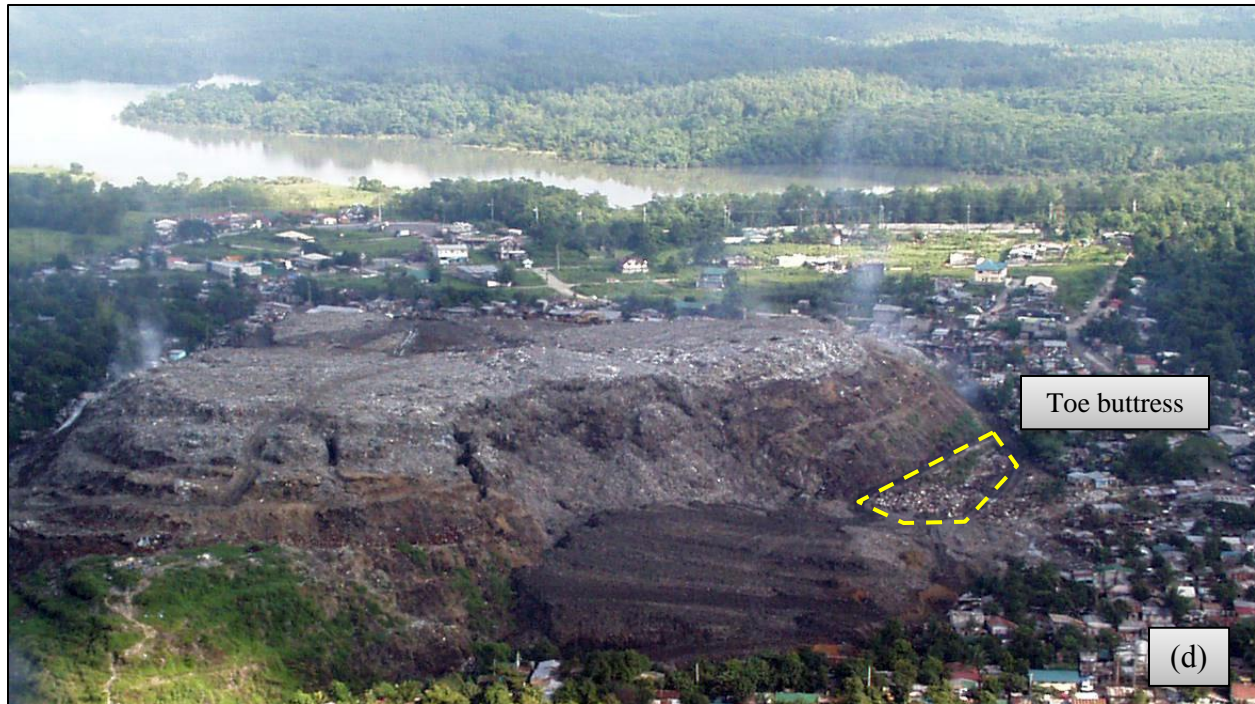
Figure 6 shows a series of aerial views of the waste slide area that were used to understand the failure surface for use in the stability analyses. Figure 6(a) and 6(b) provide side views from the southeast and northwest direction, respectively, of the waste slide. Figure 6(c) highlights benches in the landfill slope, and Figure 6(d) delineates a mildly sloped toe buttress all of which are incorporated in the cross-section shown in Figure 7. Site reconnaissance and pictures both indicate that leachate was seeping from this toe buttress. After the toe buttress, the steep side slopes range from 60 to 70 degrees (Bautista 2007; UNFCCC 2007). Digital measurements from photographs of the slope indicate slope angles in the slide area of 1.2H:1V ($\sim 40^\circ$) to 0.84H:1V ($\sim 50^\circ$) and were used to create the cross-section shown in Figure 7.

Figure 6. Slope geometry and failure surface after failure (photos by S.M. Merry).

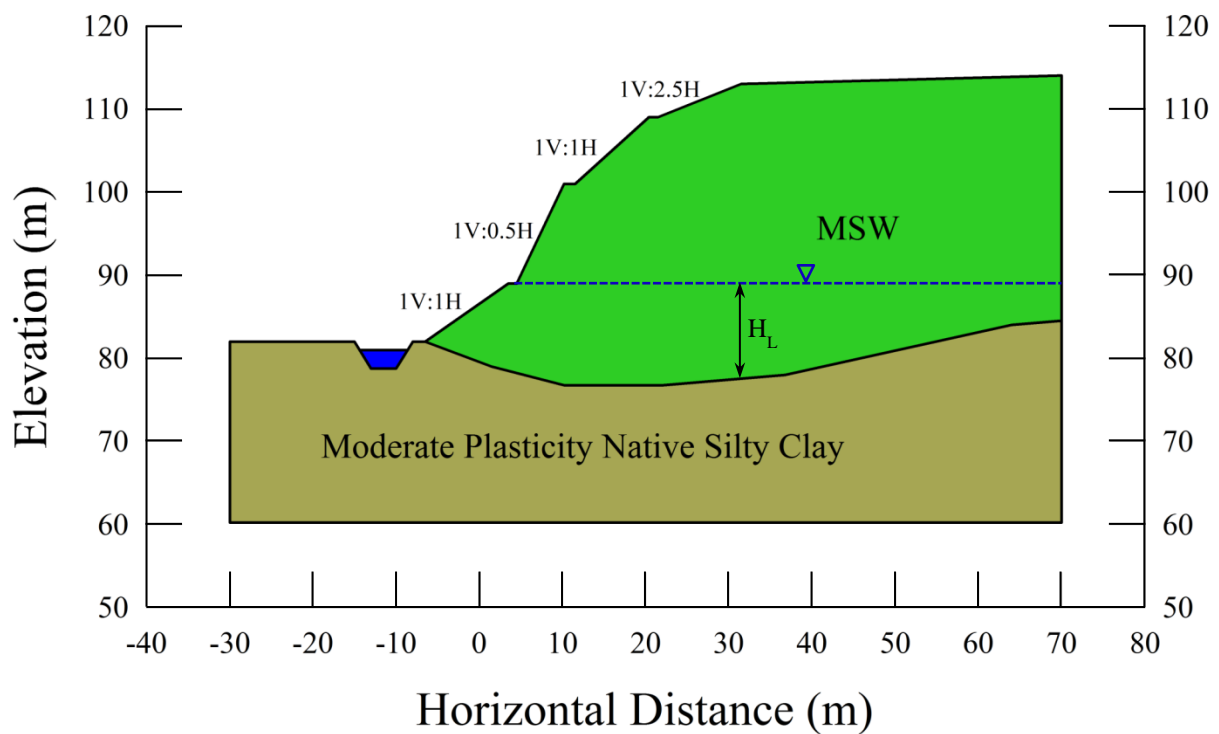
- The second factor is that the waste is underlain by a native hard, brown fine-grained loam or adobe, which is a moderate plasticity silty clay (Seman and Rydergren 1992). This second factor assumes that the brown native plastic silty clay underlying the landfill is weaker than the overlying MSW, and the failure surface passed through the brown native material below the slope toe, i.e., a failure surface passing through the MSW and then the brown silty clay and daylighting in the residential area. This is a realistic failure surface because weak soils underlying landfills have contributed to prior slope failures, e.g., Dvinoff and Munion, 1986; Oweis et al., 1985; Richardson and Reynolds, 1991; Stark et al., 2000. In this study, the failure surface was deemed not to have passed into the native brown silty clay because photographs in Figures 2, 5, and 6(c) indicate that the failure surface is relatively shallow and exits the slide mass near the toe of the MSW. This is indicative of a slab or sliver of MSW sliding off the surface of the landfill. In addition, the brown native silty clay is sloped upward (see Figure 7) near the slope toe because waste was initially placed in this depressed area.

Figure 7. Two dimensional cross-section of failed waste slope.

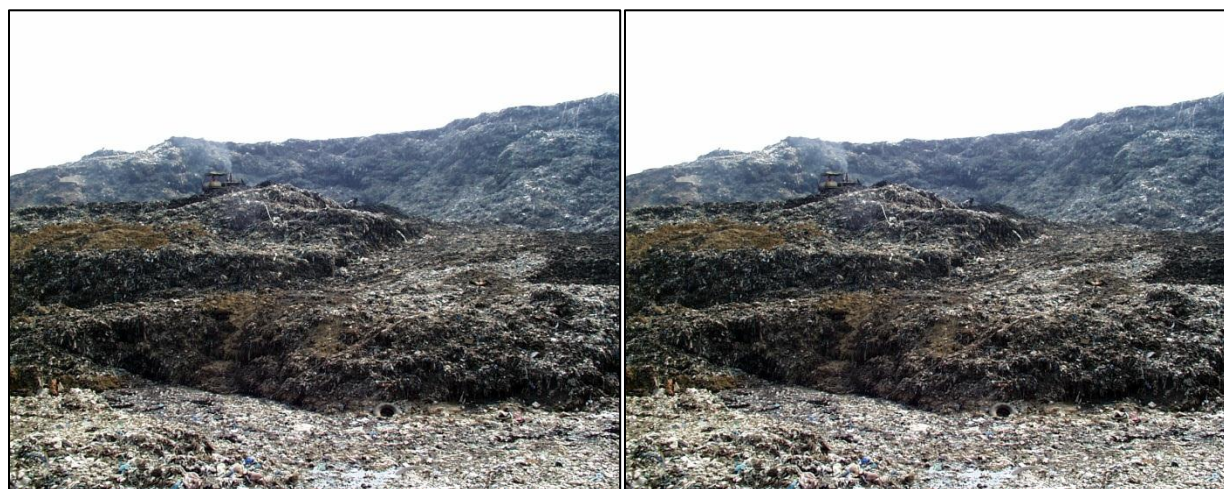
Koelsch (2001) visited the Payatas landfill four weeks after the waste slide and observed that the waste composition included a high concentration of plastics and organics and an absence of certain other materials (e.g., paper, glass, metals).

Figure 8. Composition of waste mass in slide area with no soil cover (photos by S.M. Merry).

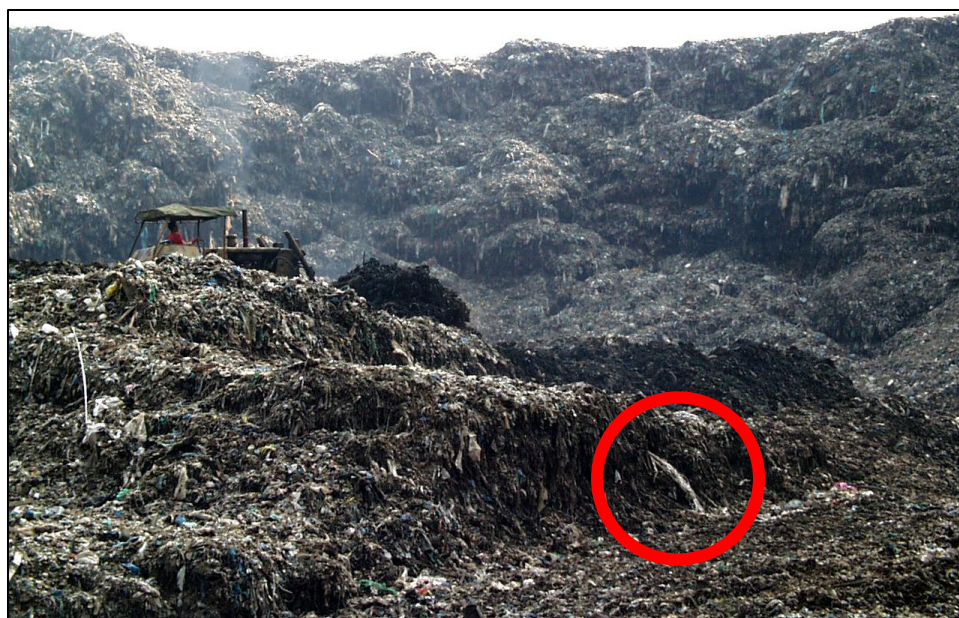
The landfill operations at Payatas consisted of open disposal with little compaction or soil cover, and a waste composition having a large percentage of fibrous (e.g., plastics) compared to organic wastes. Therefore, it is estimated that the MSW hydraulic conductivity is in a range of 10^{-3} to 10^{-5} m/s . Figure 9 shows the back scarp of the waste slide as well as a bulldozer regrading the slide mass. The individual fibrous materials observed hanging at the scarp are most likely the result of the waste pulling from the emdedded fibrous materials. In Figure 9, the red circle highlights leachate flowing from the waste mass, which indicates a high hydraulic conductivity and leachate level. This observation does not provide a quantitative MSW hydraulic conductivity, but it supports the minimum recommended MSW hydraulic conductivity of $1 \times 10^{-5} \text{ m/s}$. A value of $1 \times 10^{-5} \text{ m/s}$ is subsequently used in the HELP modeling of the leachate level and as an input parameter for estimating the landfill gas pore pressures at the time of failure.

Figure 9. View of the back scarp of waste slide and leachate flowing from the exposed MSW (photo by S.M. Merry).

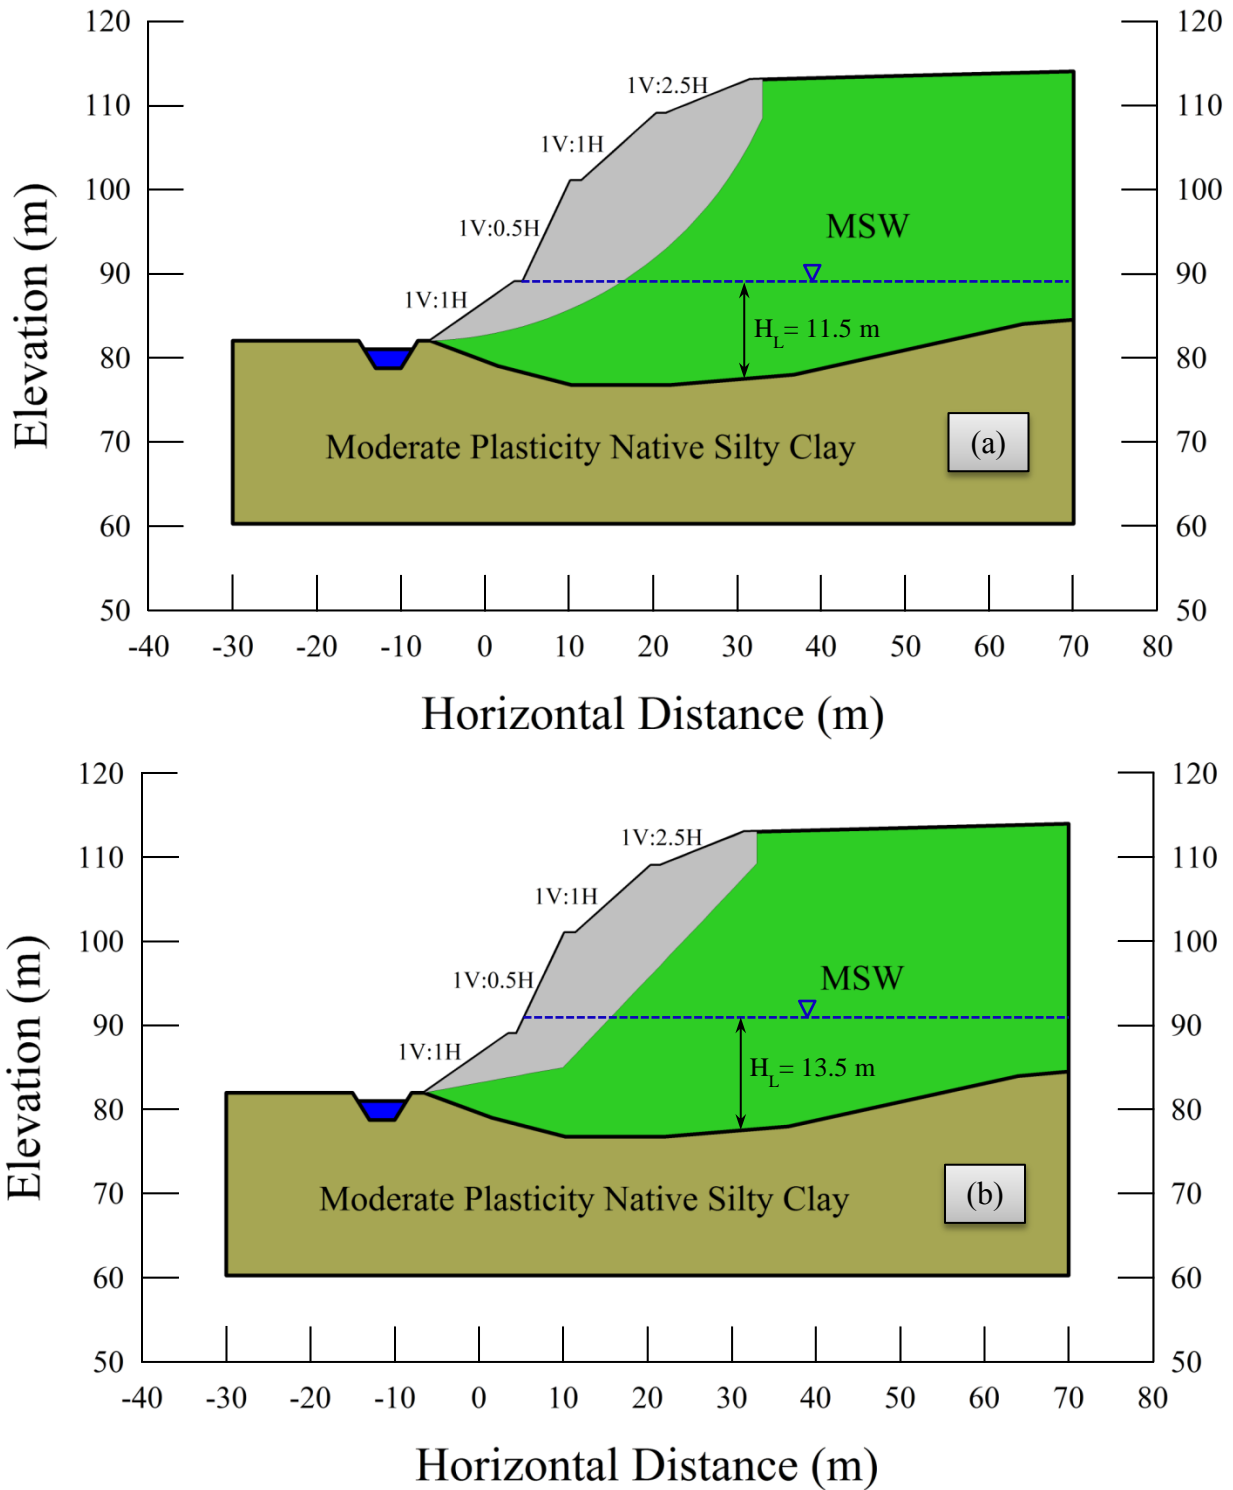
The cross section in Figures 11(a) and 11(b) show the estimated circular and planar failure surface, respectively, based on available photographs (see Figures 2, 3, 5, and 6) and site reconnaissance. The cross sections show the MSW is approximately 31 m thick and is underlain by the brown native clayey silt that slope downward towards the center of the landfill. A leachate trench is shown at the toe of the slope to model the pre-failure slope condition. These cross-sections were used in the inverse analysis described below.

Figure 11. Cross- sections showing location of (a) circular and (b) planar failure surfaces.

Although a circular failure surface indicates a homogenous material, a planar failure surface starting at the toe and daylighting at the top of the landfill was also analyzed. Because the exact location of the failure surface at the crest is not known, the scarp of the waste slide was used to estimate the location of the failure surface at the top of slope that yielded the lowest factor of safety. Furthermore, after the waste slide, the waste was regraded (see Figures 2 and 5) such that the actual slide mass geometry does not represent the possible progression of failure. A helicopter video from a news report (<http://www.abs-cbnnews.com/video/nation/metro-manila/07/10/11/payatas-tragedy-commemorated>) shows an aerial view of the landfill prior to regrading, which was also helpful in estimating the location and geometry of the failure surface. From this video, the failure progresses from the main slide mass and retrogressing from the initial head scarp to a final scarp that is about 5 m behind the slope crest. Then an ensuing block of waste toppled from the scarp creating the final geometry shown in Figure 2. Merry et al. (2005) report a steep (vertical at the top) head scarp remained above the area where heavy machinery had reworked the waste mass.
