Differential Movement at Embankment-Bridge Structure Interface in Illinois

JAMES H. LONG, SCOTT M. OLSON, TIMOTHY D. STARK, AND EMILE A. SAMARA

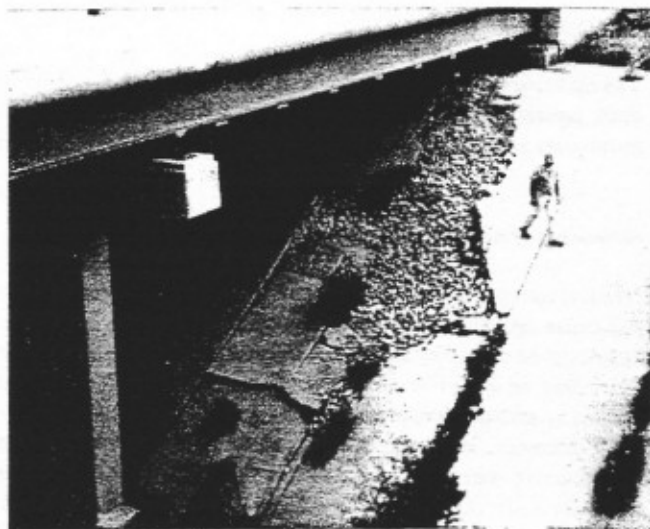
FIGURE 5 Damage to slope facing causing significant erosion of embankment soil.

The eastern approaches required fills approximately 7 m high, and the western approaches required approximately 9 m of fill. A visual inspection of the bridge structures revealed that extensive erosion was occurring at the slope faces of all of the approaches. As shown in Figure 5, the runoff drains directly onto the concrete slope facing. The practice of draining the bridge deck onto the concrete slope facing is common; however, it can be seen that in this case the runoff falls directly onto a construction joint in the slope facing. The runoff probably infiltrated below the slope facing and eroded the embankment material as it flowed downslope. This erosion led to a loss of support under the slope facing and additional damage to the facing.

Erosion also was occurring because of water infiltrating the embankment from joints in the overlying pavement. This is referred to as a roof leakage. Water infiltrates through pavement joints, joints between the shoulder and pavement, and bridge-pavement joints. Infiltrated water can flow around the abutment and underneath the slope facing (Figure 6). The soil is eroded through joints in the con-

crete slope facing, at the toe of the slope facing, and the remedial rip-rap. Interviews with IDOT field crews revealed that at this site it was necessary to remove eroded material at the foot of the slopes several times a year, and several repairs have been made to the slope facing.

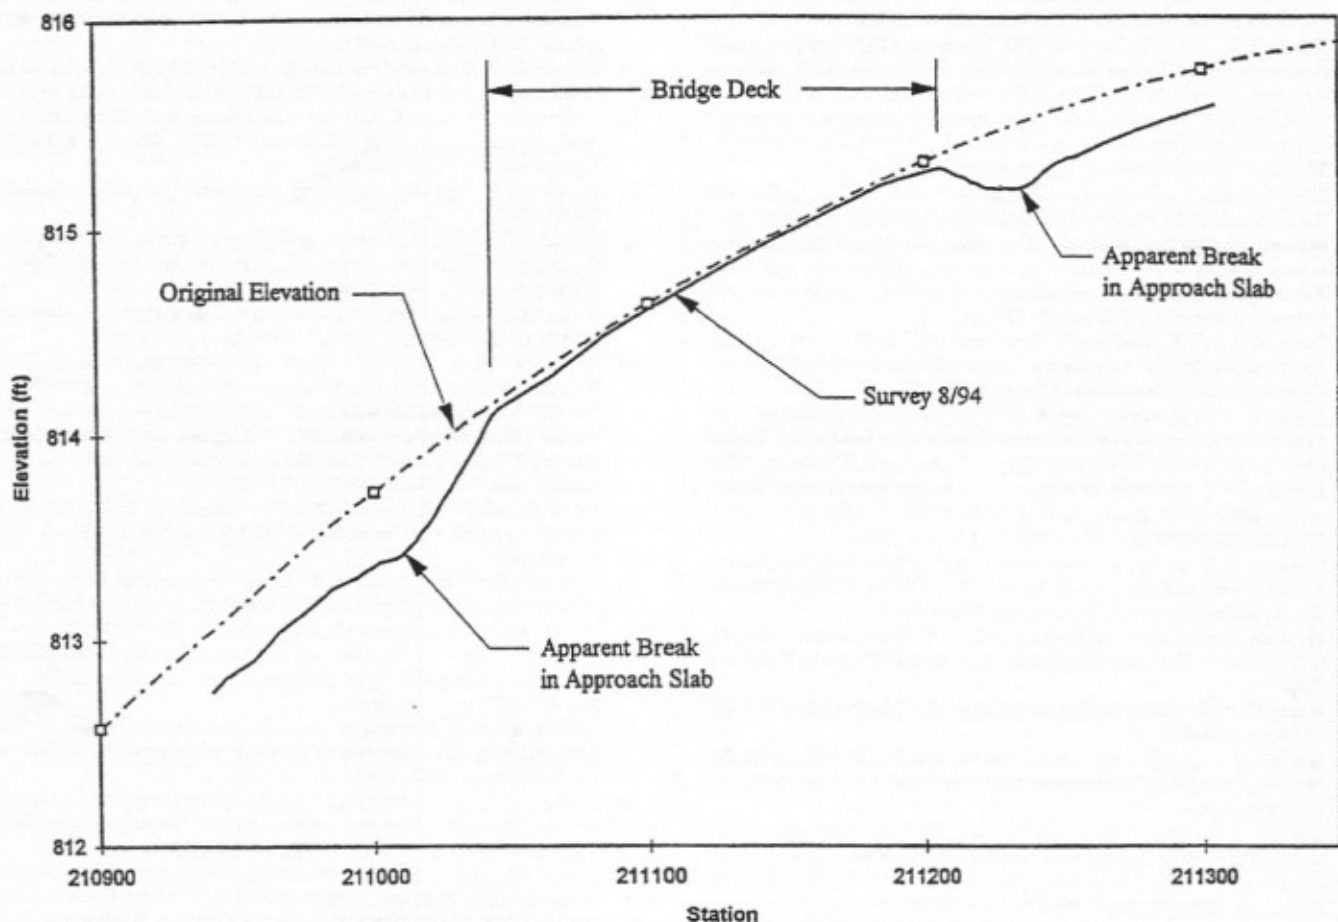
FIGURE 7 Effect of broken approach slab on entrance and exit elevation survey.

The approach slabs are 30 m in length, with only the first 9 m being heavily reinforced. Beyond 9 m, the approach slabs taper from 370 to 230 mm in thickness. Inspection of the approach pavement revealed cracks at about 7.5 to 9 m from each of the abutments, which corresponds to the location of the transition from heavy to light steel reinforcement. Two large cracks were observed in the pavement at distances of 30 and 36 m north of the southbound bridge entrance. These cracks roughly correspond to the end of the 30 m approach slabs.

Elevation surveys for the southbound and the northbound lanes extended 150 m from the bridge abutments. Figure 7 presents an expanded scale elevation plot for the southbound lanes. The entrance approach (left side of Figure 7) exhibits a maximum of 117 mm of differential settlement at a distance of approximately 10.7 m from the abutment. This results in a relative gradient of $\frac{1}{100}$. The exit approach (right side of Figure 7) exhibits a maximum of 94 mm of differential settlement at a distance of 9.5 m from the abutment. This corresponds to a relative gradient of $\frac{1}{100}$. A relative gradient criterion may be appli-

cable for assessing ride quality and therefore useful for determining repair and overlay needs.
