MUNICIPAL SOLID WASTE SLOPE FAILURE. I: WASTE AND FOUNDATION SOIL PROPERTIES^a

Discussion by Edward Kavazanjian Jr.,⁵
J. F. Beech,⁶ and Neven Matasović,⁷
Members, ASCE

Closure by Hisham T. Eid,⁸ Timothy D. Stark,⁹ W. Douglas Evans,¹⁰ and Paul E. Sherry¹¹

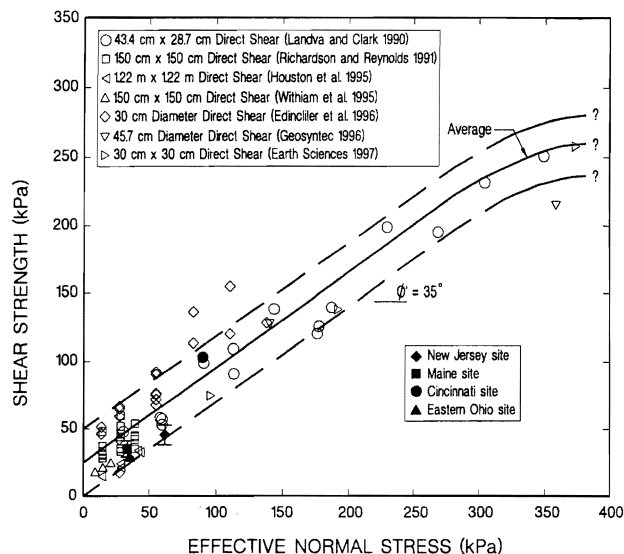
FIG. 8. Stress Dependent Shear Strength of MSW

The writers welcome the discussers' comments. The failure envelopes proposed for municipal solid waste (MSW) in Fig. 5 are intended to be used for effective normal stresses less than 400 kPa, as indicated in Fig. 5. Reevaluating the shear strength data for effective normal stresses greater than 250 kPa suggests that the trend lines may be stress dependent or non-linear, as shown in Fig. 8. However, the amount of data at effective normal stresses greater than 250 kPa is sparse. The revised failure envelopes shown in Fig. 8 do not alter the analysis of the slope failure in the companion paper (Stark et al. 2000), because the effective normal stress acting on the steeply inclined portion of the shear surface passing through the MSW is less than approximately 270 kPa.

and thus question marks are shown in Fig. 8 near an effective normal stress of 400 kPa. Thus, it is recommended that testing and stability evaluations focus on the materials underlying the MSW, e.g., soils and/or geosynthetics.

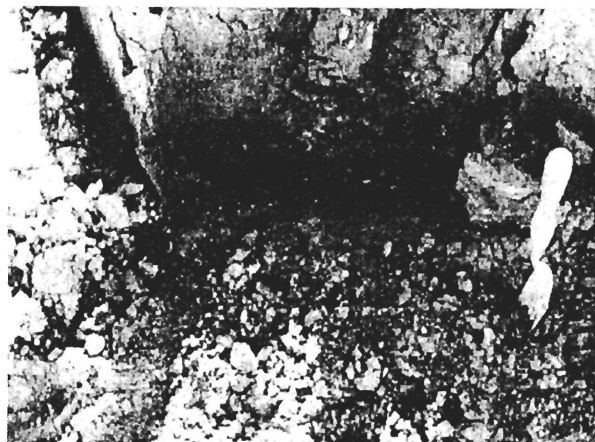
FIG. 9. Preexisting Shear Surface Observed and Sampled in Colluvial Material prior to Final Remedial Measures

This shear surface is similar to others observed before the second discussor became involved with the project. One example of such a shear surface in the colluvium is shown in Fig. 9 and was observed near the creek, which was outside the area of waste residue. This shear surface was observed at least six months prior to the second discussor's involvement in the project. Observation of this shear surface and several other episodes of sliding at the site led to the second and third writers' involvement in the project and the subsequent remedial measures undertaken at the site.

The third writer photographed and sampled the shear surface in Fig. 9, which was not located at the interface either between the burnt waste residue and the colluvium or between the colluvium and underlying weather bedrock, which is also the case for the shear surface shown in Plate 2(a). The trowel in Fig. 9 is inserted into colluvial material and not waste residue or bedrock. The shear surface was located 1–2 m above the underlying bedrock and no waste residue was present in this area. In addition, the sample shown in Plate 2(b) was taken from the lower side of the exposed shear surface in Plate 2(a). It can be seen that this sample does not correspond with the interface between the colluvium and underlying weathered bedrock or the burnt waste residue/colluvium interface because waste residue is not located above the shear surface in Plate 2(a). In summary, there is ample evidence that shear surfaces corresponding to continuous high plasticity clay seams existed within this heterogeneous colluvium. This is typical of other colluvial deposits investigated by the writers and reported in the literature cited in the subject paper and is one of the main points that the writers tried to illustrate in the paper.
