Effect of Toe Excavation on a Deep Bedrock Landslide

Timothy D. Stark¹; W. David Arellano²; Ryan P. Hillman³; Roger M. Hughes⁴; Norman Joyal⁵; and Don Hillebrandt⁶

DOI: 10.1061/(ASCE)0887-3828(2005)19:3(244)

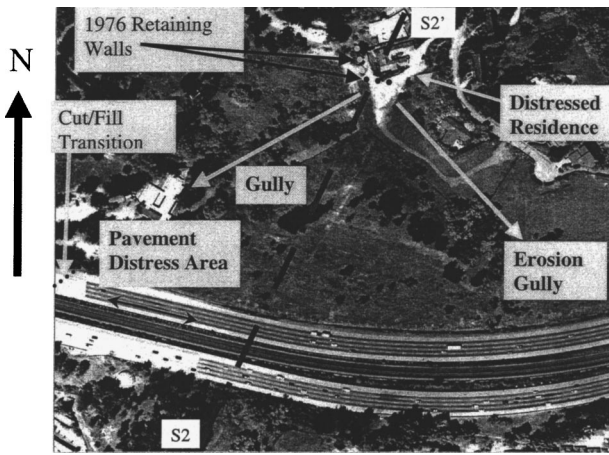
Fig. 1. Aerial photograph of cutslope and distressed residence in 1999

The rainfall from 1975 through 1977 was below 76 cm/year (30 in./year) and no residence distress was documented. In January 1976, two retaining walls (west wall and south wall, see Fig. 1) were installed to reduce the distress to the first residence, which at the time was thought to be caused by movement of the 1.5–2.5 m thick (5–8 ft thick) fill wedges underlying the residence (Pilecki 1975). The west wall was installed to resist movement towards the western erosion gully (see Fig. 1) and the southern wall was installed because the observed distress suggested a component of movement in the southern direction. The west retaining wall is 9.1 m (30 ft) long and consists of six 61 cm (24 in.) diameter concrete piers that are 7.6 m (25 ft) deep with WF10×25 steel beams or piles. The piers are spaced 1.8 m (6 ft) apart and are installed through the fill and into bedrock. The south retaining wall is reportedly about 11 m (36 ft) long and consists of a row of similarly reinforced concrete piers installed to a depth of 6.1–7.6 m (20–25 ft). However, there is no above-grade projection of the south wall so the dimensions were not confirmed by inspection. The walls were designed for fill wedge movement believed to be occurring between 1.5 and 4.0 m (5 and 13 ft) deep near the crest of the fill slopes.

The pavement heave was located just below the area of the 1970 slide (see Fig. 1) described previously. Therefore, it can be inferred that either the repair for the 1970 slide was not effective or that a deeper landslide was present below the 1970 slide. To clarify the situation, the State Highway Department installed a 21 m (70 ft) deep slope inclinometer in the northern shoulder of the highway just below the 1970 slide area (see Fig. 2). The slope inclinometer was installed in July 1982 and little movement was observed in this inclinometer through December 1982. By February 3, 1983, 3.8 cm (1.5 in.) of abrupt shear displacement had occurred at a depth of 8.5–9.2 m (28–30 ft) and the groundwater

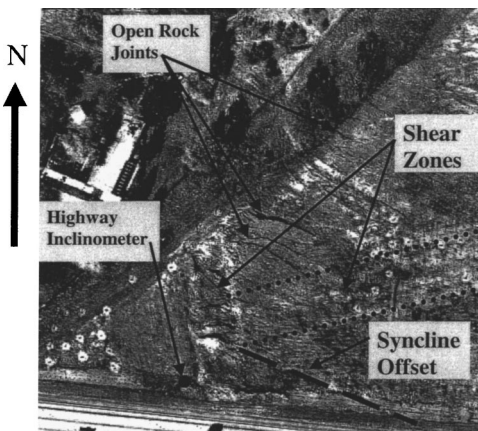
daylighted. The heavy dashed line in Fig. 2 parallels the axis of the syncline and the contact between the claystone below and the siltstone/sandstone unit above. The claystone below this dashed line represents the rock unit at the center of the syncline and the bedrock units to the north of this axis represent one side of the syncline. The axis of this syncline was reported by Heyes (1982) as “a potential natural failure plane.” A comparison of aerial photographs from 1959 and 1973 shows that the syncline was not exposed after completion of the first excavation. As a result, one of the main effects of the second excavation was to expose the syncline and daylight the weak claystone of the Orinda Formation, which provided a potential deep-seated failure surface.

As shown in Fig. 2, there are also several shear zones present in the southwest corner of the cutslope. One large shear zone extends almost vertically and truncates the syncline axis. Another shear zone extends across the face of the cutslope as indicated by the dotted lines in Fig. 2. The presence of three claystone layers with different strike and dip orientations was reported by Heyes (1982). All of this evidence indicates a zone of complex shearing and fault movement in the southwest portion of the cutslope, which is the area that exhibited deep-seated movement. Both shear zones consisted of highly sheared claystone/gouge.

Fig. 2. Aerial photograph of southwest corner of cutslope that shows discontinuities in bedrock units in 1973

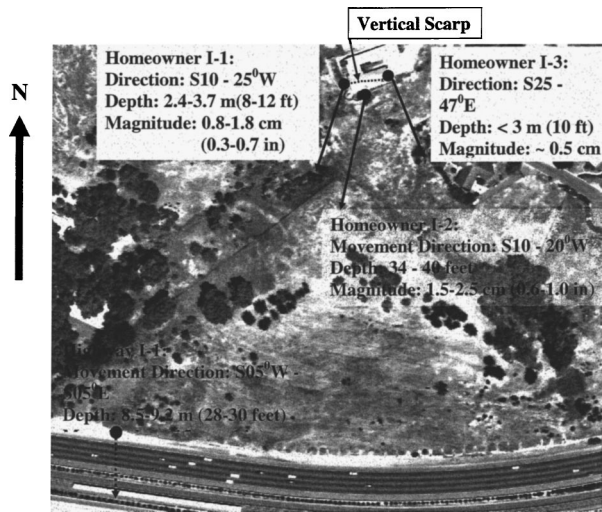
Fig. 3. Slope inclinometer data at highway and residence

The homeowner installed three slope inclinometers near the residence in January 1996 to investigate the depth and rate of movement. Fig. 3 shows the location of the three inclinometers and the direction, depth, and magnitude of movement observed in each of the inclinometers. The inclinometers were monitored from March 1996 until April 1997, at which time the residence was repaired (discussed subsequently) and the inclinometers decommissioned. The most important information derived from the inclinometers is the difference in the type, depth, and direction of

movement observed at the western and eastern ends of the residence. Inclinometers I-1 and I-2, located near the southwestern corner of the residence, both show well-defined shear movement in the claystone bedrock in the southwesterly direction (see Fig. 3). The arrows in Fig. 3 correspond to the direction of movement in the inclinometers. I-1 shows a shallower shear movement (2.4–3.7 m) because it is closer to the vertical scarp under the second residence. This scarp is in the same location as the scarp observed under the first residence (see Fig. 3). The scarp exits the west side of the residence and extends to the west retaining wall that was constructed in 1976. However, I-2, which is located near the center of the scarp and is 6.1–7.6 m (20–25 ft) south of the scarp, shows a depth of shear movement of 10.4–12.2 m (34–40 ft). Because I-1 and I-2 show movement in the southwesterly direction (see Fig. 3), the scarp has to extend steeply into the bedrock, indicating that the movement is controlled by the claystone underlying the residence and not the surficial natural or fill soil underlying the residence.

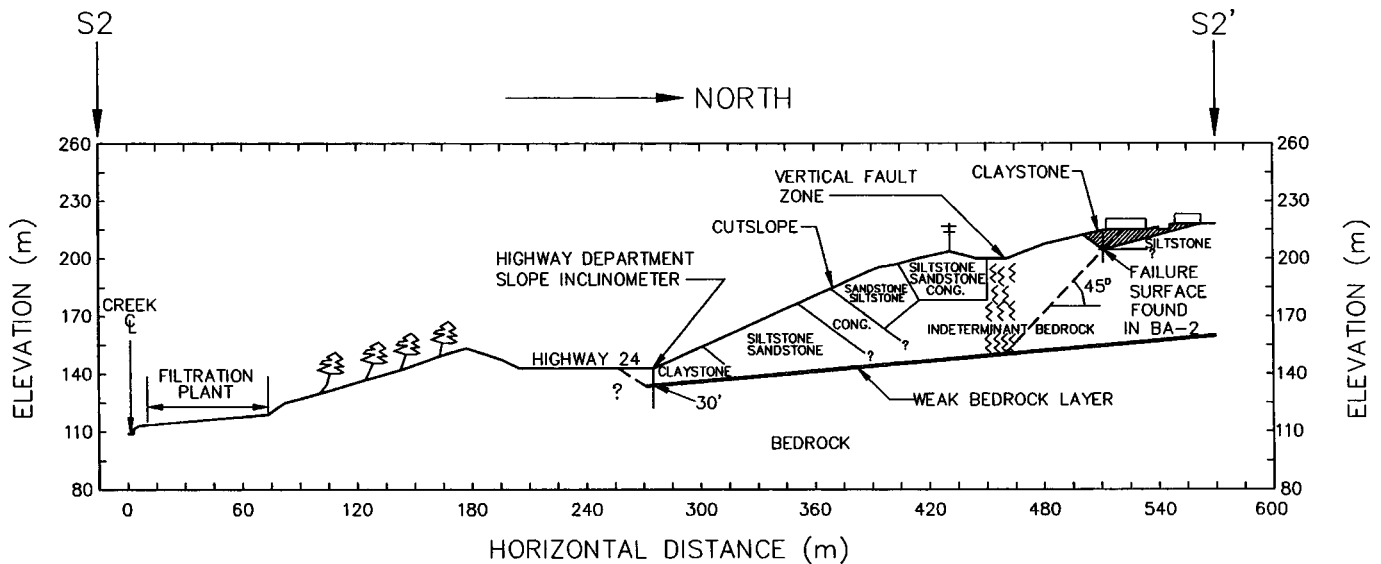
Fig. 4. Material profile used in stability analyses for cross section S2-S2'

One of the main difficulties in determining the cause of the deep-seated movement that was impacting both residences was the lack of subsurface information between the residence and the toe of the cutslope. Only surficial (1–1.2 m or 3–4 ft deep) backhoe trenching was conducted at the top and along the cutslope by the State Highway Department, even though it was suggested by experts that bucket auger borings, rock corings, and slope inclinometers be installed to clarify the deep-seated movement. Based on surficial geologic mapping, topographic maps, aerial surveys, and subsurface information at the residence and the toe of the cutslope, the postexcavation cross section shown in Fig. 4 was developed for use in the stability analyses.

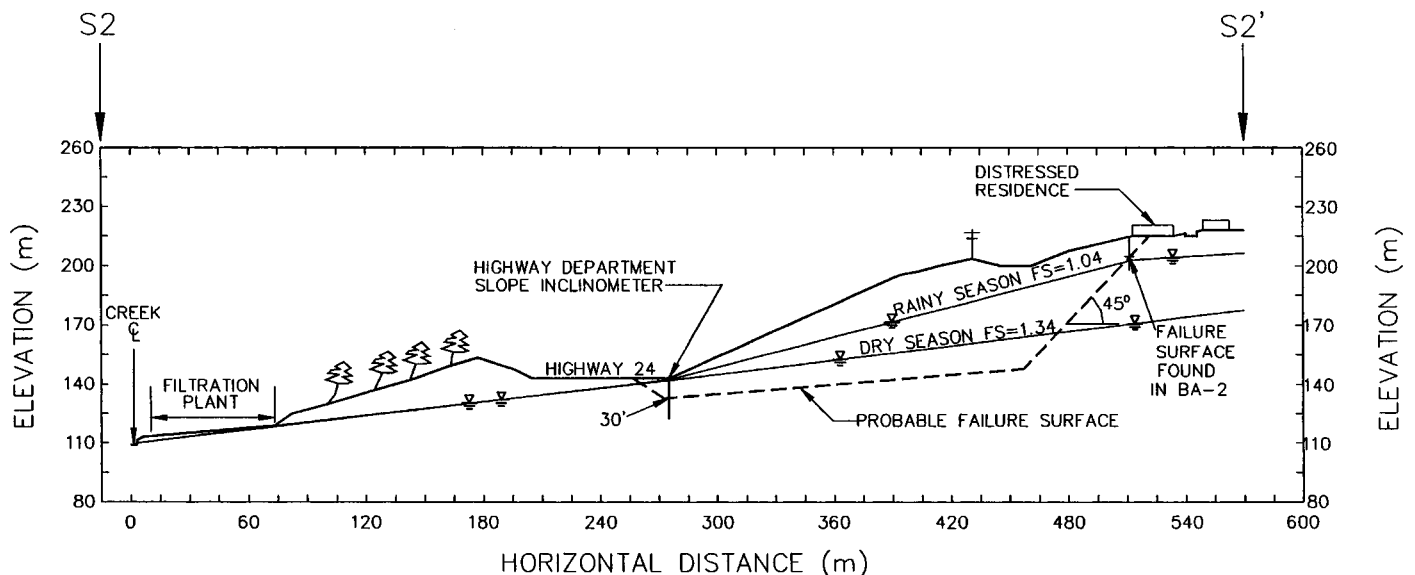
Fig. 5 presents the probable translational failure surface, which extends through claystone to a depth of 12.2 m (40 ft) under the residence, into indeterminate bedrock below the claystone, into a deep, weak bedrock layer, and then along the weak layer until it daylight in the westbound outboard lanes. This failure surface

Fig. 5. Postexcavation stability analysis for cross section S2-S2'

accounts for all of the movements observed at the residence and toe of the cutslope because: (1) it passes 9.2 m (30 ft) below the northern highway shoulder to model the shear displacement observed in the State Highway Department's inclinometer; (2) it exits into the westbound outboard lanes to account for the observed periodic pavement heave; (3) it models the scarp observed under both residences and in the west retaining wall; (4) it corroborates the observed movements in the slope inclinometers installed at the residence; (5) it models the 45° angle of inclination of the shear surface observed in bucket auger boring BA-2; and (6) it models the location of the shear surface at a depth of approximately 12.2 m (40 ft) in BA-2.

Fig. 5 presents the cross section for the analysis that represents the conditions during a rainy season, i.e., a high groundwater surface, for the probable translational failure mechanism. This factor of safety (FS) of 1.04 (see Table 3) indicates that the slope is metastable and it is in excellent agreement with the following field observations: (1) pavement heave and residence distress only occurring during or at the end of a rainy season; (2) the slope movement is slow; (3) the magnitude of movement at the residence is less than 5 cm (2 in.) per rainy season; and (4) the small movement does not result in a large scarp that is visible on the exposed ground surface. The FS for the same failure mechanism

with groundwater surface conditions during a dry season, i.e., low groundwater surface, is 1.34 (see Fig. 5). This FS is in excellent agreement with field observations that pavement heave and residence distress do not occur during the dry summer months.

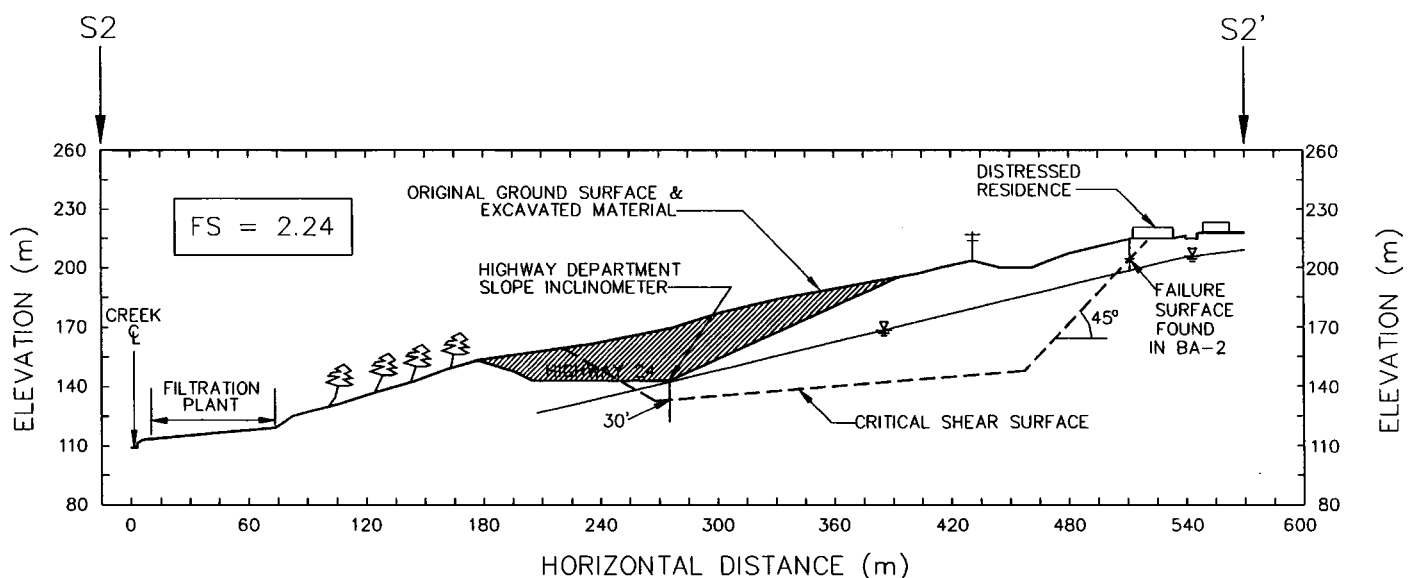
The impact of the entire highway excavation on the probable failure surface is illustrated in Fig. 6. The shear surface presented in Fig. 6 is labeled critical shear surface because a search was conducted with the probable failure surface in Fig. 5 being the starting point for the search. The groundwater surface prior to excavation was estimated using the water surface during the rainy season but lowered slightly near the residence to reflect an increased amount of runoff prior to the excavation. It can be seen from Table 3 that the factors of safety for the pre-excavation condition during the rainy and dry seasons are 2.24 and 2.52, respectively. Therefore, the highway excavations had a destabilizing effect on the slope and both of the residences probably would have performed satisfactorily had it not been for the highway excavations. These factors of safety are significantly higher than the postexcavation condition because: (1) the probable translational failure surface must pass through significantly more material to exit the slope; (2) the additional material at the slope toe (see shaded area in Fig. 6) results in a higher effective stress on the failure surface, which increases shear resistance and stability; and (3) the presence of the additional material promoted more surface runoff, which probably resulted in a lower groundwater surface near the cutslope toe than that assumed in Fig. 6.

**Fig. 6.** Pre-excavation stability analysis for cross section S2-S2'

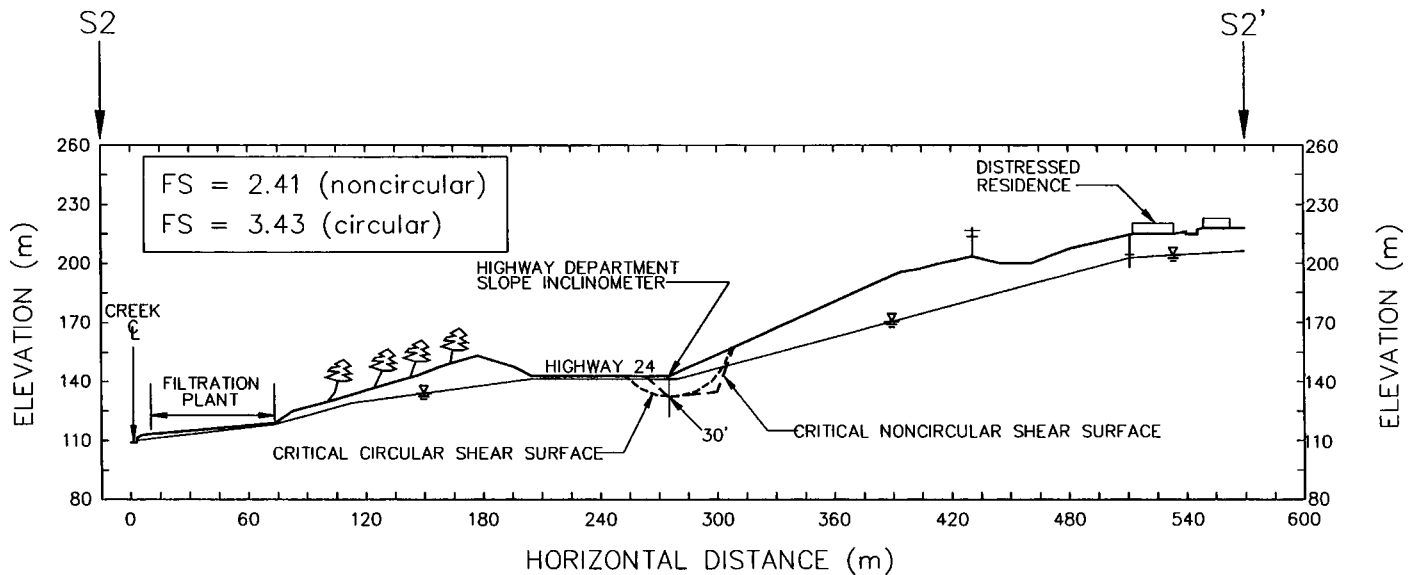
Extensive stability analyses were conducted to investigate the possibility of a landslide confined to the cutslope toe area to explain the observed pavement movements. Fig. 7 provides a summary of the stability analyses at the toe of the cutslope. The boundary conditions for these analyses include: (1) the toe of the failure surface daylighting or exiting in the westbound outboard highway lanes; (2) the failure surface passing through a depth of 9.2 m (30 ft) at the location of the inclinometer installed by the State Highway Department; and (3) the top of the failure surface exiting on the cutslope. It can be seen in Fig. 7 that these boundary conditions are satisfied using both circular (failure entirely in the claystone) and noncircular failure surfaces (heterogeneity of the materials in the slope toe area). The groundwater surface es-

Fig. 7. Stability analyses at toe of cutslope for cross section S2-S2'

tablished for the rainy season (see Fig. 5) was used for these analyses. The material properties presented in Table 2 were also used in these analyses. It can be seen that the circular and non-circular failure surfaces yield factors of safety that are significantly greater than unity (3.43 and 2.41, respectively), even for the high groundwater surface condition. Therefore, a landslide limited to the cutslope area does not appear likely. The lack of a scarp on the cutslope confirms that these failure mechanisms are unlikely and thus do not explain the historical pavement heave.

If the residual failure envelope in Table 2 is assigned to all of the material at the cutslope toe, the resulting factors of safety for the critical circular and noncircular shear surfaces are 1.58 and 0.71, respectively. Therefore, a circular failure surface is not likely because the factor of safety is substantially greater than unity. The lack of a scarp on the cutslope and the absence of catastrophic movement suggest that a factor of safety of 0.71 for the noncircular shear surface implies that a noncircular landslide limited to the toe area is not likely.

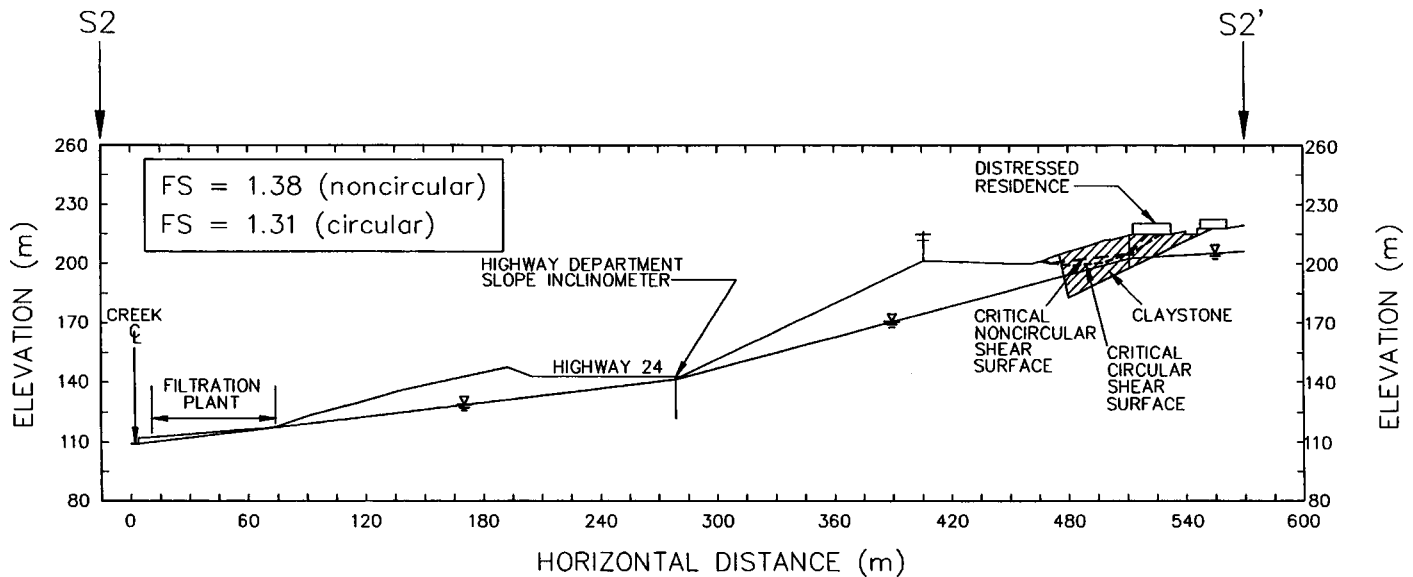
Fig. 8 provides a summary of the stability analyses near the distressed residence. The boundary conditions for these analyses include: (1) the toe of the failure surface exiting in the southwest direction and before the cutslope because there is no evidence of a landslide toe in the upper portion of the cutslope; (2) the failure surface passing through a depth of 11.6–12.2 m (38–40 ft) at the location of BA-2; (3) the steeply inclined scarp existing under the residence; and (4) movement occurring in the southwest direction. It can be seen in Fig. 8 that these boundary conditions are satisfied and circular and noncircular shear surfaces were considered. The groundwater level established for the rainy season (Fig. 5) was also used for these analyses. A circular failure surface was considered because the failure surface might remain primarily in the claystone that was encountered at the residence. A noncircular shear surface was also considered because of the heterogeneity of the materials in this area of the slope (see Fig. 4). The material properties presented in Table 2 were used in these analyses; however, the majority of the critical shear surfaces are located in claystone.

Fig. 8 shows that the critical circular and noncircular shear

Fig. 8. Stability analyses near distressed residence for cross section S2-S2'

surfaces yield factors of safety that are greater than unity (1.31 and 1.38, respectively) for the high groundwater level condition. These factors of safety are too high to account for the movement observed in the residences and slope inclinometers. Similar stability analyses conducted with the groundwater level raised to the ground surface (a worst-case scenario) yield factors of safety significantly less than unity (0.75 and 0.77, respectively). These factors of safety are too low to explain the slow, episodic movement observed in the residence and slope inclinometers. Furthermore, at no time in any of the subsurface explorations (inclinometers, borings, bucket auger holes, and deep pier excavations for repairs) was groundwater encountered near the ground surface, which makes this an unreasonable scenario. Therefore, it is concluded that a small landslide in the vicinity of the current residence could not explain the slow and episodic distress observed in both residences.
