Back-analysis of a PVC geomembrane-lined pond failure

T. D. Stark¹, E. J. Newman² and R. L. Aust³

REFERENCE: Stark, T. D., Newman E. J. & Aust, R. L. (2008). Back-analysis of a PVC geomembrane-lined pond failure. *Geosynthetics International*, 15, No. 4, 258–268. [doi: 10.1680/gein.2008.15.4.258]

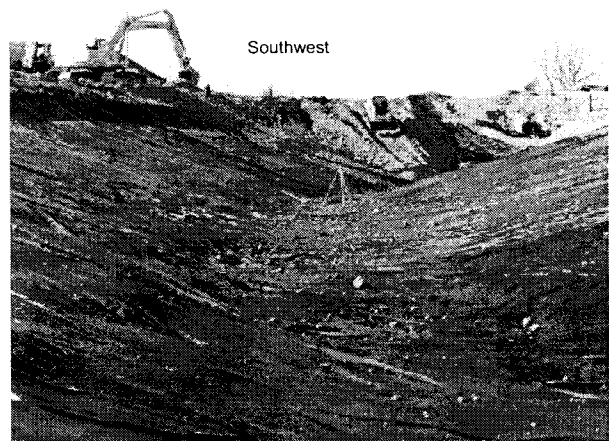
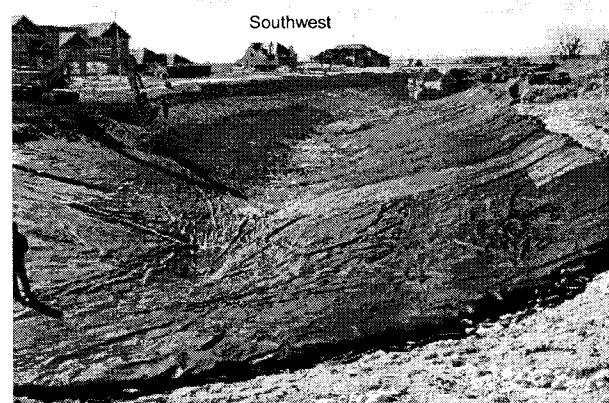
Figures 2(a) and (b) provide some insight to the construction procedures employed by the excavation contractor. Figure 2(a) shows the earthwork contractor constructing an access road down a side slope to gain access to the bottom of the pond. Figure 2(b) shows the tracked-excavator on the south side of the pond, namely the side closest to the residences and furthest from the distribution canal, placing cover soil well ahead of the access road. This resulted in a substantial amount of cover soil being placed and spread in an unsupported manner. As discussed subsequently, it is hypothesised that this unsupported load induced shear stresses along the geotextile/PVC geomembrane interface, which may have resulted in mobilisation of a post-peak interface strength. It is frequently recommended that cover soil be placed from the bottom to the top of a slope so the soil buttresses itself and reduces the

Figure 2. (a) Placement of unsupported cover material while access ramp to pond bottom is being constructed, and (b) unsupported cover material placed well in advance of buttressing soil

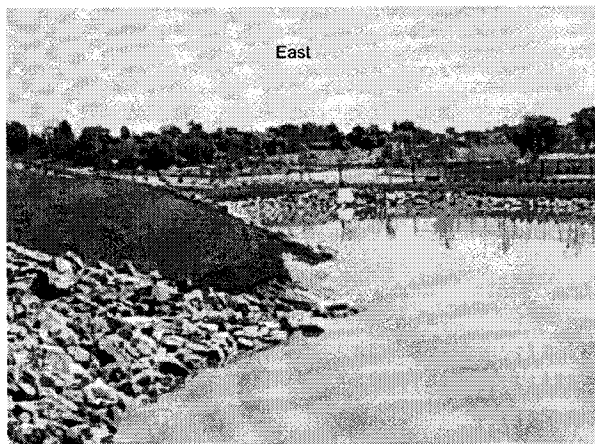
The initial slope failure occurred on 4 or 5 June 2005, which was about 4 months after construction was complete and 3 months after pond filling. Figure 3(a) shows the initial slope failure on 4 June 2005, which is the area of the photograph where the riprap is missing. The following important observations can be made from this photograph.

1. No pond drawdown or other detrimental operation event occurred prior to the first observed slope failure on 4 or 5 June 2005.
2. The newly placed sod, riprap, soil cover, and cushion geotextile slid below the water line, leaving the PVC geomembrane exposed on the slope.
3. This failure appeared to be isolated because at the time of the photo the surrounding slopes had not

Figure 3. (a) Initial slope failure with pond level at or near capacity on 4 June 2005, and (b) slope failure on 6 June 2005

failed and signs of potential failure such as tension cracks were not observed.

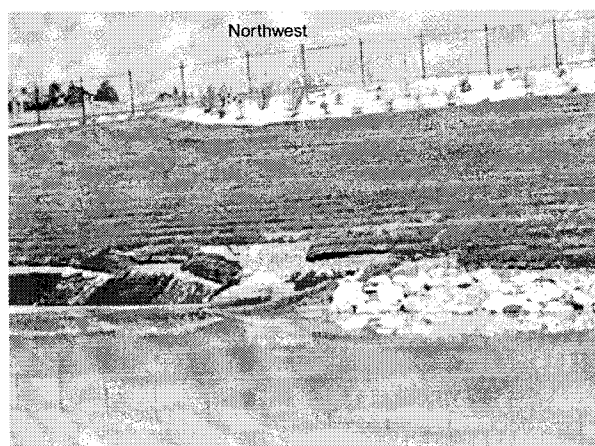
(b)

4. This failure continued to progress and expand over the next few days. Expansion of the slide was augmented by the drawing down of the pond level after the initial failure was observed. Figure 3(b) shows the initial slide 2 days later on 6 June 2005.

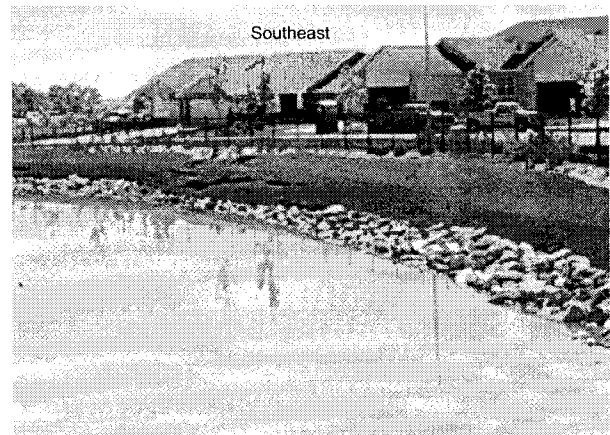
Figure 4 shows the initiation of a smaller failure on the south side of the pond. This photo was taken on 6 June 2005 and thus this slide movement occurred after the initial slide movement on the north slope shown in Figure 3. The slide in Figure 4 also involved the new sod, riprap, soil cover, and geotextile sliding off the PVC geomembrane.

Figure 4. Slope failure on south side of pond near houses

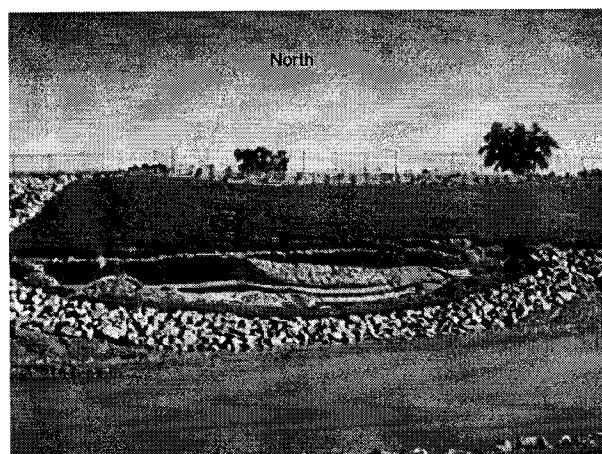
Figure 5(a) shows the failure on 8 June 2005 with the pond level drawn down about 75%. As the slide progressed, small holes started to appear in the PVC geomembrane because the geomembrane was in extreme tension. As the slide movement continued, the small holes enlarged on the left side of the slide mass shown in Figure 5(a). In Figure 5(a), however, the PVC geomembrane remained in place on the slope and thus the critical interface for sliding was the geotextile/PVC geomembrane interface.

Figure 5. (a) Progression of slope failure as pond level is drawn down, which results in geomembrane tearing, and (b) tearing of geomembrane across slide after pond level is drawn down

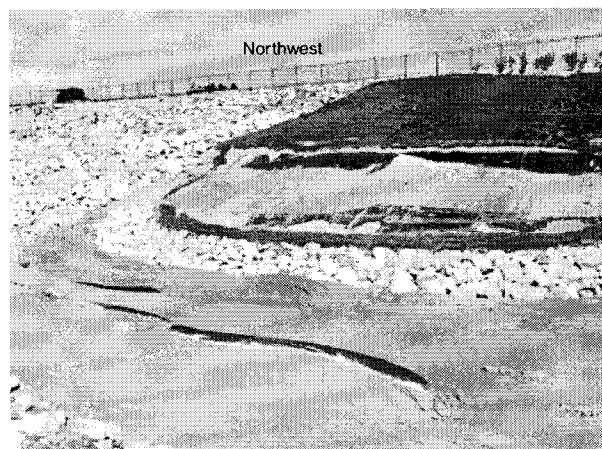
(b)

Figure 5(b) shows the slide mass after the pond had been drained. This continued drawdown and slide progression resulted in the geomembrane being torn across the initial slide. Without having the photograph of the initial slide, someone investigating the post-failure condition

might think sliding occurred on the PVC geomembrane/soil interface as shown, which was not the case.

Figure 5(b) also shows another initially confusing aspect of the failure, which was the development of bulges or bubbles in the PVC geomembrane from excess hydrostatic pressure underneath the geomembrane at the base of the pond. Without having the initial photograph, it might be postulated that sliding was caused by hydraulic pressure under the geomembrane and failure of the geomembrane subsequently occurred in tension as shown in Figure 5(b). This hypothesis could be supported by the fact that groundwater was encountered on the north slope during construction and the observation that the 150 mm under-drain pipe system was flowing completely full at the time of failure, possibly indicating that groundwater was accumulating from the agricultural irrigation at a rate exceeding the capacity of the under-drain system. Figure 6 presents a plan view of the pond that shows the location of the slope failure and the bulges or bubbles under the geomembrane found after draw down of the pond water.

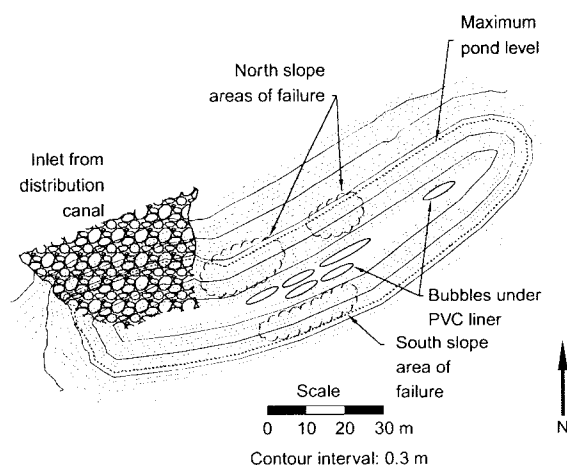
Figure 6. Plan view showing location of failures and bubbles under the geomembrane

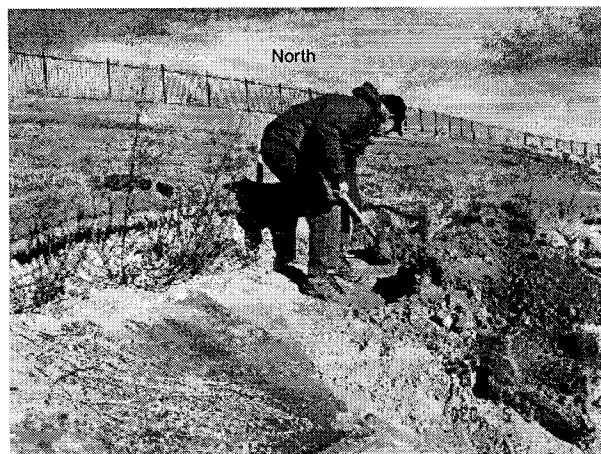
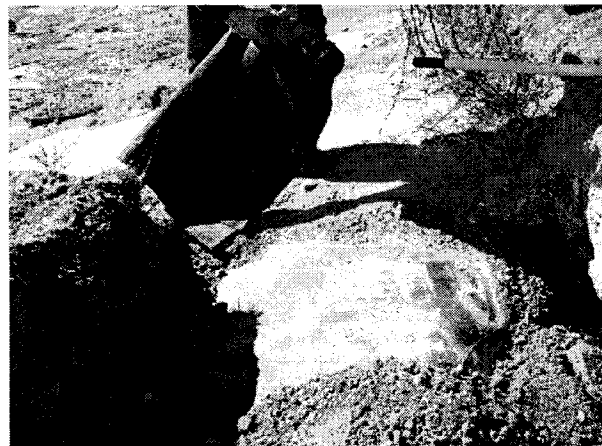
On 5 December 2005, the first author travelled to the site with the third author to inspect the slope failures and obtain samples of the geomembrane and geotextile for interface testing. Samples of the geomembrane and geotextiles 1 m wide and 2.5 m long were hand excavated near the upper right portion of the slope failure, just downslope of the anchor trench as shown in Figures 7(a) and (b). The excavation of the geosynthetics revealed that the faille side of the PVC geomembrane was in contact with the rougher side of the geotextile.

Figure 7. Excavation and sampling of installed geosynthetics for laboratory testing on northern slope

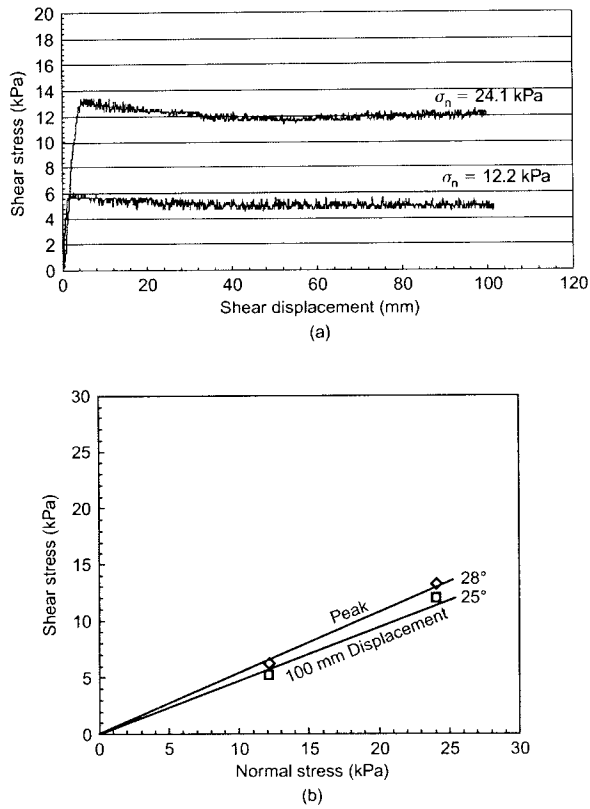
Two direct shear interface tests were conducted according to ASTM D 5321 on the PVC geomembrane/geotextile interface at the University of Illinois. The resulting shear stress-horizontal displacement relationships are shown in Figure 8. These tests utilised normal stresses of 12.2 and 24.1 kPa to simulate the loading imposed by the cover soil and overlying riprap. Assuming an adhesion of zero because of the untextured finish of the PVC geomembrane, Figure 8(b) shows the linear failure envelope drawn through the peak shear resistance measured during these shear tests. The peak failure envelope corresponds to an interface friction angle (δ_p) of 28°. The large displacement failure envelope at 100 mm of shear displacement corresponded to an interface friction angle ($\delta_{100\text{mm}}$) of 25°. The small post-peak interface strength loss of the PVC geomembrane was attributed to the large and intimate contact area between the geomembrane, the geomembrane not being textured and thus not damaging the geotextile (Stark *et al.* 1996), and the high flexibility/pliability of the PVC geomembrane (Hillman and Stark 2001).

Figure 8. Non-woven geotextile/PVC geomembrane interface (a) shear test results and (b) peak and 100 mm displacement failure envelopes

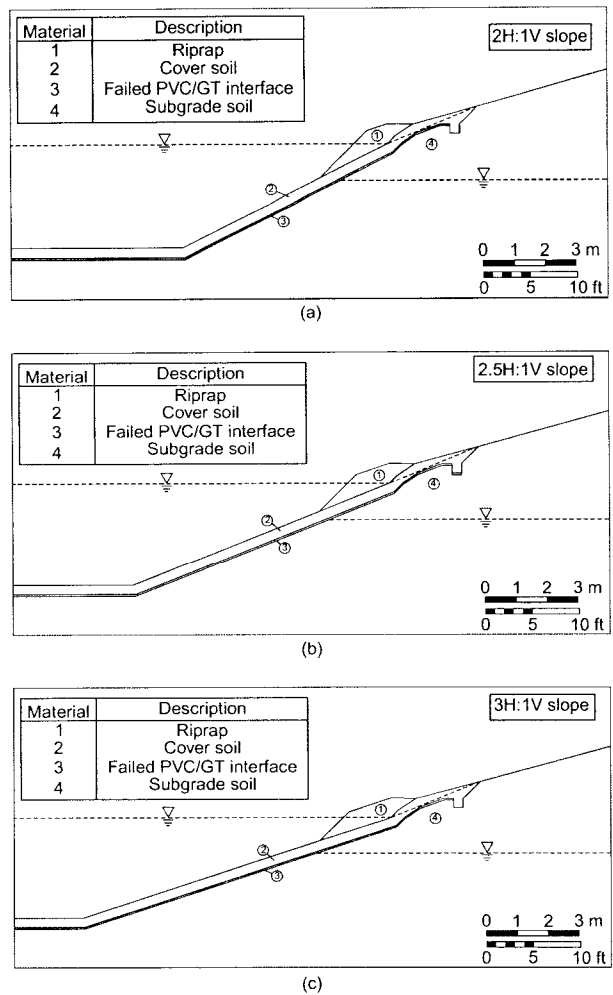
Figure 9. Cross-sections through slide on northern slope shown in Figure 6(a) with intermediate water level

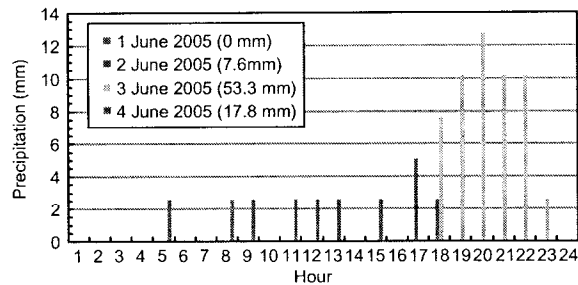
To verify the infiltration assumption, the infiltration rate can be estimated. The hourly precipitation recorded at a National Climactic Data Center (NCDC) recording station in Greeley, CO, for the days leading up to the initial slope failure is shown in Figure 10. The data show that the peak

Figure 10. Hourly precipitation from NCDC site in Greeley, CO, for the days preceding the initial instability. Total precipitation for each day is listed in the legend

precipitation rate on 3 June 2005 was 12.7 mm/h (3.5×10^{-4} cm/s) and the 6-h average was 8.9 mm/h (2.5×10^{-4} cm/s). For comparison, the 100-year, 6-h design storm for the site is 14.5 mm/h (4.0×10^{-2} cm/s) (Miller *et al.* 1973). To verify the infiltration rate was controlled by the hydraulic conductivity of the cover soil, the potential infiltration from precipitation was estimated as $P(1 - RC)$, where P is the precipitation rate and RC is a Soil Conservation Society (SCS) runoff curve number. Using the 6-h average recorded precipitation rate of 2.5×10^{-4} cm/s and a runoff curve number of 0.40 corresponding to a fair stand of grass (Qian *et al.* 2002), the potential infiltration rate is 1.5×10^{-4} cm/s. This rate is greater than the hydraulic conductivity of a silty clay loam or a silty loam (4.2×10^{-5} cm/s or 1.9×10^{-4} cm/s, respectively (Qian *et al.* 2002)). Thus, the hydraulic conductivity of the cover soil probably controlled the infiltration rate.
