Evaluation of Seepage from an Embankment Dam Retaining Fly Ash

Abstract: Observations, data, and analyses used to investigate the cause of fly ash-laden seepage from the right abutment of an earthen dam are presented herein. The investigation shows that the sediment-laden seepage occurred through permeable/jointed bedrock in the right abutment that was exposed by a landslide prior to construction of the dam. When the level of the impounded fly ash reached the level of the prior landslide, the fly ash-laden seepage migrated through the jointed bedrock of the abutment and exited on the downstream right abutment. The joint bedrock was exposed to the fly ash reservoir because the landslide removed the clayey colluvium and/or residual soil overlying the jointed bedrock that formed a natural impervious barrier to seepage. This sediment-laden seepage initially was a great concern because of the potential for erosion and piping in earth dams. However, the rapid investigation into and subsequent monitoring of the seepage revealed that accumulation of fly ash and other coarser particles created a filter cake that reduced the seepage and eventually sealed the joints and fractures in the sand

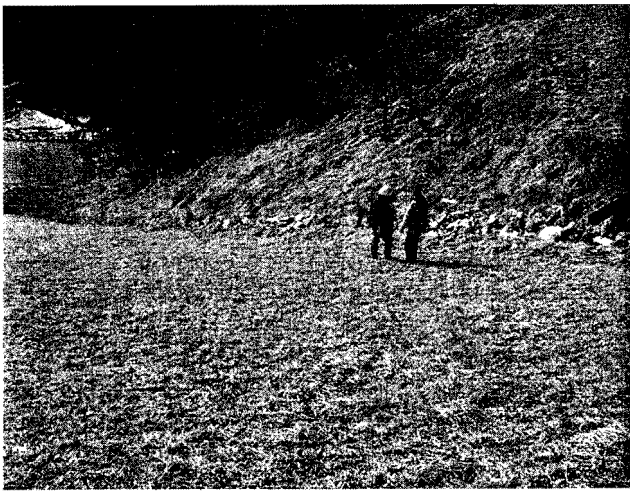
Fig. 3 shows a partial view of the downstream slope of FAD2 near the right abutment. At the right of the photo is Drain Pipe

Fig. 3. Photograph of right groin ditch formed by the right abutment and downstream slope of the dam and large drain pipe in right abutment that discharges into groin ditch

No. 7, which consists of a 0.15 m (0.5 ft) diameter corrugated high-density polyethylene (HDPE) pipe. This drain pipe discharged clear water on February 16, 2004 and continued to discharge clear water during the four subsequent fly ash sediment-laden discharge events. This drainage pipe drains the upper portion of the jointed rock that forms the right abutment of FAD2. Also shown in Fig. 3 is the right downstream groin ditch which is the area at the interface between the right abutment and the downstream slope of the dam. In other words, the groin is located at the connection between the right abutment and the downstream slope of the dam. The contact between the right abutment and the downstream slope of the dam forms a ditch. The wooded area near the bottom of Fig. 3 is the location of the sandstone outcrop that is shown in more detail in Fig. 4 as well another HDPE drain pipe that drains the middle portion of the jointed rock formation of the right abutment of FAD2.

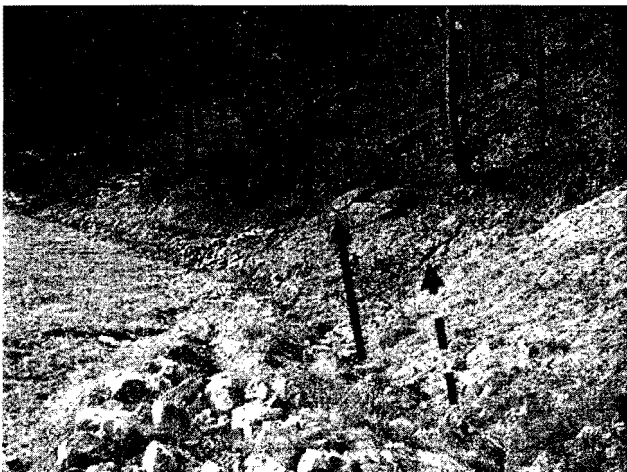
Fig. 4 shows the sandstone outcrop where the sediment-laden seepage was observed on February 16, 2004. A second light gray discharge occurred on February 19, 2004 from the right down-

Fig. 4. Photograph of drainage pipe near midpoint of downstream slope in right abutment (see dashed arrow) and sandstone outcrop downslope of pipe where spring flow occurs (see solid arrow)

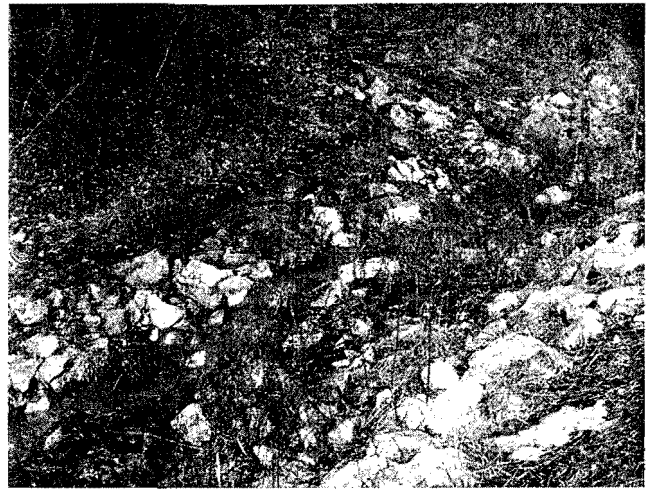
Fig. 5. Photograph of anomalous seepage emanating from sandstone outcrop on right downstream abutment

stream abutment. Just upslope of the sandstone outcrop that is indicated by a dashed arrow is another HDPE drainage pipe. Fig. 5 shows the right groin ditch with light gray sediment-laden seepage exiting the abutment near the sandstone outcrop and flowing down into the groin ditch. The fly ash seepage then continued down the downstream slope of FAD2 in the groin ditch to the toe of the dam.

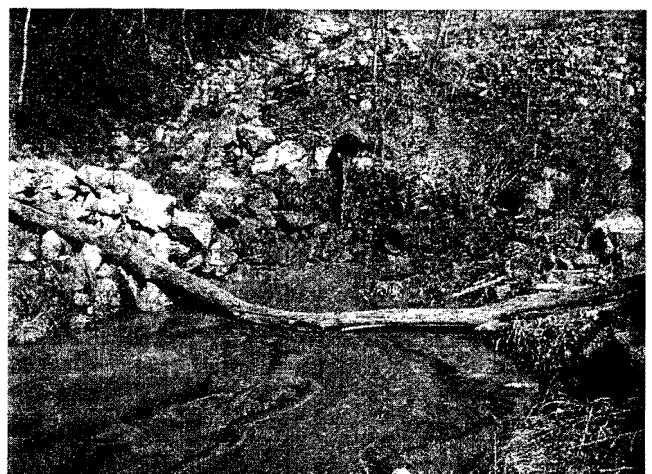
Fig. 6 shows three HDPE drainage pipes located at the toe of the downstream slope of FAD2. From left to right in the photograph are Drain Pipe Nos. 2 (left), 3 (center low), and 4 (right). Drain Pipe No. 2, which collects abutment seepage that enters the right side of the drainage blanket immediately below the right groin ditch, is shown discharging a similar light gray liquid as observed exiting the sandstone outcrop on the right abutment. Drain Pipe No. 3 collects seepage from the drainage blanket immediately downstream of the clay core and Drain Pipe No. 4 collects seepage from a central trench constructed below the slag buttress.

Drain Pipe Nos. 3 and 4 did not discharge any light gray sediment. Drain Pipe No. 3 had to be carefully inspected and monitored to ensure that it was not discharging the observed light

Fig. 6. Photograph of three drains at bottom of right downstream abutment with anomalous seepage

gray sediment because the discharge from Drain Pipe No. 2 sprayed liquid on the drain pipe and the area surrounding the drain pipe, as shown in Fig. 6. This gave the impression that Drain Pipe No. 3 had discharged fly ash-laden sediment. Drain Pipe No. 4, which is normally without a flow, did not show any discharge during the five anomalous seepage events. Drain Pipe No. 4 has experienced intermittent flow in the past and thus is assumed not to be clogged or broken.

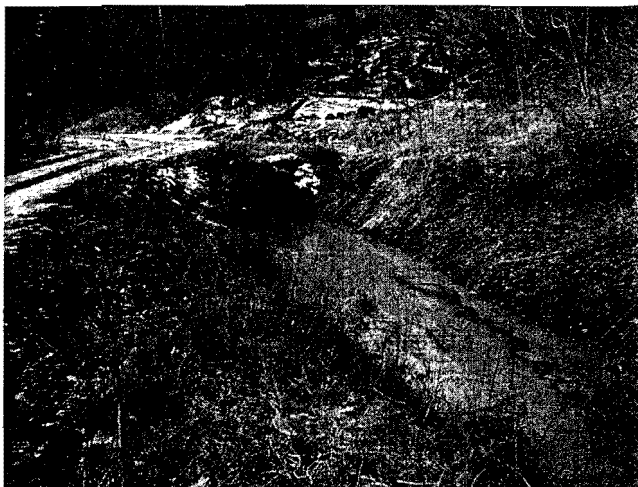
Fig. 7. Photograph of fly ash sediment in downstream creek from five major fly ash discharges

Fig. 7 shows the stream channel downstream of FAD2 with an accumulation of fly ash. Approximately 703,000 kg (775 t) of fly ash sediment had to be excavated from the stream channel as a result of the five fly ash discharges. Fig. 8 shows a partial view of the fly ash reservoir impounded by FAD2 and the slope immediately upstream of the right abutment which is adjacent to the RCC crest of FAD2. At the time of the photo, February 2004, the reservoir pool was frozen.

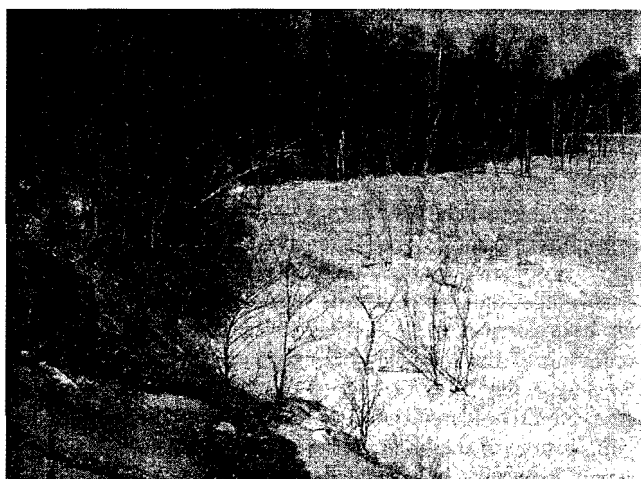
Fig. 8. Photograph of native slope just upstream of right abutment

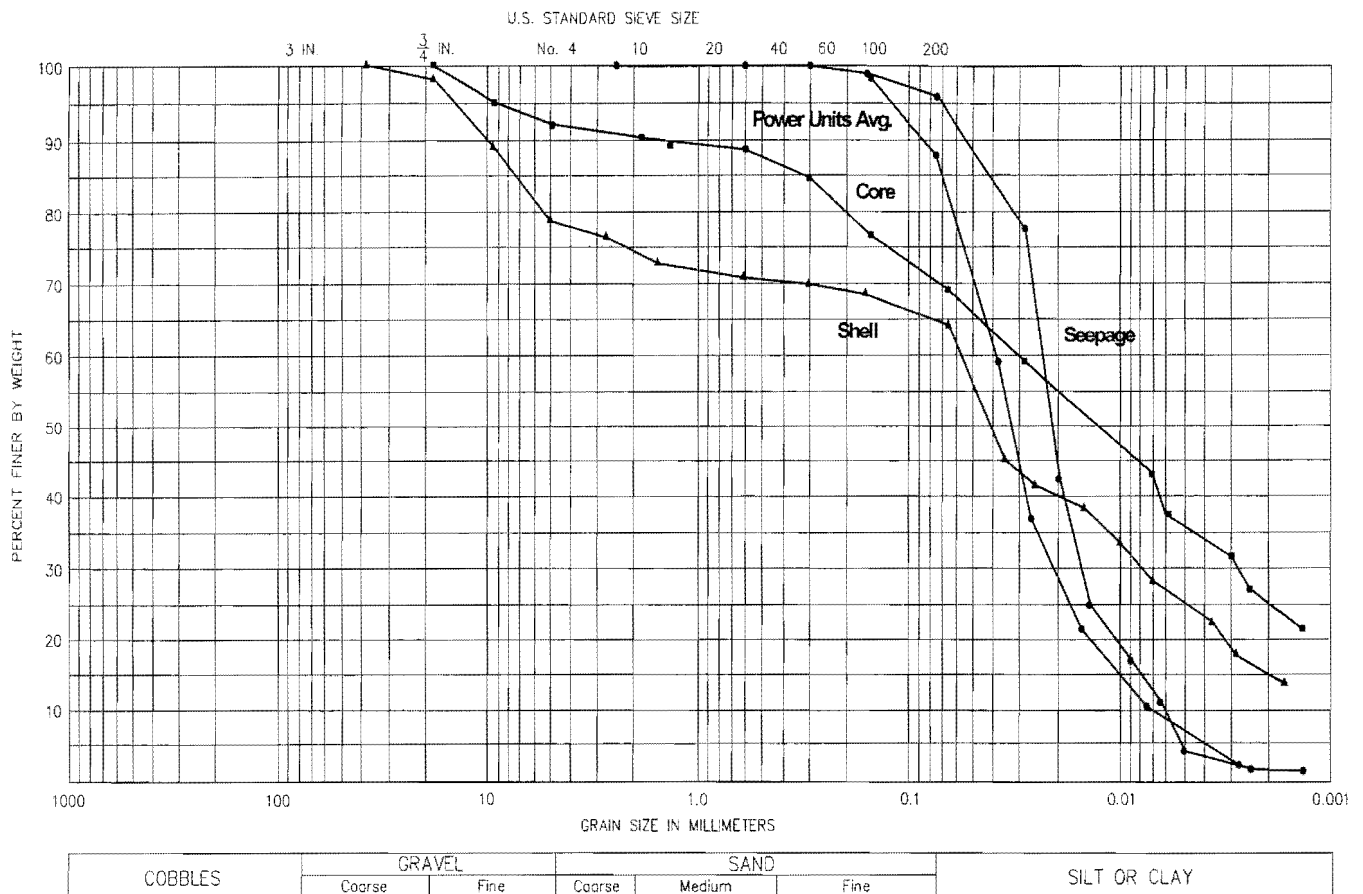
Fig. 9. Comparison of soil gradation relationships for clay core and shell material of the dam and fly ash seepage

Fig. 9 illustrates the disparity between the particle size gradations of the fly ash seepage, clay core, and shell fill materials. Also shown in Fig. 9 is the average gradation obtained from fly ash samples collected from the slurry lines that transport fly ash from the three power units to the FAD2 reservoir. Fig. 10 shows the particle size gradations of the fly ash collected from the slurry line for Power Unit Nos. 1, 2, and 3. The three gradations shown in Fig. 10 were used to develop the average of the fly ash generated by Power Unit Nos. 1, 2, and 3 shown in Fig. 9 and labeled Power Unit Avg.

Fig. 9 shows agreement between the gradations of the fly ash seepage and the average of the fly ash generated by Power Unit Nos. 1, 2, and 3. However, there is a lack of matching of the grain size distributions between the clay core, shell materials, and the fly ash gradations. This indicates that the sediment in the observed seepage was not embankment dam material but fly ash material. Fig. 10 also shows the similarity in particle size gradation of the sediment-laden seepage and the fly ash collected from the slurry lines for Power Unit Nos. 1, 2, and 3 that would be deposited in the reservoir of FAD2.

and (2) clogging of the chimney drain and drainage blankets that could lead to instability of FAD2 due to the buildup of pore water pressures were dismissed. The piping of the clay core and shell fill material was dismissed because Fig. 9 shows that the gradation of the observed seepage does not match the gradation of the clay core or downstream shell materials. The clogging of the chimney drain and drainage blankets was dismissed because instability has not occurred in the downstream slope and seepage from the drainage blankets did not change during or after the observed fly ash seepage.

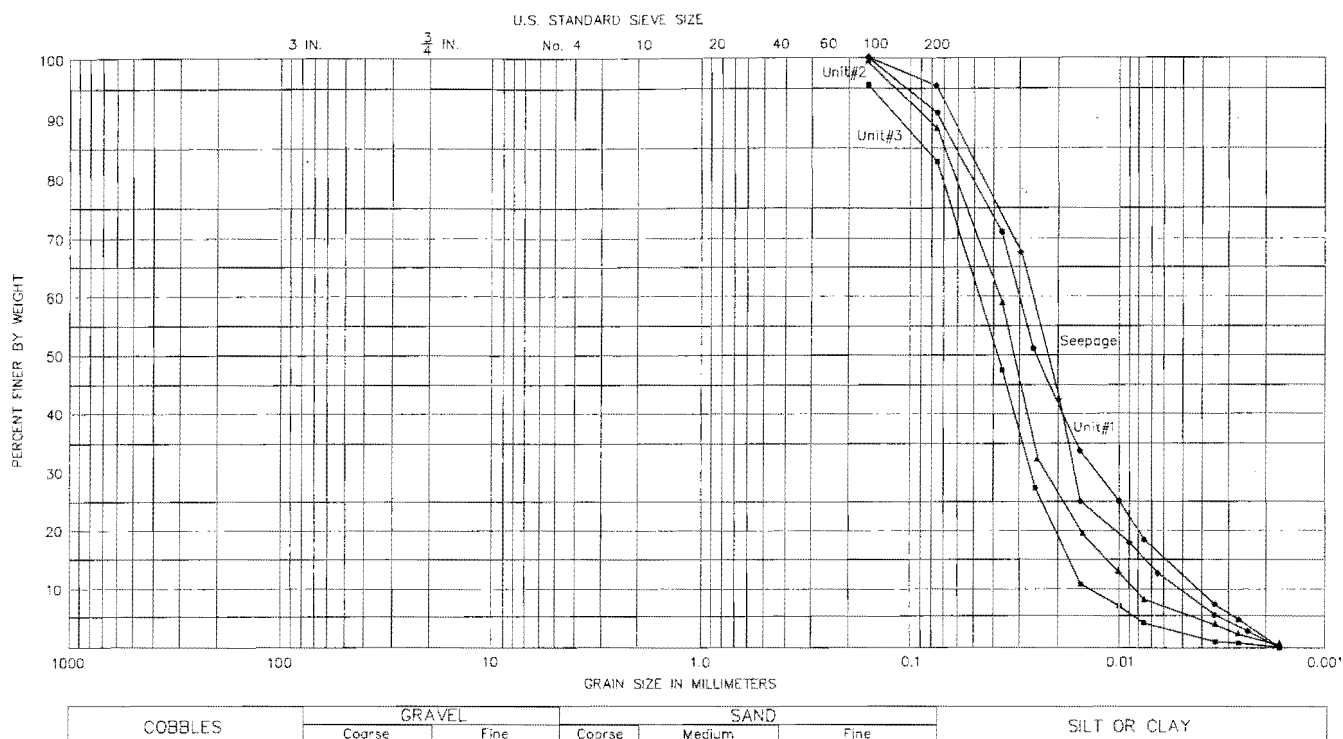
Fig. 10. Comparison of soil gradation relationships for fly ash seepage and new fly ash from Power Unit Nos. 1, 2, and 3

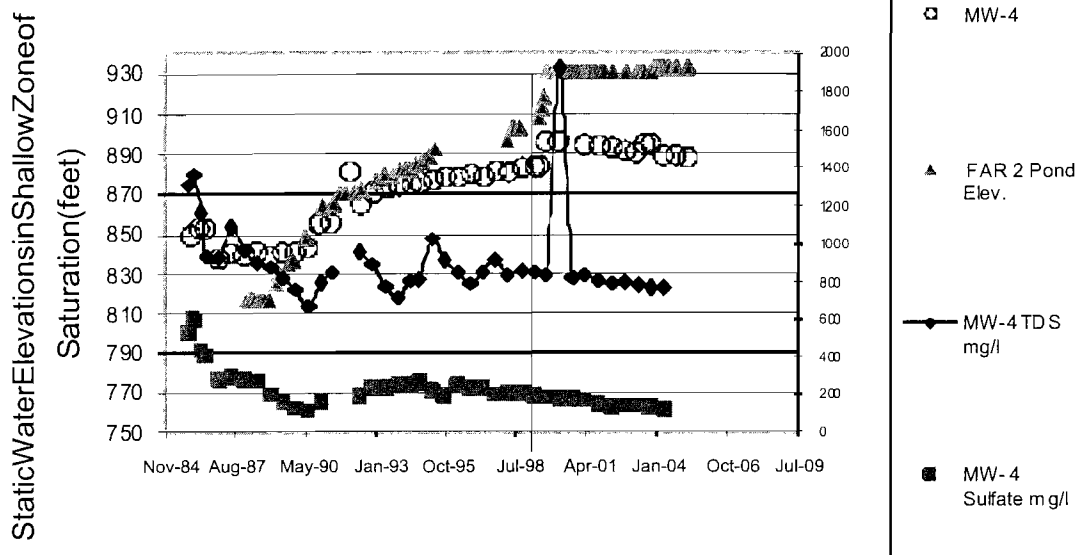
Fig. 11. Data from Monitoring Well No. 4 and FAD2 reservoir level

abandoned strip mines during the baseline monitoring period. Subsequent filling of the FAD2 reservoir resulted in a rise in groundwater levels which eventually reversed the hydraulic gradient within the Morgantown Sandstone such that the fly ash reservoir is able to recharge the jointed sandstone. This is evident from the observed environmental ground water monitoring program that shows sulfate concentrations and total dissolved solids (TDS) in nearby monitoring wells experiencing improved water quality as the fly ash reservoir recharges the bedrock formation, as shown in Fig. 11, which shows the decrease in TDS over time except for one anomalous point around 2000 that is included for completeness. For comparison purposes, Fig. 11 shows the level of Fly Ash Reservoir No. 2, i.e., FAR2, that is impounded by FAD2. The reservoir increased with time because of fly ash disposal but the TDS decreased over this time period. The water level in Monitoring Well No. 4 (MW-4) shows an increase with time which reflects the increasing level of FAR2 with time. In April 2001, ground water levels in the bedrock formation began to decline in several monitoring wells as the fly ash delta began to cover the formation and reduce the amount of flow. Covering of the formation provided a seal for the sandstone and also allowed recharge of the formation (see Fig. 11). This seal helps explain the decrease in sulfate in MW-4 with time, also shown in Fig. 11.
