Fill Placement on Slopes Underlain by Franciscan Mélange

Timothy D. Stark, Ph.D., P.E., F.ASCE¹; Erik J. Newman, Ph.D.²; Gregory de la Peña³; and Donald H. Hillebrandt⁴

Abstract: Distress in two housing developments was caused by a deep bedrock landslide triggered by placement of a large upslope fill. The large fill was placed to create a visual barrier between the upslope development and downslope housing developments and to balance the cut and fill quantities for the upslope site. This case history presents some of the ramifications of fill placement on natural slopes surrounded by urban areas, such as overstressing underlying weak material that may exist below the depth of borings typically conducted for single family residences and office complexes; the importance of surface and subsurface information in a formation known locally as Franciscan complex/mélange (which is a block-in-matrix rock formation common to the area); the shear behavior of serpentinite, which is part of the Franciscan complex; and the importance of natural and man-made changes to a slope, such as rainfall, surficial grading, home construction, and fill placement. It also illustrates the importance of loca

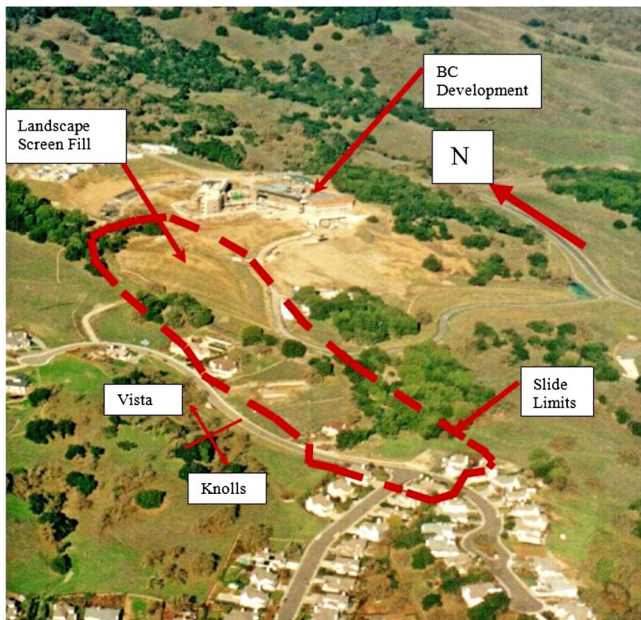
Fig. 1. Aerial view of housing developments, BC development, and an outline of the slide mass

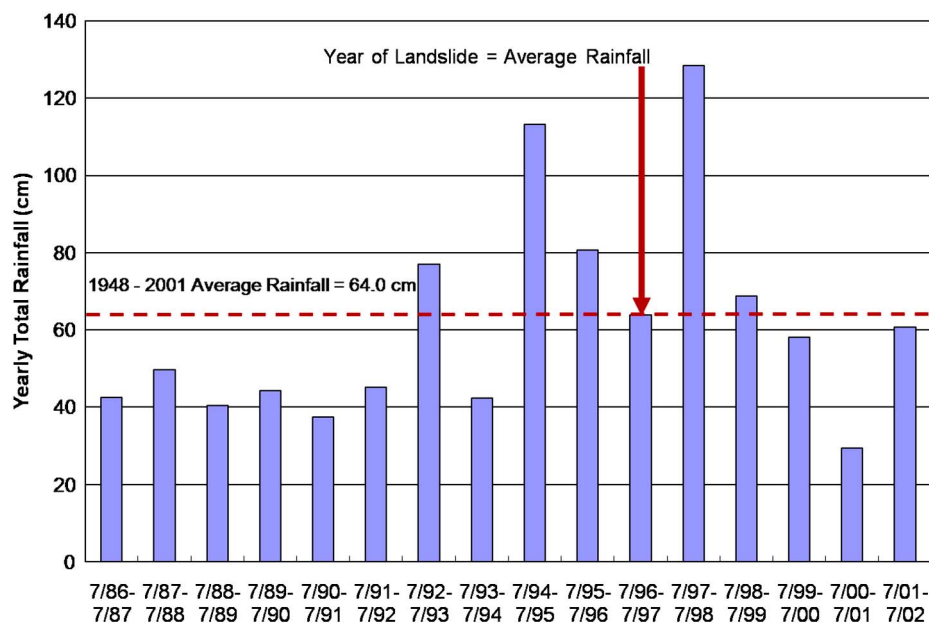
Before the reported distress in late December 1996, more rainfall occurred in three prior years and no landslide occurred. The major difference between these years and 1996–1997, when slope movement did occur, is that the landscape screen fill had not been constructed. In the 1996–1997 rainy season, less rainfall occurred than in several previous years, but a landslide occurred. Thus, it was postulated that rainfall alone was not the landslide trigger and additional investigation was undertaken.

Fig. 2. Annual rainfall data from nearby fire station

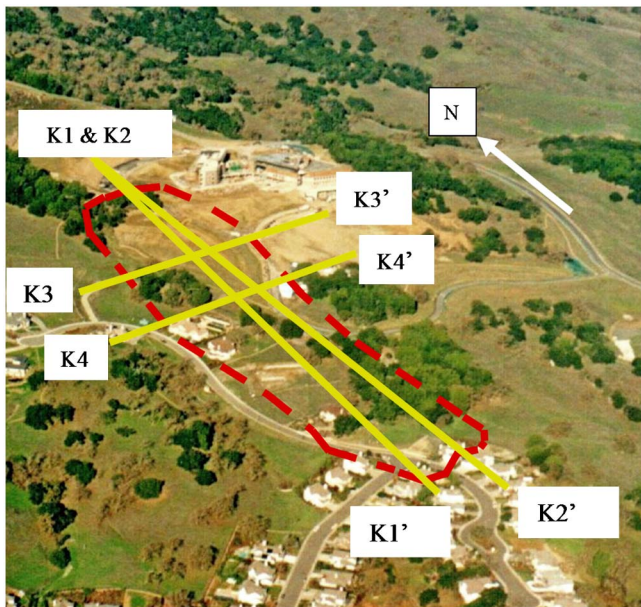
Fig. 3. Aerial view of the landslide illustrating four cross sections considered

Knowing that the landslide is underlain by the highly variable Franciscan complex/mélange, four cross sections were drawn to try to understand the materials present, the variability of the materials, and the presence of unusual and varying subsurface features, such as a buried sandstone ridge under the eastern portion of the slide mass. These four cross sections are shown in Fig. 3 and are labeled K1–K1' through K4–K4'. The stability analyses revealed that K1–K1' in the western portion of the slide is the critical cross section, i.e., it yields the lowest factors of safety. As a result, the causation analysis described subsequently focuses on K1–K1'. Cross sections K3–K3' and K4–K4' revealed the presence of a buried sandstone ridge that increases from a depth of about 40 m on the western portion of the slide mass to a depth of only about 18 m on the eastern portion of the slide mass in the vicinity of K2–K2'. The presence of the sandstone ridge provided some resistance, which increased the stability along cross section K2–K2' and contributed to K1–K1' being the critical cross section.

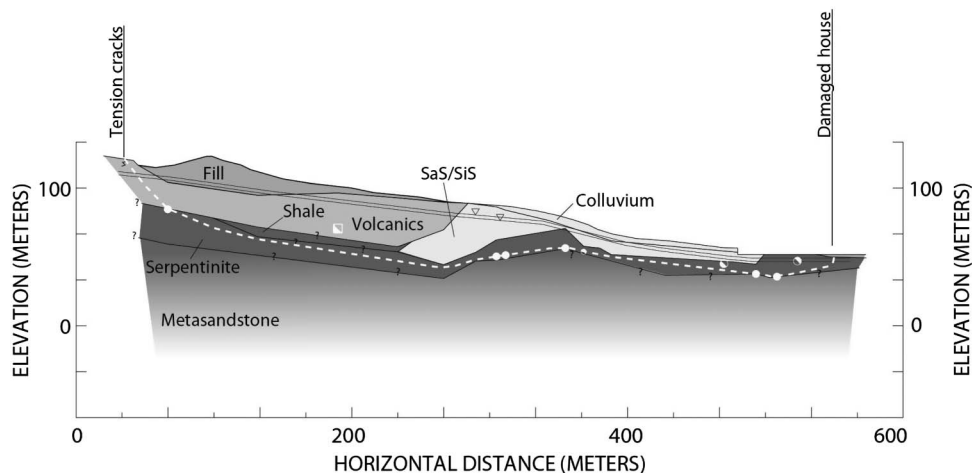
Fig. 4. Plan view showing location of 16 inclinometers installed

The appearance of continuous and substantial tension cracks along the top of the slide limits, i.e., upslope of and around the landscape screen fill, indicated that landscape screen fill was pulling away from the upslope materials. This is an indication of a translational failure mechanism instead of a rotational failure mechanism (Cruden and Varnes 1996). The tension cracks upslope of the landscape screen fill continued to widen until the landscape screen fill was removed between December 1997 and April 1998. In addition, no vertical offset was associated with these tension cracks, which is expected for a translational slide that only experienced about 0.2–0.25 m of movement at the toe of the slide mass. This magnitude of movement is based on the observed housing distress and inclinometers installed prior to landscape screen fill removal in December 1997. Eighteen inclinometers were installed in and around the slide mass, and the locations are shown in Fig. 5. The first set of inclinometers was installed in late February 1997 by the project engineer, and they are shown as squares in Fig. 5. The second set of inclinometers was installed in mid-September 1997 by another engineering firm. They are shown as circles in Fig. 5.

not provide direct slide movement information. Each of the nine useful inclinometers showed only one slide plane at depths ranging from 5 m near the landslide toe to about 40 m near the middle of the slide mass. The depth of movement, or the total depth of the inclinometers, is plotted on cross section K1–K1' in Fig. 4 using various symbols. A solid circle corresponds to an inclinometer that is within 30 m of cross section K1–K1' and exhibits a distinct shear displacement; a partially shaded circle corresponds to an inclinometer that is not within 30 m of K1–K1', but shear displacement was observed in the inclinometer. The failure surface in Fig. 4 (see dashed line) was developed by connecting the location of shear movement in the inclinometers, following the various material types, and passing the failure surface through the cracks observed at the top of the landslide and distress observed at the landslide toe.

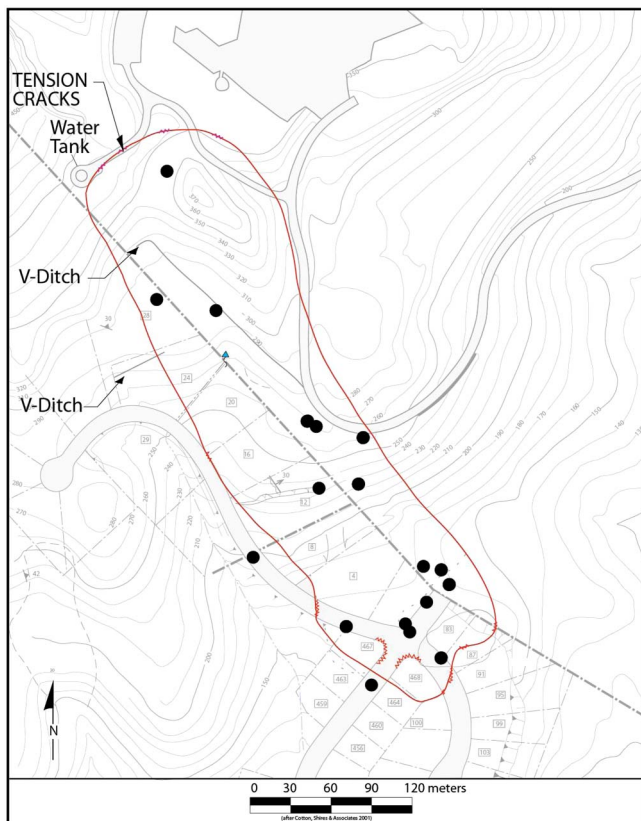
Cross section K1–K1' is shown in Fig. 4 and was obtained from the results of 74 borings drilled in and around the slide mass shown in Fig. 1. Some of these borings were drilled before the landslide and some after the slide to install piezometers and inclinometers or to assess soil stratigraphy. Based on field observations, slope inclinometer results, and the stratigraphy developed from the results of the subsurface investigation, the 1996 failure surface passes through the tertiary volcanics upslope of the landscape screen fill at a steep inclination to the underlying weak and saturated serpentinite (Fig. 4). The failure surface continues along the serpentinite layer until the depth of overburden allows it to daylight in the Knolls development. The landslide also damaged Vista development homes along the western edge of the slide mass.

Therefore, the failure surface shown in Fig. 4 corresponds to a translational failure mechanism, although it is somewhat atypical in that it passes up and over a metasandstone ridge near the middle of the cross section. A similar process was used to develop cross section K2–K2' prior to the stability analyses.

Fig. 5. Cross section K1–K1' through western portion of landslide after surficial grading and placement of landscape screen fill

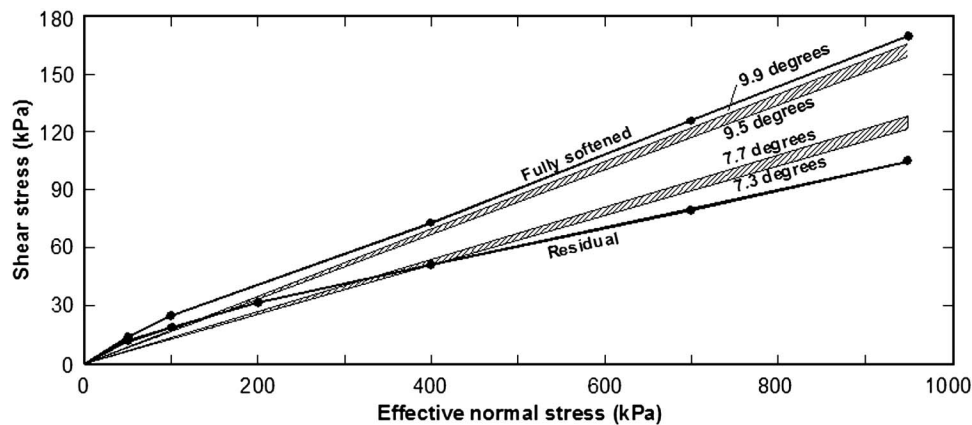
The results of the back-analysis of cross sections K1–K1' and K2–K2' are presented in Fig. 6. The back-calculated failure envelopes for K1–K1', i.e., friction angles of 9.9 and 9.5° for high and low water, respectively, are slightly below the fully softened failure envelope measured in the torsional ring shear tests. The back-calculated failure envelopes for K2–K2', i.e., friction angles of 7.7 and 7.3°, are well below the measured fully softened failure envelope and are in better agreement with the measured residual failure envelope. In engineering practice, it is more appropriate to round friction angles to the nearest one-half degree, but if this was done for the back-analysis, it would appear that there is no effect of the different water levels for K1–K1' because both back-calculated friction angles would be reported as 10.0°, instead of 9.9 and 9.5°, which would not make sense.

Fig. 6. Serpentinite failure envelopes derived from torsional ring shear tests and back-analyses

The cross section that yields the highest back-calculated friction angle is the critical cross section. Therefore, the western portion of the slide mass, i.e., K1–K1', is critical because it yielded higher back-calculated friction angles for both the high (rainy season) and low (dry season) groundwater levels considered than did K2–K2'. This is in agreement with distress being first reported in homes in the western portion of the landslide toe and the western portion of the Vista development. Therefore, it was concluded that shear movement started along cross section K1–K1' and induced movement along K2–K2'.
