Compacted Soil Liner Interface Strength Importance

Timothy D. Stark, F.ASCE¹; Hangseok Choi²; Chulho Lee³; and Brian Queen⁴

Abstract: This paper describes an interesting slope failure in a liner system of a municipal solid waste containment facility during construction because the sliding interface is not the geomembrane (GM)/compacted low-permeability soil liner (LPSL) but a soil–soil interface within the LPSL. Some of the lessons learned are as follows: (1) compaction of the LPSL should ensure that each lift is kneaded into the lower lift so a weak interface is not created in the LPSL; (2) the LPSL moisture content should be controlled so it does not exceed the specified value, for example 3–4% wet of optimum, because it can lead to a weak interface in the LPSL; (3) drainage material should be placed over the GM from the slope toe to the top to reduce the shear stresses applied to the weakest interface; and (4) equipment should not move laterally across the slope if it is unsupported but up the slope while placing the cover soil from bottom to top. DOI: [10.1061/\(ASCE\)GT.1943-5606.0000556](https://doi.org/10.1061/(ASCE)GT.1943-5606.0000556). © 2012 American Society of Civil E

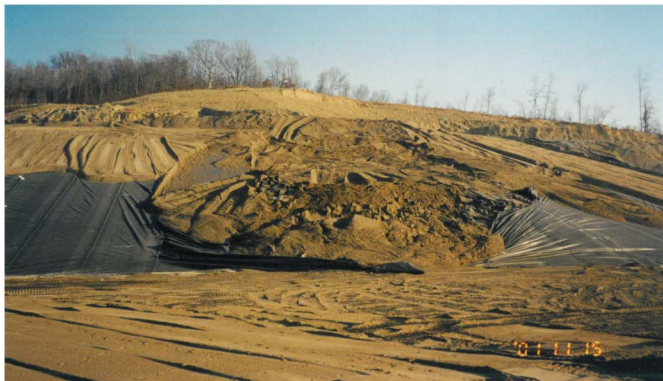
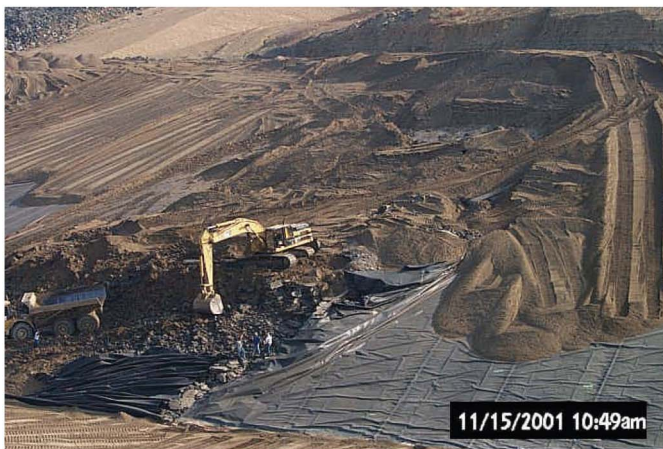
Figs. 1 and 2 are photographs of sideslope construction and show the liner system installed and granular drainage layer (GDL) placed from the top to the bottom of the slope. This placement practice is not recommended because the GDL is unbuttressed and imparts high shear stresses on the liner system and the weakest liner system interface because of the weight of the GDL and equipment operating on the inclined slope (Giroud et al. 1995; Koerner

Fig. 1. Overview of failed slope and folded geomembrane at slope toe

and Soong 1998; Stark and Choi 2004). As a result, it is frequently recommended that GDL be placed from the bottom to the top of the slope so that the GDL buttresses itself and reduces the shear stresses and shear displacement applied to underlying liner system interfaces (Giroud et al. 1995; Koerner and Soong 1998; Stark and Choi 2004). This top to bottom placement technique was especially problematic in this case because the slope is fairly long, so a considerable thickness of material had to be pushed from the top to the bottom of the slope. Figs. 1 and 2 show that the unbuttress thickness of GDL near the slope toe is substantial and ranges in thickness from 1 to 1.5 m (3–5 ft). This large thickness can impart large shear stresses in the liner system and on the weakest interface.

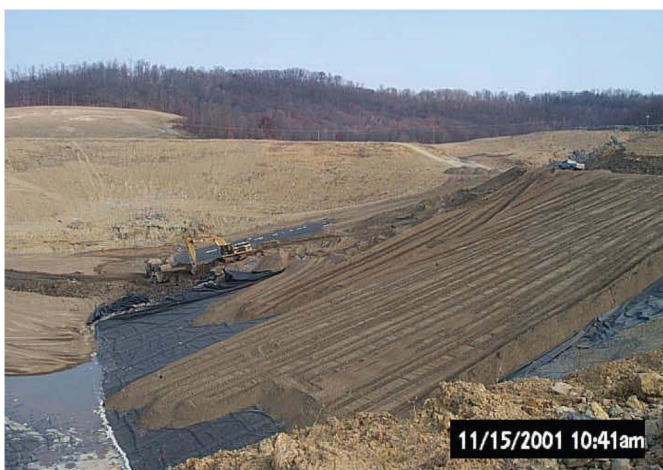
The GDL was stockpiled by large, off-road dump trucks at the crest (top) of the slope. The GDL stockpiles at the crest were 1.5–2.4-m (5–8 ft) high in some cases. Two low ground pressure (LGP) bulldozers (CAT D6 and John Deere 850) were used to move material from the crest down the slope as shown in Fig. 2. The dozers were assumed to exert a ground pressure of 34.4 kPa (720 psf) on the basis of manufacturers, literature. In the area of the failure, the dozers made a number of lateral passes on the slope instead of maintaining top to bottom or bottom to top passes, while spreading the sand cover material. This resulted in the equipment and drainage material remaining unsupported across the slope as the equipment moved laterally across the slope. Granular drainage layer was not spread on the lower third of the slope at the time of the failure as shown in Fig. 2.

There were no observations of GM distress before the first slope failure. The GM distress would have been apparent because the cover soil was placed from the top down (see Fig. 2), so GM would have started to accumulate at the slope toe, but none was visible.

Fig. 2. Overview of sideslope and protective sand placement on geomembrane

- Cover soil placement should start at the slope toe and progress up the slope. This allows the cover soil at the slope toe to buttress the upslope material, so an infinite slope condition, that is, an unbuttressed slide block, does not develop and apply larger shear stresses to the interfaces and materials in the composite liner system.

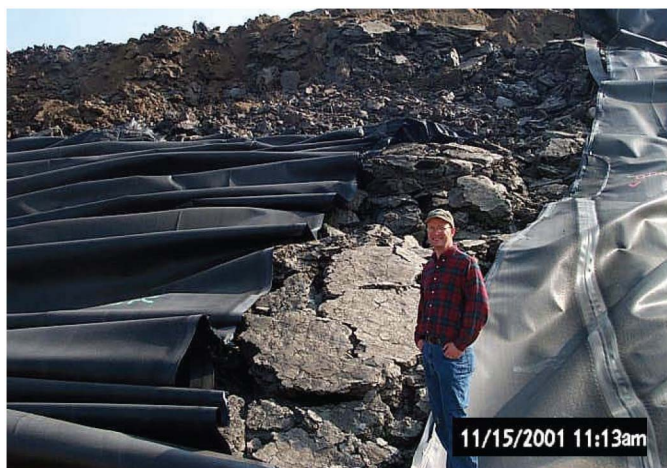
Fig. 3 is a photograph near the toe of the slope and shows the damaged GM because of the slope movement. This type of GM damage is typical in slope movement situations because the GM easily tears under the large applied shear and normal stresses.

Fig. 3. Photo of failed slope and damaged geomembrane

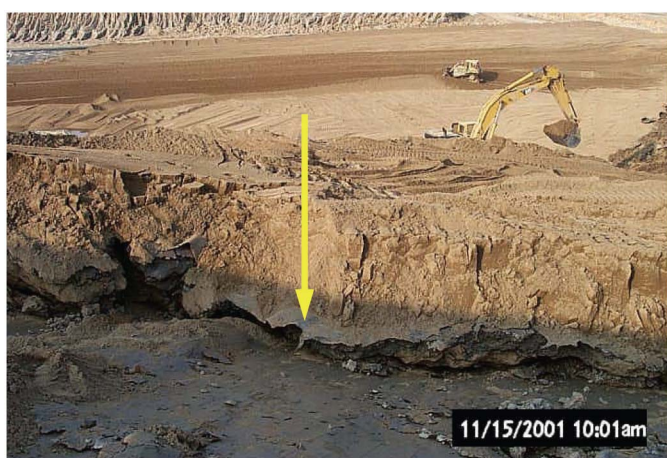
Fig. 4 is a photograph from upslope of the slide movement. This photograph shows the drainage material overlying the torn GM and the sliding surface below the torn GM. The failure surface was primarily confined to a depth of 75–150 mm (3–6 in.) into the compacted LPSL interface but not at the GM/LPSL interface. More importantly, Fig. 4 shows that the failure or slickensided surface extended the entire length of the slide because the drainage material and GM are missing from upslope of where the slide mass stopped (see arrow in Fig. 4) to where the slide block stopped.

Fig. 4. Photo of slide surface and torn geomembrane

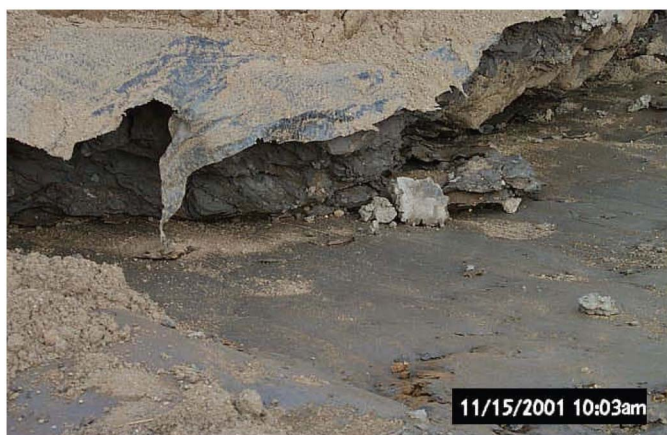
The arrow in Fig. 4 also shows the location of the photograph in Fig. 5. Fig. 5 is a close-up photograph of the torn GM that clearly shows the slide surface occurring below the torn GM. From Fig. 5, it may be concluded that sliding occurred in the compacted LPSL first and the GM was torn as a result of this movement. A back-analysis using the software SLOPE/W was conducted and

Fig. 5. Close-up of torn geomembrane that shows the slide surface is below the geomembrane/LPSL interface

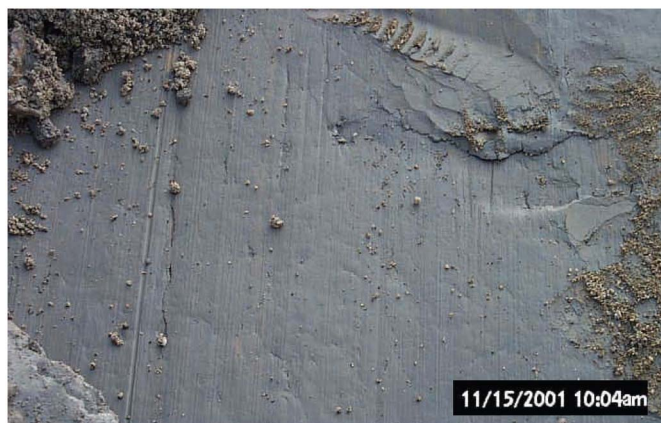
Fig. 6 is a photograph of the exposed sliding surface in the compacted LPSL. This photograph shows striations in the LPSL that confirms the location of sliding was in the LPSL. In addition, a

Fig. 6. Close-up photo of slide surface in the LPSL

footprint is evident that indicates the soft and moist nature of the surface of the LPSL.

After the slide, four moisture content specimens were obtained from the exposed slide surface as shown in Fig. 6. The measured moisture contents are 24.9, 28.6, 26.5, and 26.9 with an average of 26.7%. These moisture contents correspond to a moisture content of approximately 4.1% above the optimum moisture content.

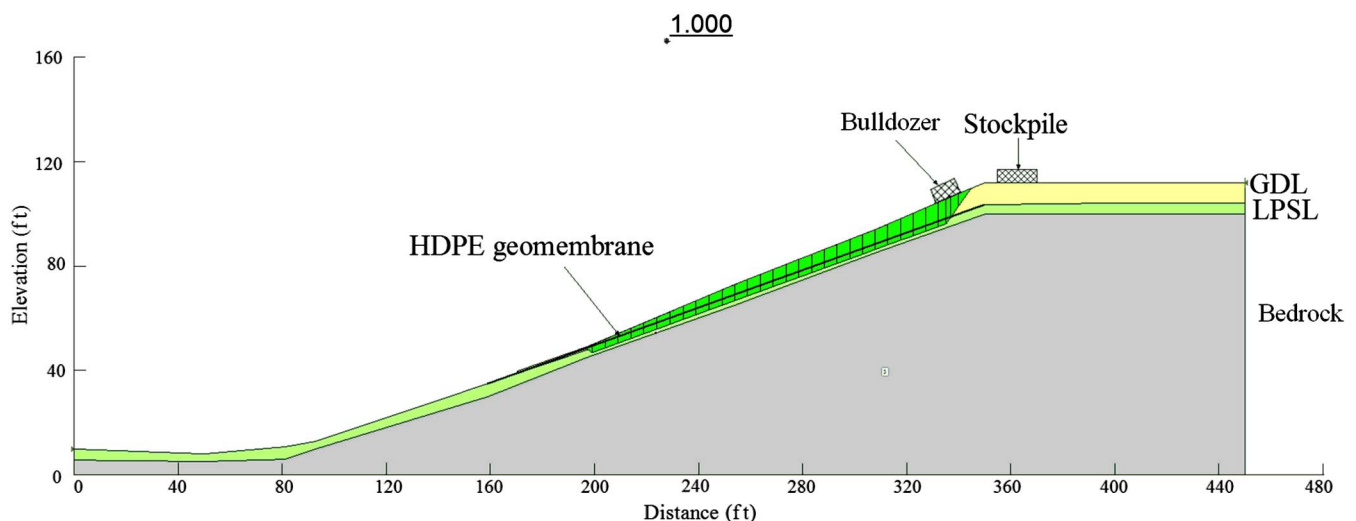
Fig. 7 shows a LGP bulldozer operating on the slope that was modeled in SLOPE/W as a loaded area for the back-analysis. A seismic coefficient of 0.005 was used to model the vibration or acceleration effects of the dozer operating laterally on the slope as reported. In addition, a surcharge attributable to loaded trucks

Fig. 7. Slope geometry before slide movement and back-analysis by using Morgenstern–Price’s stability method

In the back-analysis, effective stress cohesion of the compacted LPSL to achieve a factor of safety of unity (slope failure) was estimated. The slope geometry and failure surface used in the back-analysis with the Janbu (1957), Morgenstern and Price (1965), and Spencer (1967) stability procedures are also shown in Fig. 7, which shows the Morgenstern and Price back-analysis results. The back-calculated (or mobilized) effective stress cohesion values for

the compacted LPSL are summarized in Table 3 for the Janbu, Morgenstern–Price, and Spencer stability procedures. Table 3 shows the back-calculated effective stress cohesion ranges from 0.70 to 1.25 kPa. The back-calculated values are significantly smaller than the effective stress cohesion obtained from the laboratory CU triaxial compression tests (13.4 kPa). The difference between the back-calculated and laboratory values of effective stress cohesion may be related to the difference in field (direct shear) and laboratory (triaxial) modes of shear, the triaxial specimen not having the weak soil–soil interface or the soil–soil interface not oriented properly in the triaxial device, and differences in moisture content and level of compaction between the field and laboratory.

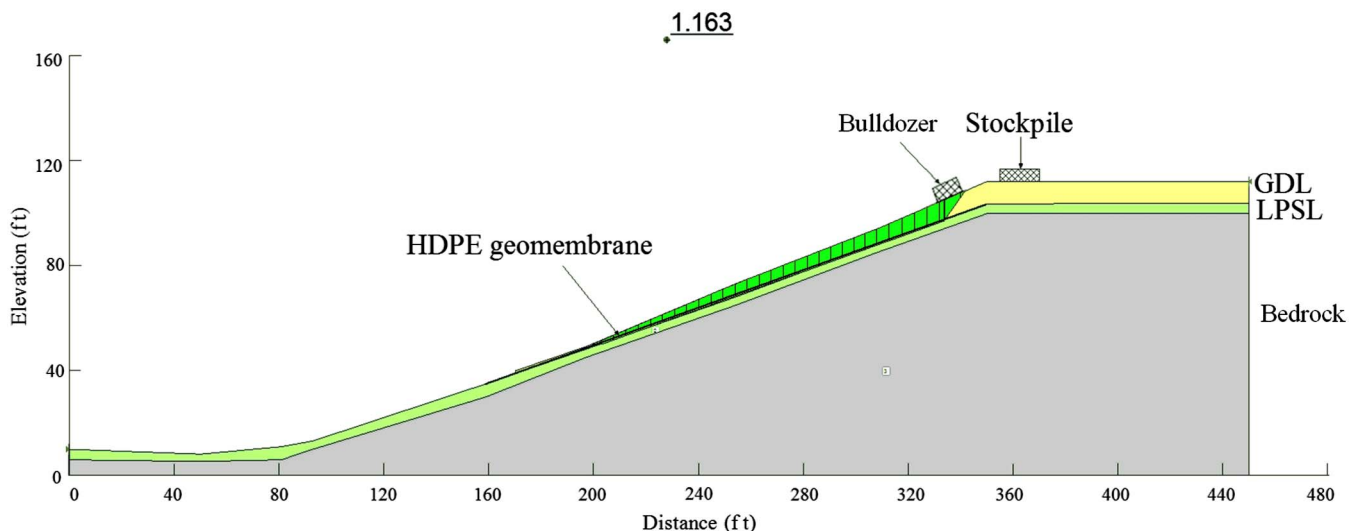
In the additional slope stability analysis (the Morgenstern and Price method) with the same slope geometry and material properties including the back-calculated effective stress cohesion of 1.14 kPa, all potential failure geometries yielded a factor of safety greater than unity. Especially, the failure surface at the GM/LPSL interface provided a factor of safety of approximately 1.16 as shown in Fig. 8, which implies the slope failure would not occur at the GM/LPSL interface but would occur at the soil–soil interface within the LPSL.

**Fig. 8.** Morgenstern–Price's stability analysis for failure surface at GM/LPSL interface

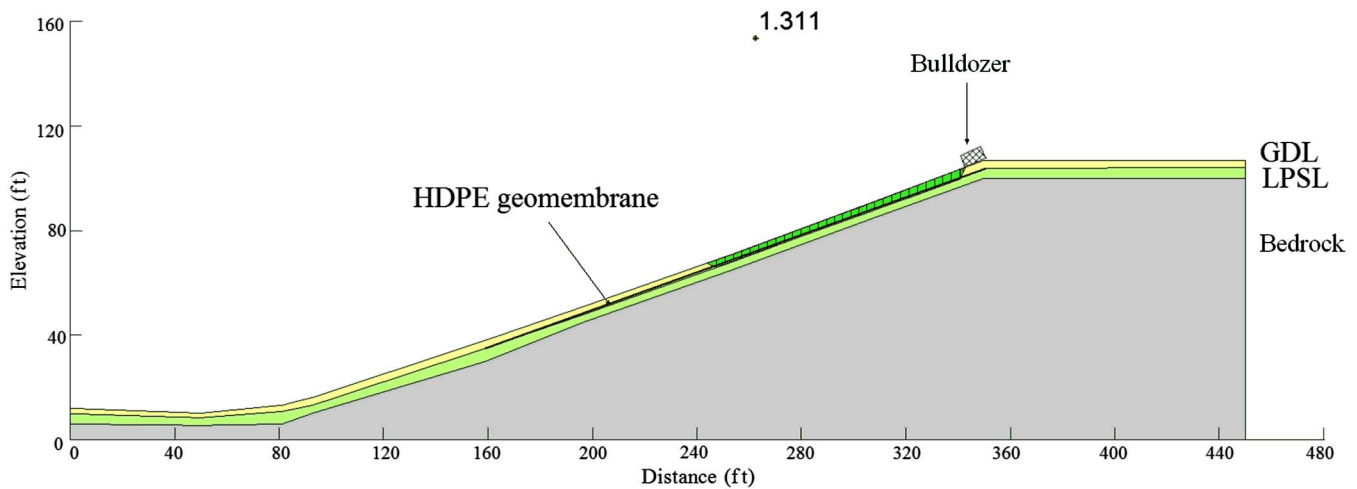
Fig. 9. Slope analysis by using the Morgenstern–Price method and soil placement from bottom to top of the slope

Strength parameters used in this analysis are the same as those in Table 1 except the back-calculated cohesion of 1.14 kPa (23.8 psf) for the compacted LPSL was adopted because Morgenstern and Price's procedure is more rigorous than the other two stability procedures. Fig. 9 shows the slope geometry and LGP equipment on the slope with cover soil placed from the bottom to the top of the slope and the slope geometry and critical failure surface for the Morgenstern and Price (1965) procedure, which yielded a factor of safety of approximately 1.31. The factors of safety for the Janbu (1957) and Spencer (1967) stability procedures are approximately 1.30 and 1.35, respectively, for soil placement from bottom to the top of the slope. Thus, placing the cover soil from the bottom to the top of the slope would have increased the factor of safety by approximately 40% so the slope probably would have been stable if the cover soil had been placed from the bottom to the top of the slope.
