Jet Grouting and Safety of Tuttle Creek Dam

Timothy D. Stark, Professor of Civil and Environmental Engineering, University of Illinois at Urbana-Champaign, USA, tstark@illinois.edu

TUTTLE CREEK DAM

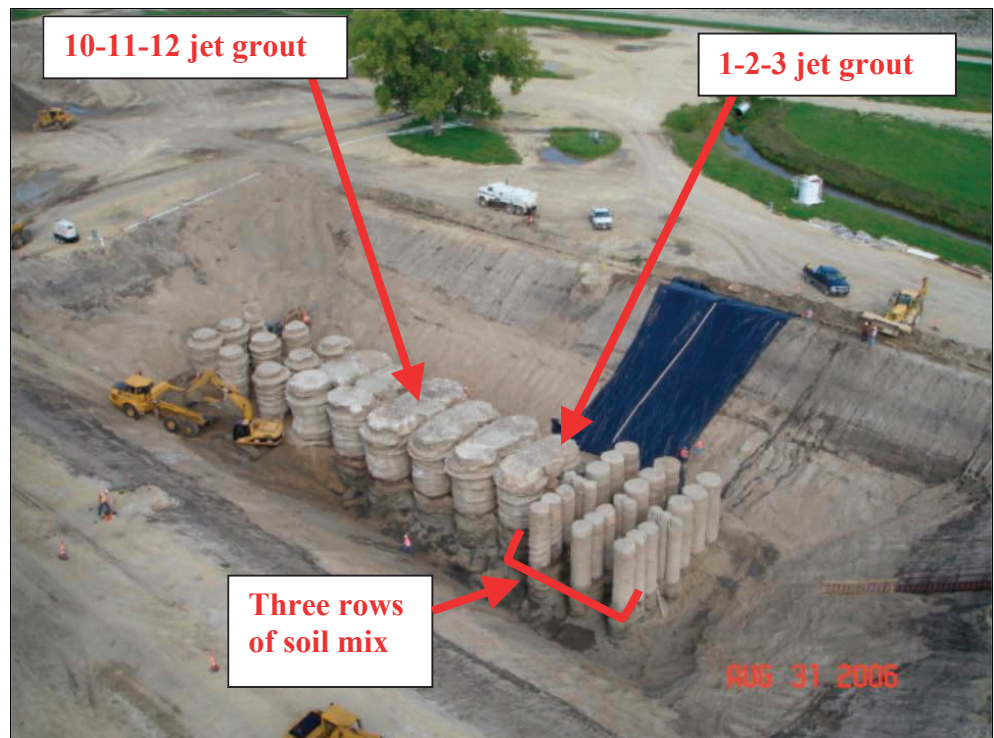
The sectioning revealed that the cross-section of the jet grout test columns contained more than 40 to 50% native soil that was not broken up and evacuated during the jet grout process (Stark et al. 2009). In other words, 40 to 50% of the sectioned column consisted of chunks of native soil and about 60 to 70% of the sectioned triple-fluid column consisted of native soil. The inclusions were encountered throughout the entire diameter of the column. Most of the inclusions were greater than 75 to 100 mm (3 to 4 inches) which could lead to blockage of spoil return. This large amount of soil inclusion could also have impacted the hydraulic conductivity of the resulting column.

The observed inclusions in the completed jet grout columns included significant amounts and large pieces of both fine-grained (silts and clays) and coarse-grained (fine sands and sands) soils. The following are two explanations for the inclusions: (1) fine grained soils can be difficult to erode and break up into small enough

[FIG. 3] Downstream parametric jet grout and soil mix column groups during excavation and columns to be sectioned

In summary, the significant amount and large size of the soil inclusions found in the completed columns suggests that blockage of the annulus between the boring casing and jet grouting drill rod should be expected. This may lead to accumulation of high pressures in the subsurface and likely induce ground fracturing.

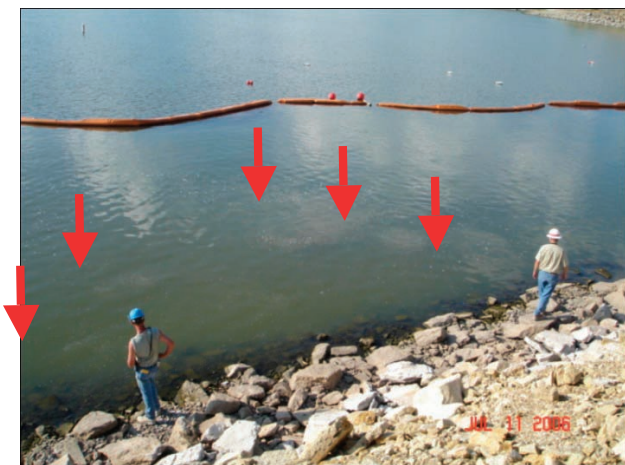
At 16:55, contractor and USACE personnel noticed vigorous air bubbling in the reservoir about 15.3 m (50 ft) upstream of the work area. After this observation, the contractor stopped jet grouting, pulled the drill rods, and grouted up the drill hole around 17:00. The arrows in Fig. 4 indicate large areas of intense air bubbling in Tuttle Creek Reservoir in the vicinity of jet grout column S2-A3. The bubbling air in the reservoir appeared from approximately Station 65+00 to 67+00 and suggested that ground fracture may have occurred. The air bubbling continued for almost 48 hours after jet grouting indicating a large volume of air was stored, probably in the pervious foundation materials, prior to release into the reservoir.

[FIG. 4] Photograph of air bubbling in Tuttle Creek Reservoir during jet grouting of upstream column S2-A3 with reservoir turbidity curtain in background

Therefore, a plausible mechanism for air bubbling in the reservoir during jet grouting for columns S2-A3 and S2-A7 is the accumulation of sufficient pressure with reduced spoil return, storage of large quantities of air in the permeable and high void ratio foundation sands, and subsequent fracture of the natural fine-grained soil blanket that released the stored air for at least 48 hours after cessation of jet grouting. However, the most plausible mechanism for the air bubbling in the reservoir for double fluid column S2-A7B appears to be different and is discussed below. After blanket fracturing occurred, the stored air exited the foundation sands and entered the reservoir. The bubbling was able to continue for over 48 hours because of the large void space of the foundations sands allowed a substantial amount of air to be stored. It is likely that the reason air bubbling was not observed sooner in the reservoir is: (1) the distance air had to travel, from elevation 305.7 (1002.3 ft) or lower to the natural fine-grained blanket, (2) the time required for sufficient pressure to accumulate to fracture the natural fine-grained blanket, and (3) the time required to fracture and/or permeate the reservoir sediment and/or the overlying shale/limestone fill. This assumes that the air traveled upstream of the impervious fill, which is reasonable given the hydraulic conductivity of the impervious fill and the additional vertical stress imposed by the thicker embankment. This scenario also explains air bubbles appearing in the reservoir shortly/immediately after spoil returned slowed in column S2-A7 because the air pressure of 1,200 kPa (174.0 psi) fractured the lower sands and nearby natural fine-grained blanket and shale/limestone fill had been previously fractured by column S2-A3.

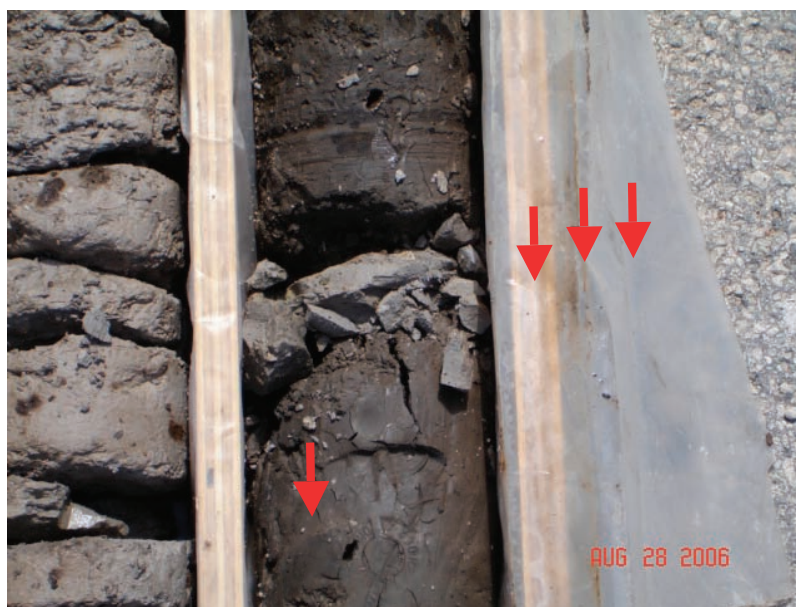
Additional evidence of ground fracturing during the upstream parametric columns was obtained via the subsequent subsurface investigation. The evidence consisted of core samples containing a grout fracture from a boring near upstream jet grout column S2-A1. The arrows in Fig. 5 point to grout lenses found in the natural fine-grained blanket at a depth of 23.8 m (78 ft). This core sample was obtained at a ground surface distance of only 1.2 m (4 ft) from the center of jet grout column S2-A3. This ground fracture is significant because it is located downstream of the column. This proved that ground fracturing can occur downstream (towards higher confining stress) as well as upstream of the jet grouting. Appearance of bubbles was not possible downstream of the jet grouting because the surface of the work platform was dry. Hence, air release may have occurred but would have gone undetected by site personnel. Fractures created downstream of the cutoff wall can provide seepage paths through the fine-grained blanket after the wall is complete. These seepage paths could lead to undesirable erosion and piping downstream of the cutoff wall. This is of critical importance because a completed cutoff wall could address the upstream fractures but cannot address downstream fractures. This scenario becomes increasingly dangerous at elevated pool levels that are certain to occur in a flood control reservoir.

[FIG. 5] Grout fracture in the core for column S2-A1 at a depth of 23.8 m (78 feet) (arrows indicate grout found in the embankment materials)
