1 **CASE STUDY: SEISMIC RETROFIT OF TUTTLE CREEK DAM**

38 **Paper# GTENG-2238-R2**

39 A case study submitted for RE-review by EDITOR ONLY and publication in the
40 *ASCE Journal of Geotechnical and Geoenvironmental Engineering*

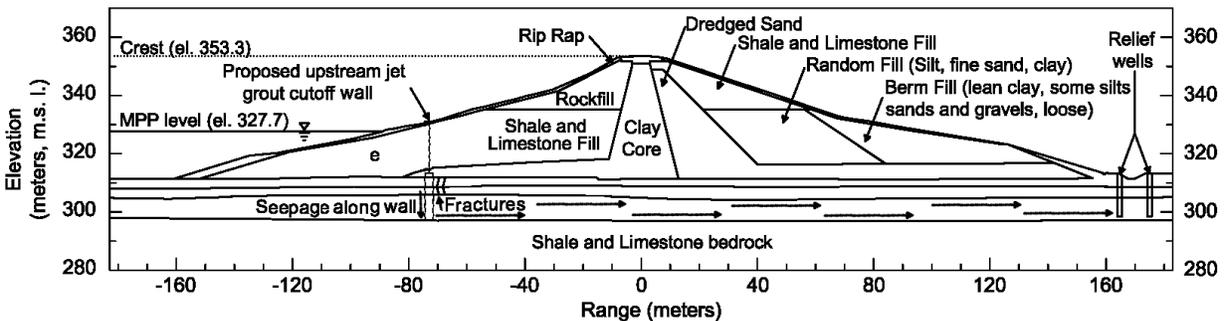
877
 878 Figure 5. Risk of decrease in vertical head loss through fine-grained blanket due to jet grouting

483 Piezometric data suggested the upstream fine-grained blanket caused a significant vertical head
484 loss, so any increased flow would render the cutoff wall ineffective. Figure 5 shows the
485 reduction in seepage path, and thus vertical head loss, through the fine-grained blanket would
486 greatly increase the hydraulic pressure in the pressure relief wells at the toe of the dam.
487 Additionally 75 to 90% of the completed field trial jet grout columns had a void at the top
488 because the grout level dropped due to bleed and/or unhardened grout permeating into the coarse
489 sands and gravels near the base of the columns. The grout level was subsequently brought to the
490 top of the column however intimate contact with the overlying embankment might be difficult to
491 achieve in light of column roof instability. These factors lead to concerns about erosion of the
492 foundation and embankment soils and unacceptable increased seepage, hydraulic gradients, and

493 formation of sink holes in the upstream embankment which could lead to dam failure.

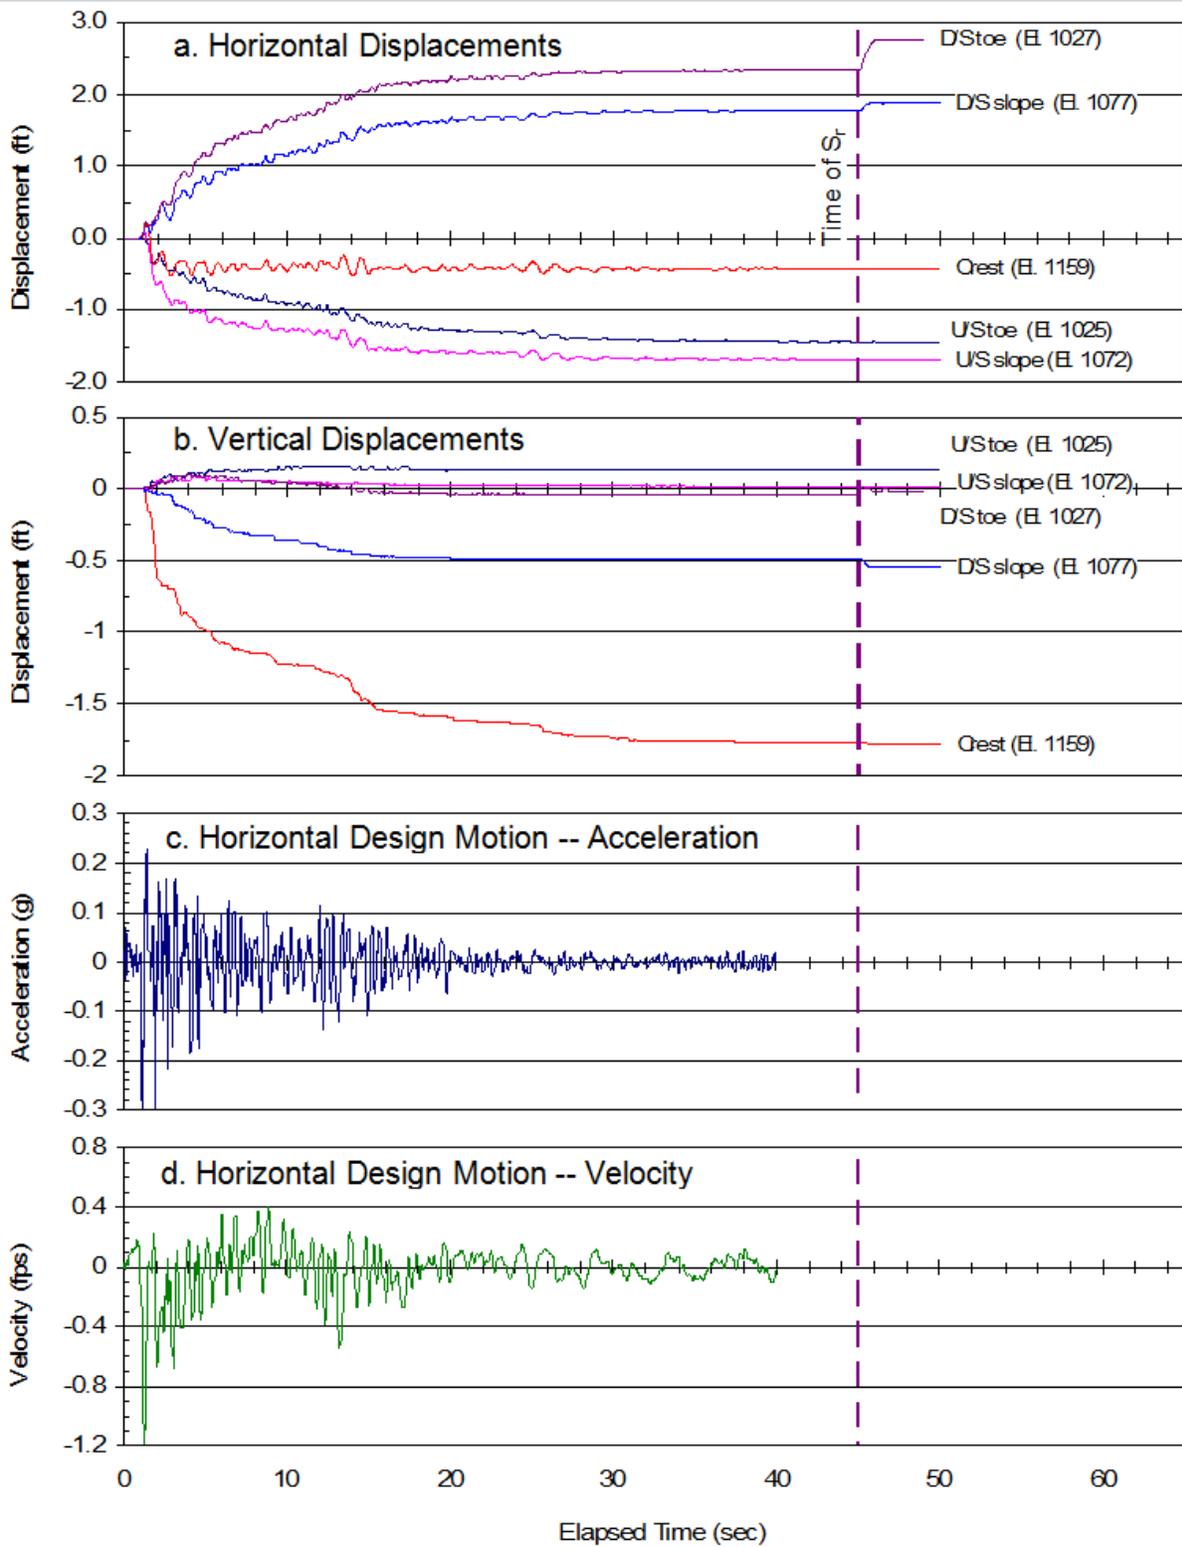
Figure 6. Time histories of vertical and horizontal displacements and horizontal acceleration and velocity design ground motion

567 The predicted evolution of permanent vertical and horizontal displacements during the
568 earthquake is shown in Figure 6 at several locations on the surface of the dam. The horizontal
569 velocity and acceleration design ground motion is initially large and dissipates, while most of the
570 displacement accumulates in a steady and gradual manner over the first 20 seconds of the design
571 ground motion. The estimated permanent deformations result from limited liquefaction at the
572 upstream toe, extensive liquefaction of foundation sand at the downstream toe, and liquefaction
573 of the fine-grained blanket under the dam (see Figure 7).

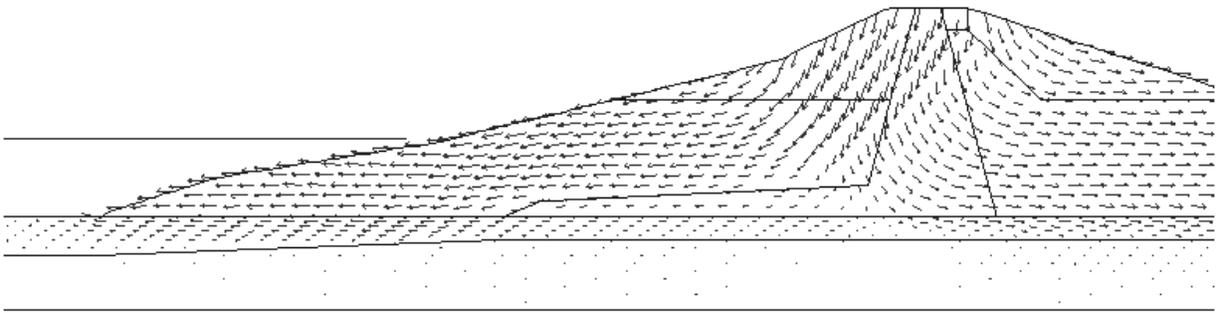
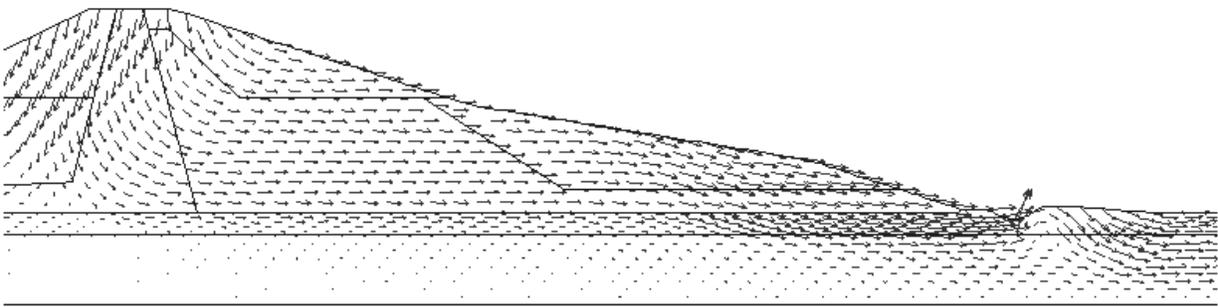
Figure 7. Upstream and downstream displacement vectors at end of post dynamic analysis with application of liquefied strengths for initial unremediated case

a. Upstream displacement vectors

b. Downstream displacement vectors

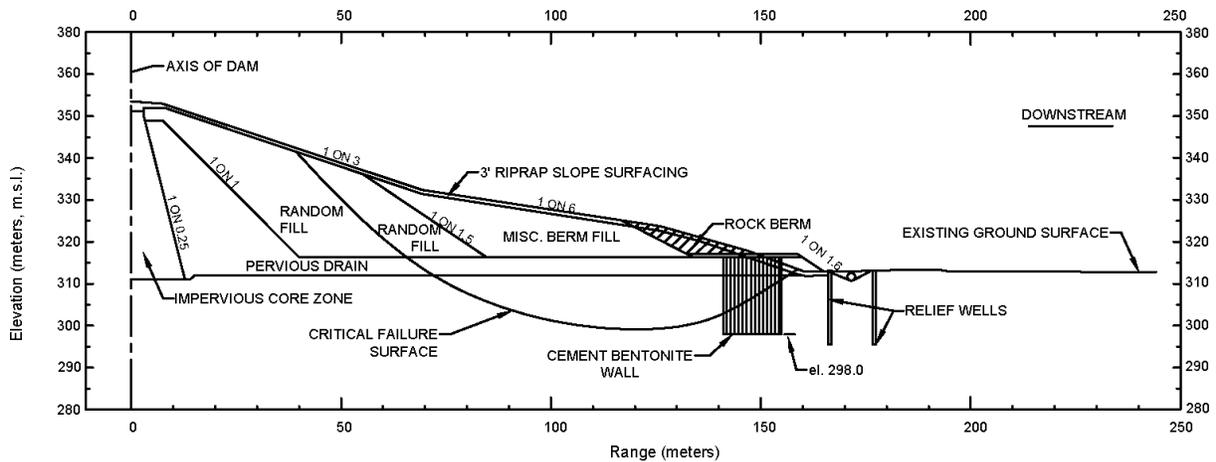
Figure 8. Cross section showing cement-bentonite transverse shear wall and critical limit equilibrium failure surface

667 The displacements could be larger or smaller than estimated if field shaking and engineering
668 properties differ from those used in the seismic analysis. However, it was concluded that the
669 transverse shear walls provide a worthwhile benefit to the seismic response of the dam and
670 reduce the likelihood of a large liquefaction-induced flow slide as indicated by limit equilibrium
671 slope stability analyses. In addition to the 351 transverse shear walls installed along the
672 downstream toe of the dam, the existing relief well ditch was replaced with a buried collector
673 system to further improve downstream slope stability (see Fig. 8).
