MUNICIPAL SOLID WASTE SLOPE FAILURE. II: STABILITY ANALYSES

By Timothy D. Stark,¹ Hisham T. Eid,² W. Douglas Evans,³ and Paul E. Sherry⁴

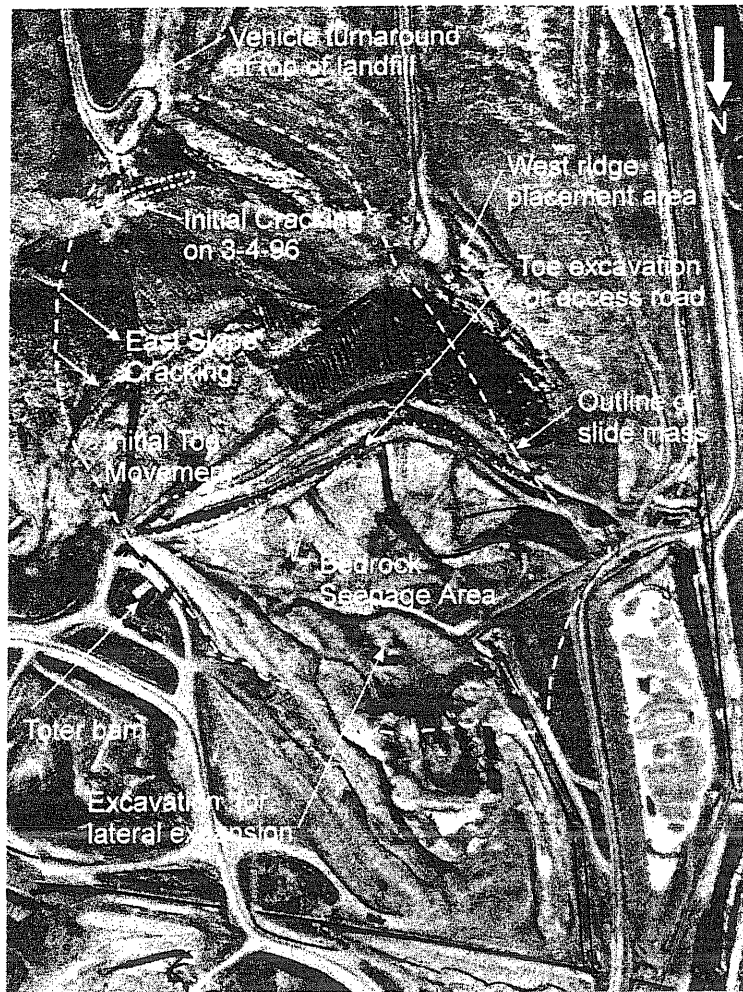
Another important feature in Fig. 1 is the vehicle turnaround at the top of the landfill. Approximately one-half of the daily 4.5×10^6 kg of waste was being placed at the top of the slope in the months preceding the slide (King 1998). Placement activities are evident in Fig. 1 and were evident from the presence of three compactors at the top of the landfill immediately after the wasteslide. The other two compactors that were being used at the time of the slide were located at the west ridge placement area and are shown in Fig. 1, with the presence of four unloading trucks.

FIG. 1. Aerial View of Landfill on February 6, 1996 (32 Days Prior to Wasteslide)

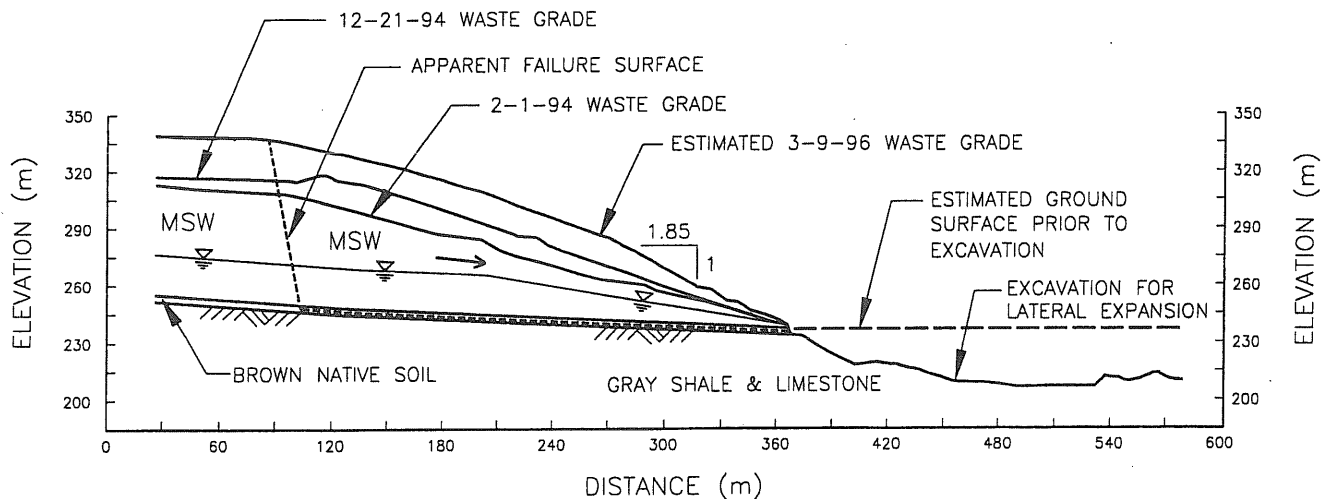
FIG. 2. Slope Cross Section B-B' Showing Recent Waste Placement

Based on annual owner/operator aerial surveys, a 9 to 20 m thick layer of waste was placed over the existing 60 m high waste pile within the 14 months prior to the wasteslide (Fig. 2). This corresponds to an average filling rate across the slope of 0.02 to 0.05 m/day. It was thought that this filling might generate excess pore-water pressures in the brown native soil and consequently a decrease in the effective normal stresses acting on the failure surface. Boussinesq stress distribution theory showed that the increase in vertical stress at the base of the 60 m high waste pile due to the placement of 0.02 to 0.05 m of waste/day over the slope was small. The maximum vertical stress increase in the brown native soil was found to occur at the slope midheight, that is, only about 38 m of existing waste and 14 m of new waste in 14 months, and ranges from 20 to 25% of the existing vertical stress. Based on Terzaghi's theory of consolidation (Terzaghi et al. 1996), a degree of consolidation of 90%, double vertical drainage, layer thickness of 3 m, and coefficient of consolidation of 4 m²/year estimated from oedometer tests on specimens of the native brown soil, the majority of the excess pore-water pressure should have dissipated during the 14 month waste placement period. In summary, if excess pore-water pressures were generated in the brown native soil due to waste placement, it would have been only a minor contributing factor in the cause of the failure.

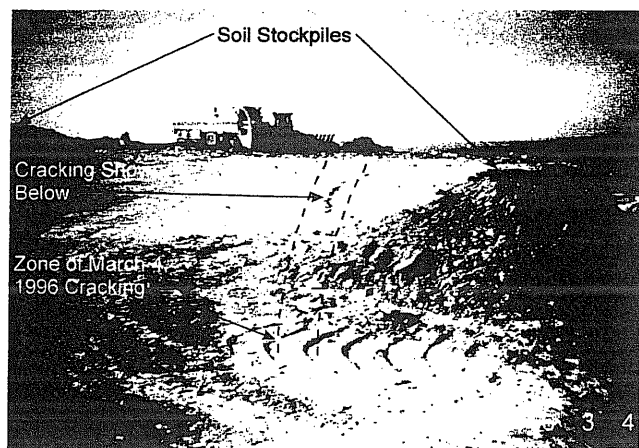
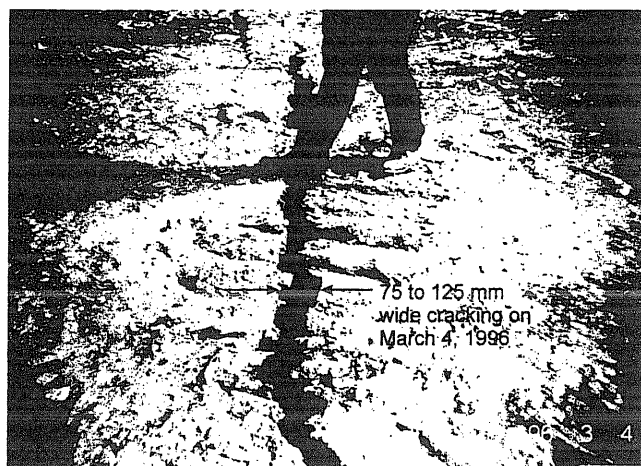
FIG. 3. (a) Waste Placement and Cracking at Top of Landfill on March 4, 1996, and (b) Closeup of March 4, 1996, Cracking

On the morning of Monday, March 4, 1996 (five days prior to the wasteslide), landfill operating personnel noticed some cracking in recently placed cover soil just north of the vehicle turnaround (Fig. 1) at the top of the slope. Fig. 3(a) shows some of the cracking extending across the top of the landfill with a vertical offset of 25 to 50 mm as waste placement and soil stockpiling activities continued on March 4, 1996. A closeup of the crack [Fig. 3(b)] shows that the longest crack had a width of 75 to 125 mm and extended 15 to 30 m across the crest of the slope. The location of this cracking essentially corresponds to the location of the scarp that resulted from the wasteslide (note truncated vehicle turnaround at top of landfill in Fig. 4) and thus delineates the extent of the slide mass. Owner/operator personnel inspected the entire slope, including the toe, to determine if the cracks were an indication of slope instability. No other cracks or other indications of slope movement were identified on the slope or at the toe on March 4 (Kenter et al. 1996, 1997a, 1997b). Consequently, the owner/operator concluded that the cracks were caused by landfill settlement, and ongoing visual monitoring and covering the area with soil to control infiltration were deemed appropriate. As a result, waste placement continued at the top of the landfill (until the failure occurred), and blasting resumed on March 5.

the wasteslide occurred on Saturday, March 9, 1996. This cracking was a manifestation of the translational movement that was occurring in the brown native soil underlying the waste. A major problem in MSW slopes is distinguishing settlement-induced cracks from slope instability cracks. The reappearance of significant cracking in the same location is more likely an indication of slope instability than settlement. In general, settlement cracks will not reappear in the same location in a short period of time because the biological and mechanical processes that cause the settlement require time.

4, 1996, was a manifestation of the shear failure that was occurring, and probably had been occurring, in the brown native soil at this location of the failure surface. As the fully softened shear resistance of the brown native soil was exceeded in the vicinity of this cracking, shear stresses were transferred to the native soil farther down the slope. Therefore, cracking reappeared the following day at the top of the slope because this MSW and native soil displaced downslope to mobilize additional shear resistance. On March 5, the largest blast in the past 33 days occurred, causing additional shear displacement and stress transfer. Therefore, this blast accelerated the timing or occurrence of the slope failure, as discussed subsequently. As the shear resistance of the downslope brown native soil was exceeded, shear stresses were transferred farther down the slope, and thus cracking reappeared on March 6, 1996. Shear stresses continued to be transferred down the slope toward the toe from March 4 to March 9, 1996, resulting in continued and substantial cracking at the top of the slope. Between the evening of March 8 and the morning of March 9, 1996, the shear stresses and progressive failure had been transferred to the vicinity of the slope toe at the eastern flank of the landfill. Since the toe had no buttress and the shear stresses exceeded the shear resistance of the brown native soil on the eastern flank of the landfill (Fig. 1), the toe started moving toward the access road. After the entire failure surface had been engaged in the brown native soil, the entire slide mass accelerated toward the access road. As the slope toe reached the northern edge of the access road, the materials descended into the deep excavation on the eastern flank of the ravine. As the materials descended, the buttressing effect that would have existed had the ground surface not been excavated (Fig. 2) was absent, and the slide mass accelerated, resulting in the global failure.

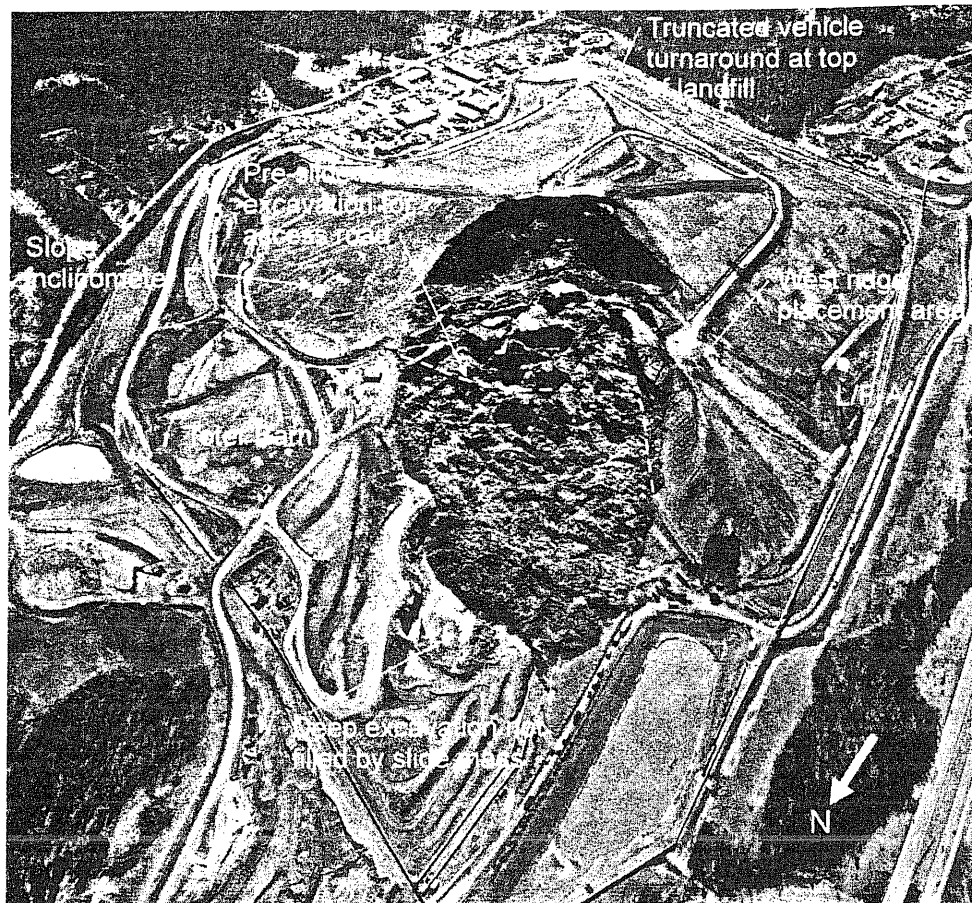
FIG. 4. Aerial View of Wasteslide on March 11, 1996 (Two Days after Wasteslide)

The appearance of substantial cracking initially at the top of the slope and formation of a large slide block, graben, and nearly vertical scarp (Figs. 4–6) are characteristic of a translational failure (Cruden and Varnes 1996). In addition, observations at the slope toe and slope inclinometer readings after the slide, discussed subsequently, suggest that the failure was translational and occurred through the weak brown native soil underlying the MSW. Based on field observations and the results of a subsurface investigation, the failure surface was estimated to have passed through the solid waste at a steep in-

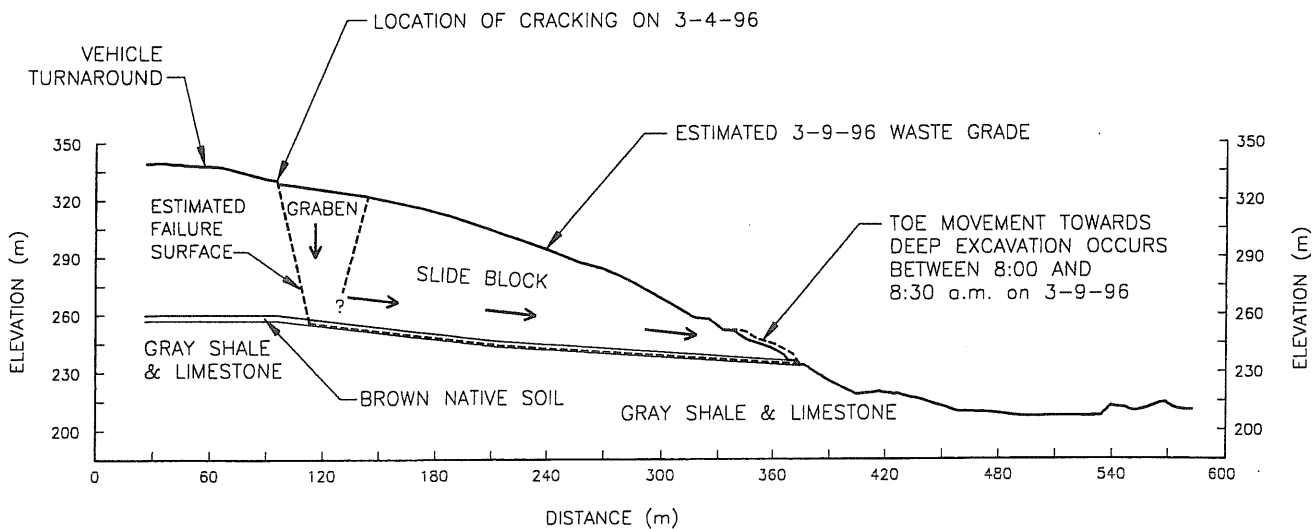
FIG. 5. Cracking and Translational Movement of Waste Slope along Cross Section A-A'

clination to the underlying weak, saturated brown native soil (Fig. 5). The failure surface continued along the brown native soil until it daylighted at the vertical excavation at the slope toe that exposed the MSW and native soil.

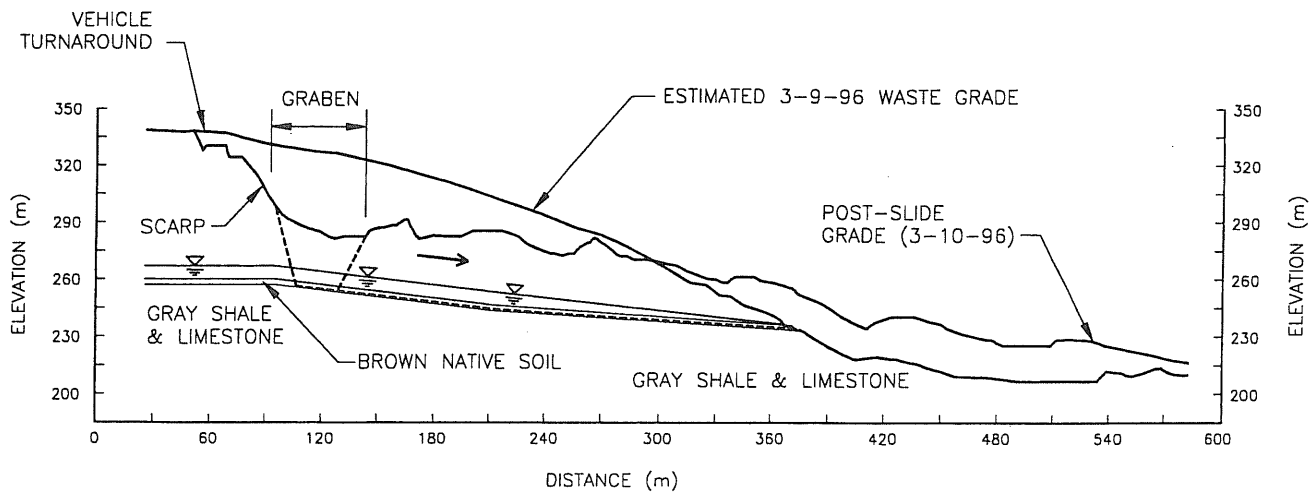
FIG. 6. Graben and Slope Geometry after Translational Movement of Waste Slope along Cross Section A-A'

The piezometric level in cross section A–A' (Fig. 6) was based on observations after the slide, information from Boring G (Fig. 2 in Eid et al. 2000), and Boring L/F-A (Fig. 4), which is located on the western flank of the ravine underlying the MSW and is the counterpart to Boring G because both borings are located on a flank of the ravine underlying the MSW and thus should exhibit comparable leachate and bedrock piezometric levels.

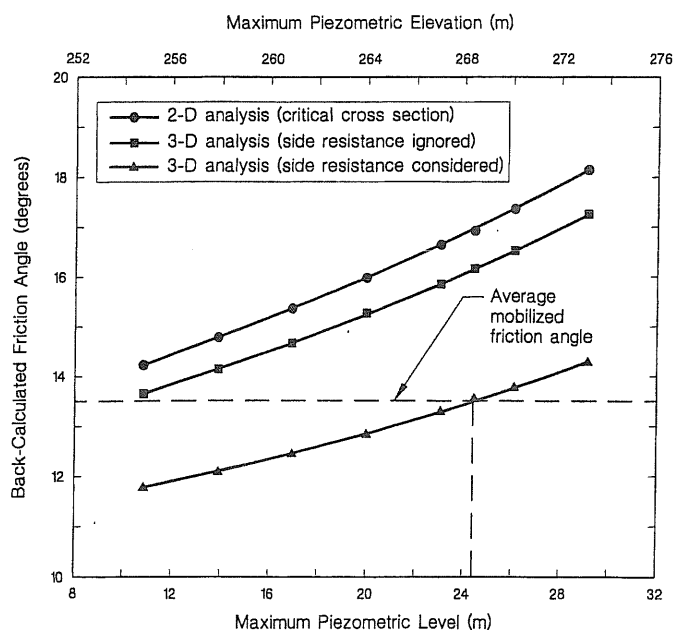
Fig. 7 presents a sensitivity analysis of the relationship between maximum piezometric level at the ravine axis near the scarp and the ϕ'_{mob} for the brown native soil using 2D and 3D analyses. A 2 m increase in the piezometric level in Fig. 7 corresponds to the entire level being increased by 2 m. Therefore, the depth at the axis of the ravine and eastern flank would both increase by 2 m. The 3D analysis shows that the ϕ'_{mob} of the brown native soil ranges from approximately 11.5 to 14.5° for a practical range of maximum piezometric level of 11 to 30 m, respectively. Using a maximum piezometric level of 24.5 m, the average mobilized friction angle for the brown soil is 13.5°. When side resistance is considered, the 3D FS shows less sensitivity to the estimated piezometric level than the 2D FS. This is attributed to the larger shear forces along the sides of the nonsymmetrical slide mass reducing the effect of the piezometric level on the calculation of effective and driving stress at the base of the slide mass.

FIG. 7. Maximum Piezometric Level at Ravine Axis and Associated Back-Calculated Friction Angle for Brown Native Soil

Finally, Fig. 7 shows the 2D analysis yielded a ϕ'_{mob} of approximately 14 to 18° for the brown native soil for a maximum leachate level ranging from 11 to 30 m, respectively. The analyses were performed using the same stability method—that is, Janbu's simplified method of slices (Janbu 1968)—as the 3D analyses using the 2D option in CLARA 2.31 (Hung 1988) and cross section B–B'. As expected, the 2D analysis yields the highest values of ϕ'_{mob} . For a maximum piezometric level at the scarp of approximately 24.5 m, the 2-D ϕ'_{mob} of the brown native soil is about 17°. [Use of Spencer's (1967) stability method and cross section B–B' yielded a ϕ'_{mob} of 16°.] For comparison with cross section B–B', the 2D ϕ'_{mob} calculated using both cross section A–A' and the piezometric level shown in Fig. 6 was 14°, instead of 17°. Since toe movement initiated in the vicinity of cross section A–A', the 2D ϕ'_{mob} of 14° may be more representative than 17°.

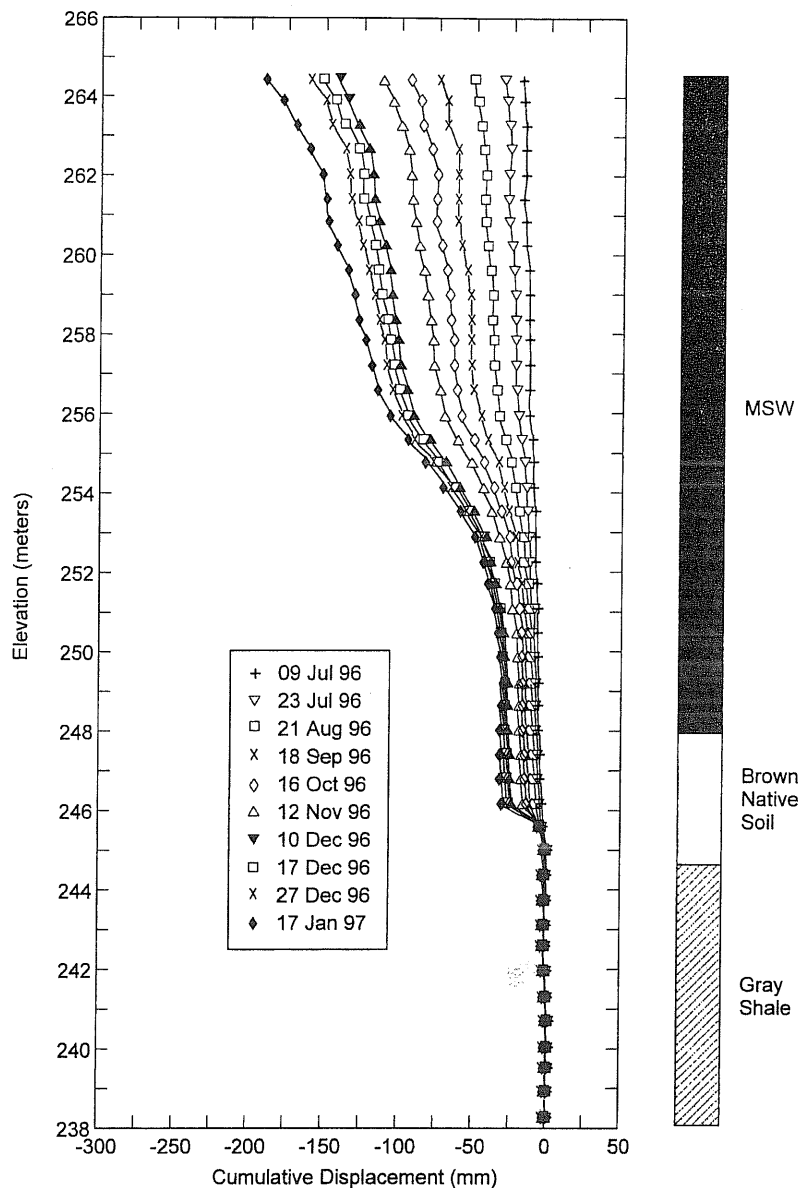
Fig. 8 presents data from slope inclinometer F (Fig. 4) on the eastern slope from July 9, 1996, to January 17, 1997. It can be seen that the MSW shows a consistent out-of-slope movement. Siegel et al. (1990) and Coduto and Huitric (1990) have reported similar time dependent out-of-slope movement of MSW slopes. More important, the out-of-slope movement is inducing shear displacement in the brown native soil that underlies the eastern slope. The corresponding shear displacements may have been even greater under the north slope because the toe was excavated and the underlying topography dips toward the deep excavation. In summary, the time-dependent lateral displacement of MSW also may have induced shear displacement in the brown native soil that could have facilitated mobilization of a postpeak shear strength.

FIG. 8. Slope Inclinometer F from Eastern Slope after Wasteslide
