Avoiding Surprises in Slope Stability

By Timothy D. Stark, Ph.D., P.E., D.GE, F.ASCE, Brian H. Queen, and Hangseok Choi, Ph.D., P.E.

A Unique Case History

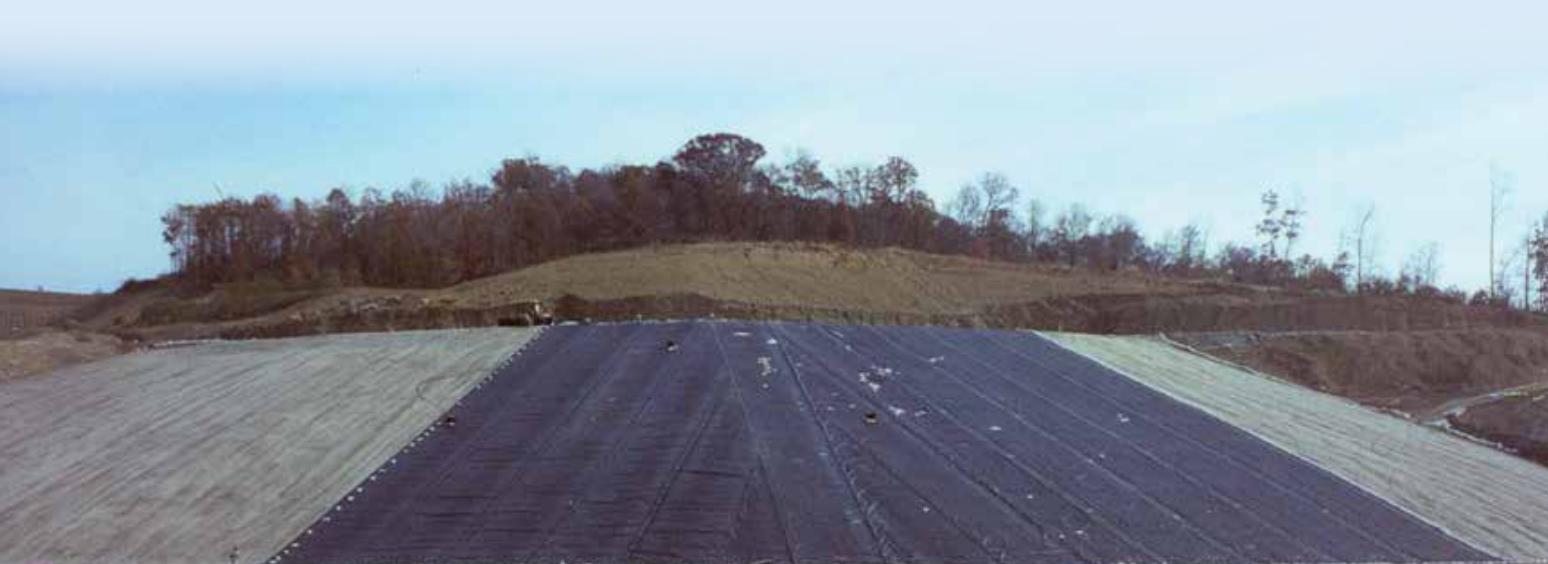
Figure 1. Slope overview and placement of geomembrane over completed low permeability compacted soil liner. (photo by Craig L. Walkenshaw)

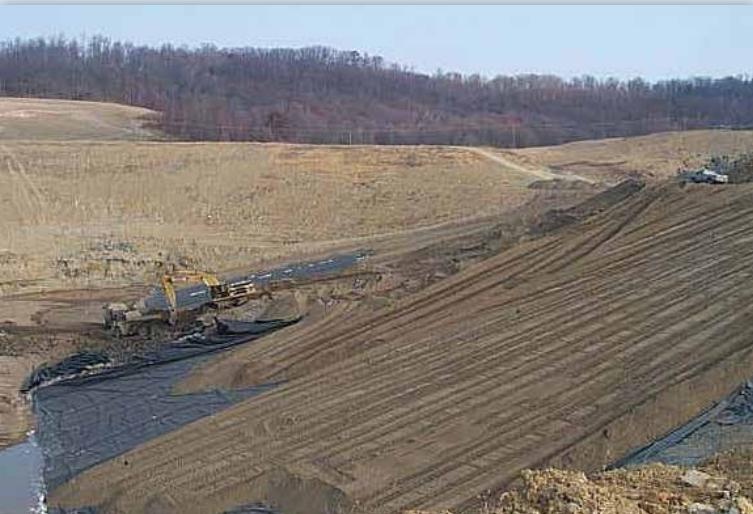
who were constructing the liner system, decided to save time by spreading the granular drainage layer (GDL) from the top of the slope to the bottom on the completed geomembrane (Figure 2). Landfill personnel who were performing the construction decided to spread the GDL from slope top to bottom because there was easy access for gravel trucks to unload at the top of the slope instead of accessing the bottom of the slope.

Figure 2. Overview of sideslope and protective sand placement on geomembrane from top of slope to bottom.

The granular drainage layer (GDL) was placed during sideslope construction from the top of the slope to the bottom. This placement practice is not recommended because the GDL is unbuttressed and imparts shear stresses in the liner system due to the weight of the GDL and equipment operating on the inclined slope. Thus the recommended practice is to place the GDL from the bottom to the top of a slope so the GDL buttresses itself and reduces the shear stresses and shear displacement applied to underlying liner system interfaces. Even though placement from top to bottom is not recommended, it is used because of easy access and ease of pushing material downslope versus upslope.

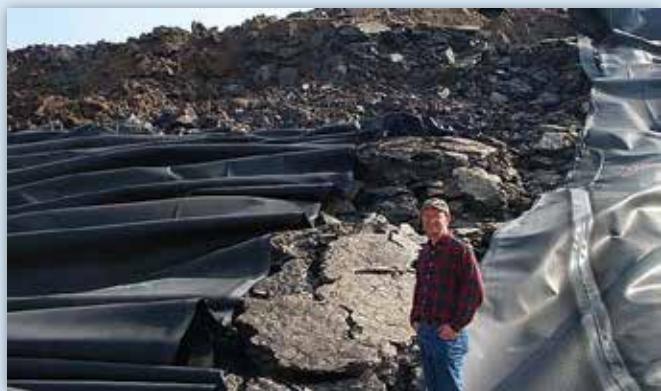
Figure 3 shows the damaged geomembrane near the toe of the slope due to the slope movement. This type of geomembrane damage is typical when slope movement occurs because the geomembrane and other geosynthetics easily tear under the applied shear and normal stresses. A view from upslope of the slide movement shows the drainage material overlying the torn geomembrane and the sliding surface below the torn geomembrane (Figure 4). The failure surface is located at a depth of 75–150 mm into the CSL and not at the geomembrane/CSL interface.

Figure 3. Failed slope and damaged geomembrane.

The repair of this slope failure delayed the construction for over a month and cost the facility hundreds of thousands of dollars. The slope was repaired by removing the GDL, the geomembrane, and the CSL down to a firm base, which involved the subgrade in some areas. Afterwards, the sideslope liner system was reconstructed, consisting of the CSL and the geomembrane, and then placing the GDL from the bottom to the top of the slope. A different on-site borrow source with a lower plasticity and in situ moisture content was used for the CSL. The CSL was placed in loose lifts a maximum 0.2 m thick with compaction to 95 percent of maximum Standard Proctor dry density. Each lift was kneaded into the underlying lift to help ensure integrity between the lifts.

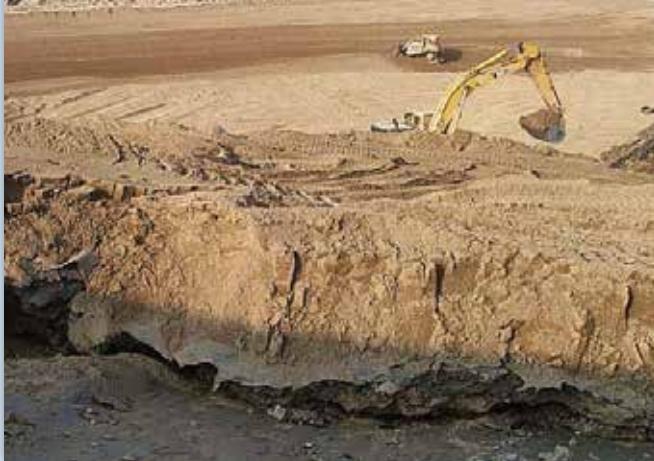
More importantly, Figure 4 shows that the failure surface extends the entire length of the slide because the GDL and geomembrane are missing from upslope of the slide mass to where the slide block stopped. A close look at the torn geomembrane (Figure 5) clearly shows the slide surface occurring below the torn geomembrane, from which it may be concluded that sliding occurred in the compacted CSL first and then the geomembrane tore as a result of this movement.

Figure 4. Slide surface and torn geomembrane.

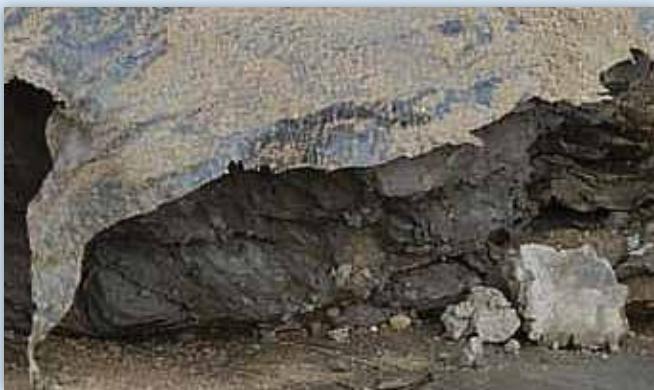
Figure 5. Close-up of torn geomembrane which shows slide surface is below geomembrane/CSL interface.
