**Federal Railroad
Administration**

RESEARCH RESULTS
FRA OFFICE OF RAILROAD POLICY & DEVELOPMENT

RR 15-13 | May 2015

HIGH-SPEED PASSENGER RAIL TIE-BALLAST INTERACTION

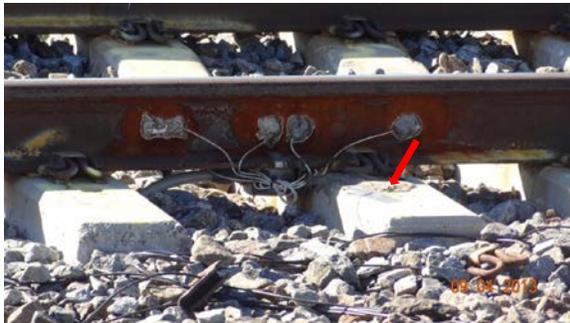
Figure 1. Photograph showing strain gages on rail and LVDT location on tie (see arrow)

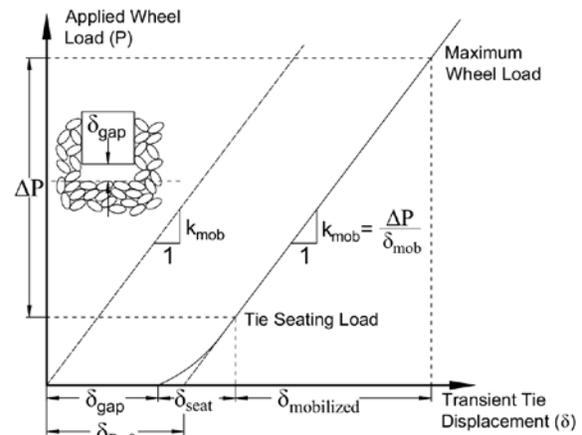
Figure 2 shows the transient tie displacements that must occur before the peak wheel load can be supported by the ballast, i.e., tie-ballast gap (δ_{gap}), seating displacement (δ_{seat}) to mobilize full ballast stiffness, and ballast displacement to resist the peak wheel load ($\delta_{mobilized}$).

Figure 2. Theoretical tie-ballast interaction model

In other words, δ_{gap} and δ_{seat} must occur before the full support of the ballast is mobilized to resist the applied wheel load. Because measurements below the seating load are rarely obtained, the tie-ballast gap is estimated by extrapolating the linear relationship with a slope of k_{mob} (Figure 2) to the unloaded condition ($P=0$). This estimated “gap” is represented as $\delta_{P=0}$. While this method slightly overestimates the actual tie-ballast gap, the seating displacement (δ_{seat}) is small because the ballast is well compacted due to prior train passage and tie displacements.

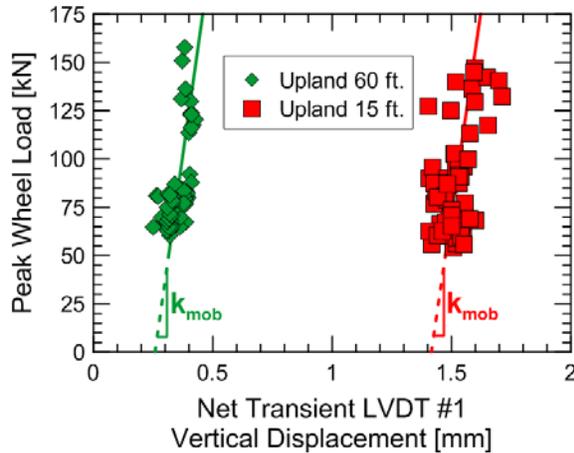
Figure 3 illustrates estimation of the tie-ballast gap, i.e., $\delta_{P=0}$, using transition (15 ft from bridge) and free field (60 ft from bridge) data from the Upland Street Bridge on the NEC. Upland (60 ft.) shows a small tie-ballast gap (~ 0.25 mm) which results in the smallest permanent vertical displacement of all six instrumented locations. Conversely, Upland (15 ft.) shows the largest tie-ballast gap (~ 1.4 mm)

which resulted in the largest permanent vertical displacement. However, both locations exhibit similar ballast stiffness, k_{mob} , after the gaps are closed.

Figure 3. Comparison of transient vertical tie displacement behavior at Upland Street (15 ft.) and Upland (60 ft.) on 26 January 2013

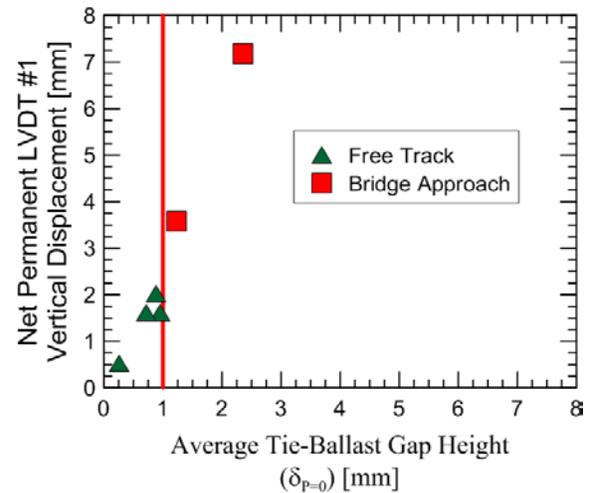
Figure 4 shows a strong correlation between the average tie-ballast gap ($\delta_{p=0}$) obtained during four different data recordings and the accumulated permanent vertical displacement measured over the same time period. This data implies the tie-ballast gap is the primary cause of the observed permanent vertical displacements because the two bridge approach sites (red squares) exhibit excessive permanent vertical displacements while the four free track sites (green triangles) do not. As a result, the red vertical line separates sites with low and high permanent vertical displacements, which suggests a tie-ballast gap ($\delta_{p=0}$) greater than about 1.0 mm can lead to excessive permanent vertical displacements because of load redistribution among adjacent ties. While a gap of 1.0 mm seems unrealistically too small, this behavior of increased permanent vertical displacements from tie-ballast gaps of greater than 1.0 mm is also reported by Selig and

Figure 4. Correlation between tie-ballast gap height and permanent tie displacement.

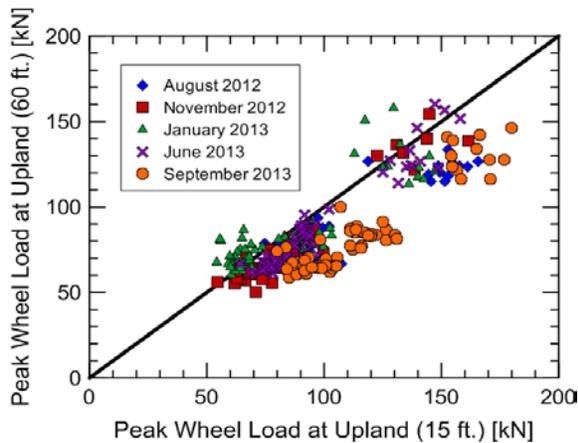
Increased applied loads at sites experiencing greater tie-ballast gaps are illustrated through measured wheel loads using strain gages on the rail and numerical results below. In Figure 5, each symbol represents the measured wheel loads at Upland (60 ft.) and Upland (15 ft.) for the same passing wheel at different times. Figure 5 shows measured wheel loads at Upland (15 ft.) are consistently greater than at Upland (60 ft.). This implies the transition zone is experiencing greater dynamic loads than the free field, which are reflected in greater permanent vertical displacements.

Figure 5. Comparison of Measured Peak Loads at Upland (15 ft.) versus (60 ft.)

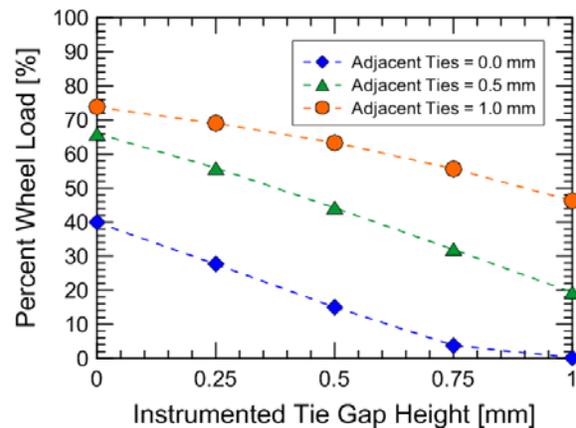
Second, numerical analyses of the entire track system, i.e., train bogie, rails, ties, ballast, and substructure, with the dynamic software package LS-DYNA quantify the load redistribution. Modeling various gap heights at the instrumented and two adjacent ties, the force along the instrumented tie-ballast interface, e.g., tie load, is calculated as a percent wheel load where 40% is considered good load distribution (see tie gaps = 0.0 mm for all ties in Figure 6).

Figure 6. Numerically Calculated Tie Loads as Percent Wheel Load for Various Tie-Ballast Gaps

The results in Figure 6 show significant load redistribution as the tie-ballast gap increases. If the tie-ballast gap of the instrumented tie increases, the instrumented tie load decreases because the load on adjacent ties increases. If the tie-ballast gaps of the adjacent ties increase, the instrumented tie load increases. This implies the wheel load is redistributed from ties experiencing poor tie support to surrounding ties with good tie support. This progressively expands the range of poorly supported and damaged ties, leading to a progressive degradation and potential failure of the track section.
