## Effect of Hand Tamping on Transition Zone Behavior

## **ABSTRACT**

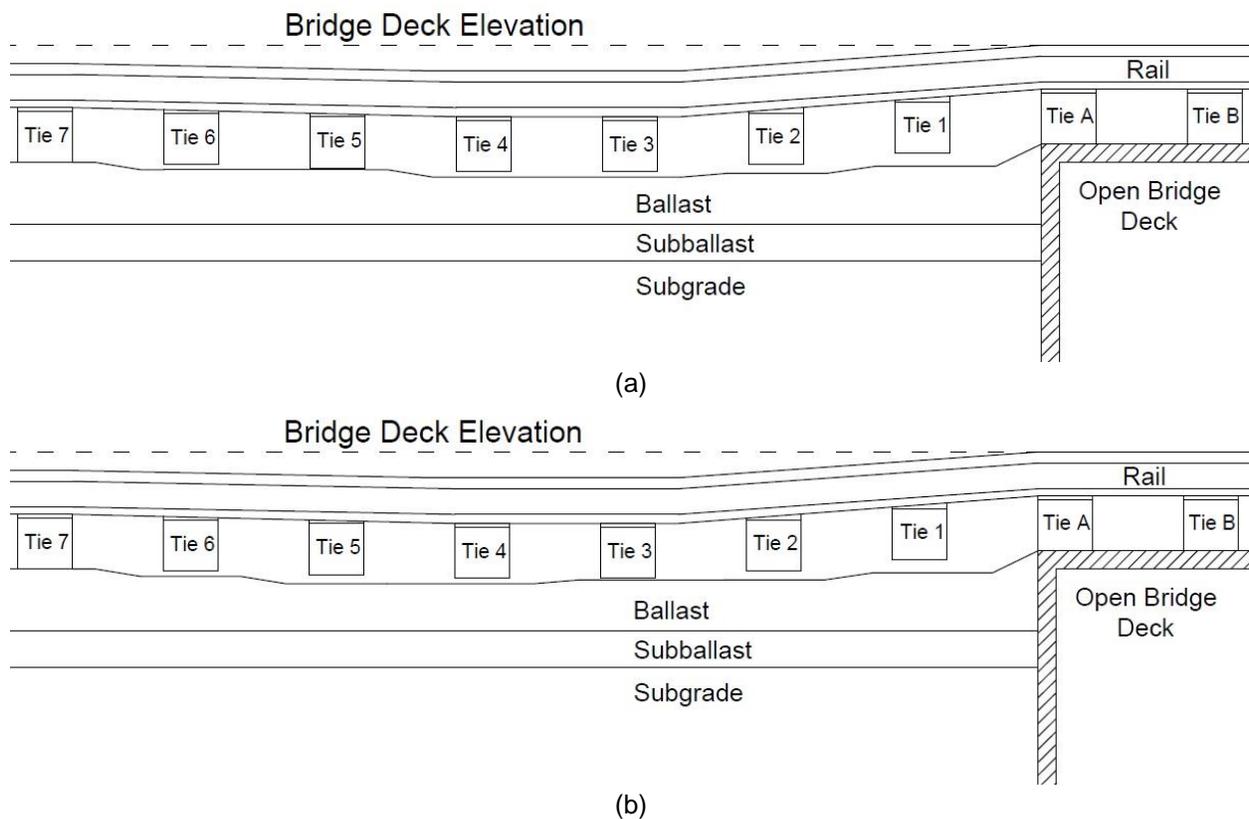
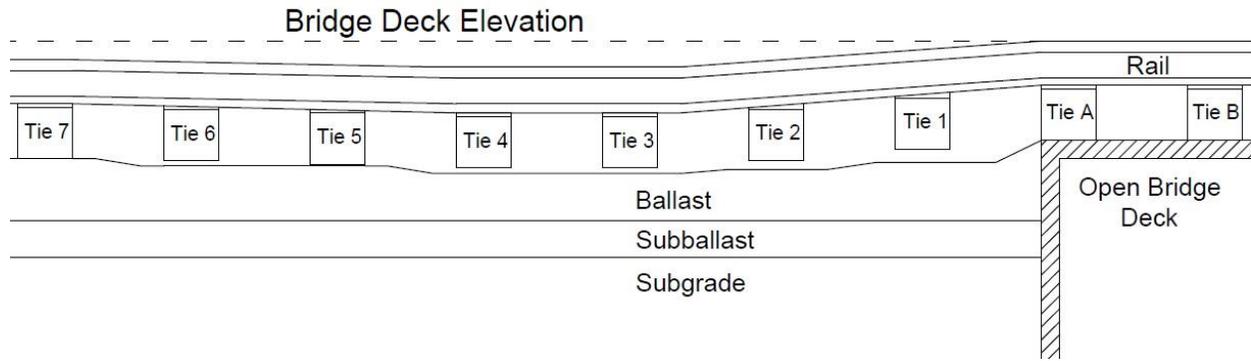
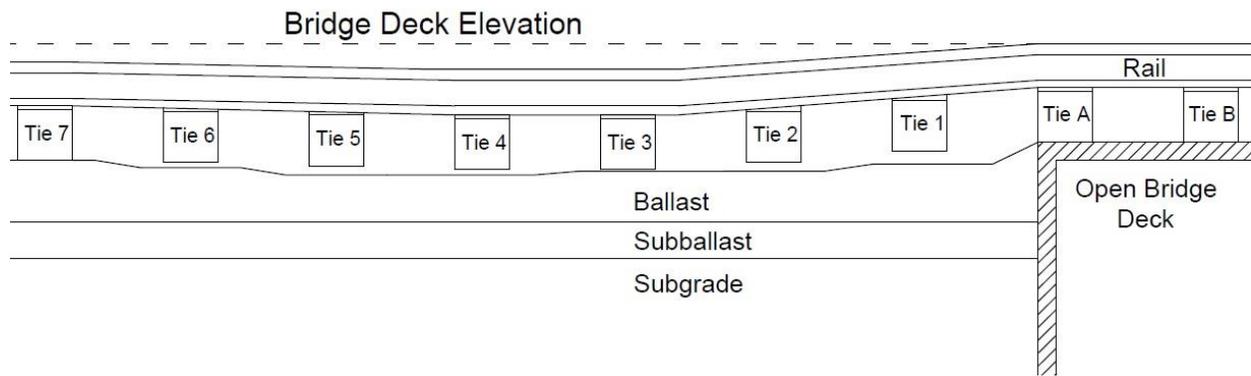
While ballast settlement is undesirable anywhere in railroad track, it is especially problematic at locations where the potential for settlement varies considerably across a short distance such as bridge transition zones or culverts. This is because the rail and ties naturally rest upon the underlying layer, e.g. ballast or bridge deck, but local differential settlement and the high bending stiffness of the rail causes the rail and tie to be supported at the regions that experience the least amount of settlement and hang over regions that experience the greatest amount of settlement, i.e. hanging ties. At bridge transition zones, this leads to the “dip” where the rail is supported from the bridge deck and also out farther in the open track, i.e. 15 or 20 feet out, and results in either rail-tie or tie-ballast gaps in the transition zone. Two examples of tie-ballast gaps in transition zones are displayed in Figure 1 where the rail is supported at the bridge deck (Tie A) and Tie 7 in both situations.

**Figure 1: Two Example Diagrams of Bridge Transition Zones with Tie-Ballast Gaps.**

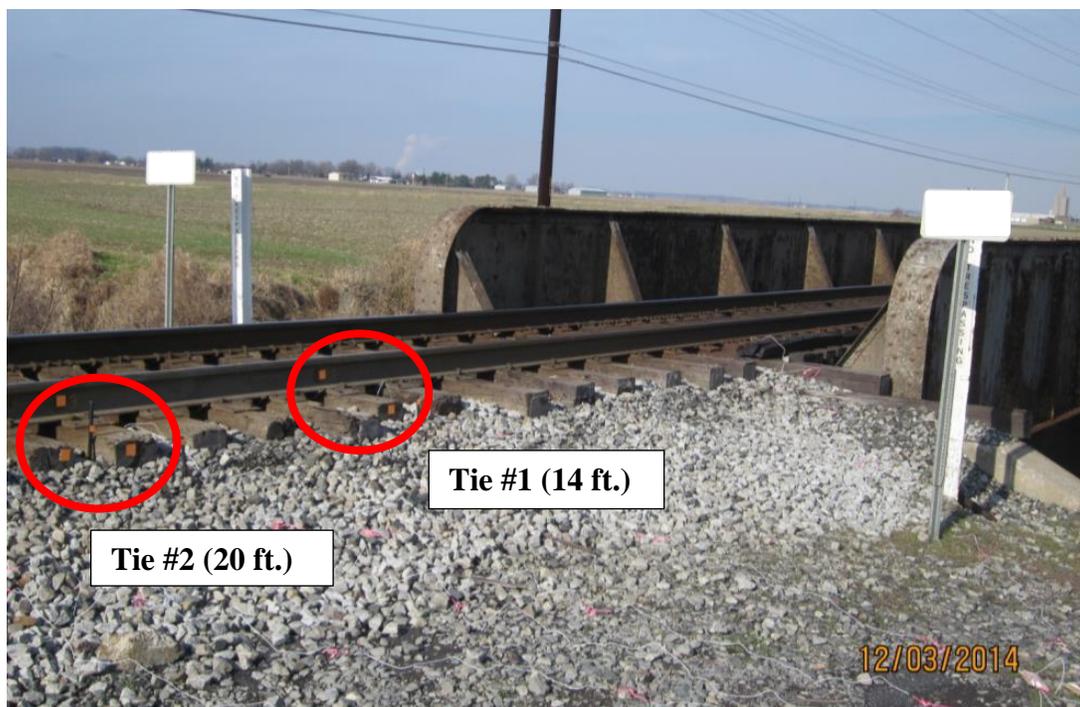
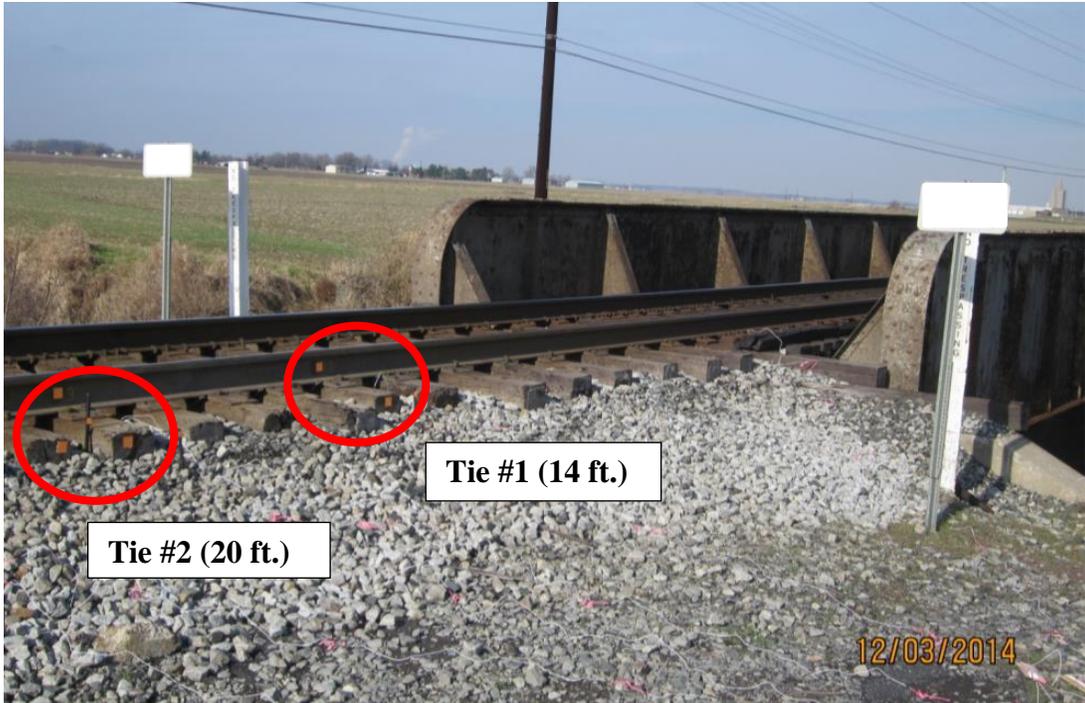
The instrumented site involves the south end of the railway bridge transition zone displayed in Figure 3. The traffic is considered Class 4 for track operations and consists of mixed freight, loaded coal, and intermodal trains passing from 30 to 60 mph. The bridge is roughly a 50 ft. steel open deck bridge constructed in 1923 with few bridge or transition zone design features to minimize differential displacements. The first six ties are longer at 10 feet in length instead of the standard 8.5 foot ties and a

timber support connected to the bridge abutment was placed under the first two ties in attempt to limit track settlement but the timber support has become tilted and likely does not receive any load. Nearly every tie in the southern transition zone contains either a rail-tie and/or tie-ballast gap and ballast fouling is prevalent in and around all of the ties. The rail-tie gaps are found within 16 ft. (5 m) of the bridge abutment and tie-ballast gaps are mainly observed 16 ft. (5 m) or more from the abutment. The rail-tie gaps develop from the upward reaction force of the rail after unloading which pulls the spikes from the tie. Because the rail-tie gaps are found within 16 ft. (5 m) of the bridge abutment, this suggests that the upward reaction force is greater within the 16 foot zone than outside it.

Additionally, an asphalt road crossing exists about 70 ft. (20 m) south of the bridge abutment, which results in two transitions in the instrumented region, i.e., a transition from an asphalt crossing to open-track to a steel open deck bridge, and likely blocks drainage. This means that both north and southbound trains experience “galloping” or “bouncing” when passing over the nearby transition zones because of the multiple abrupt changes in track displacements, modulus, and geometry (13).

**Figure 3: Photograph of the South End Bridge Transition**

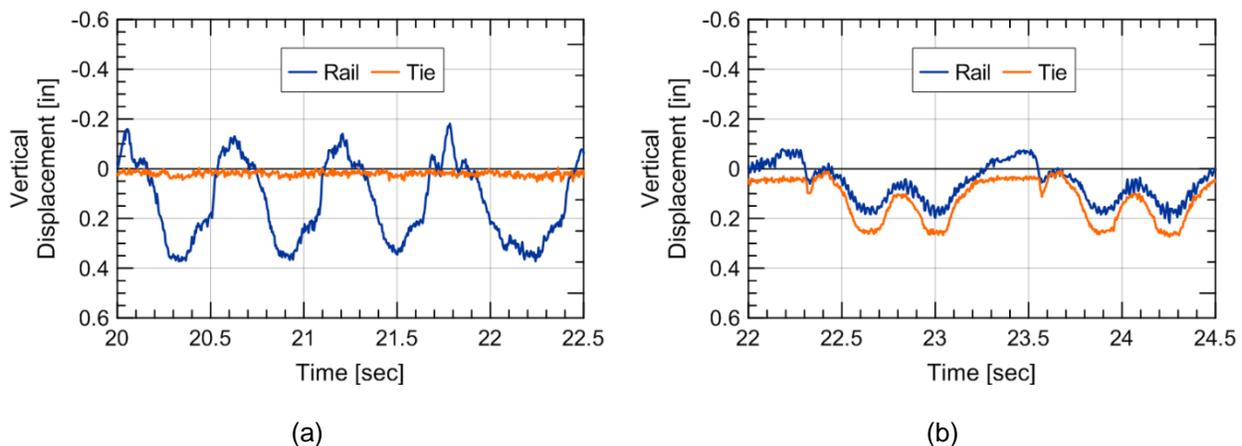
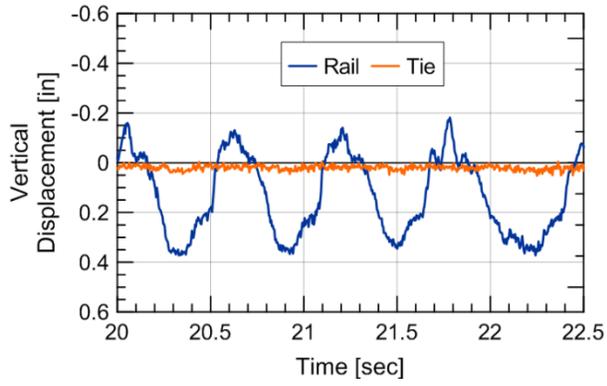
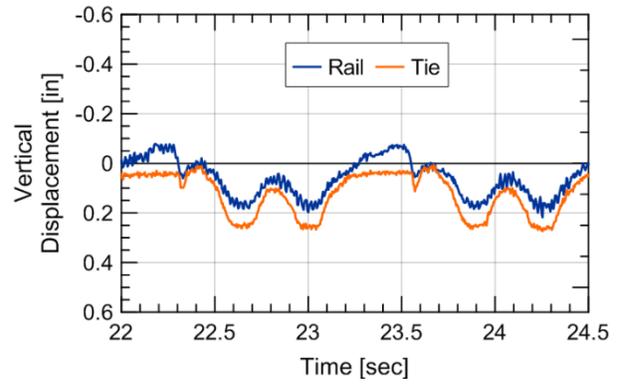
Only two seconds of the time histories are shown to better illustrate the differences in track behavior. The rail-tie gap location (Tie #1, 14 ft.) only shows significant peak displacement of the rail (0.4 in/~10 mm) while the peak displacement of the tie is insignificant (0.05 in/~1.25 mm). This is expected because the rail-tie gap limits the amount of loading the rail applies to the tie and is expected to redistribute to surrounding ties. The tie-ballast gap location (Tie #2, 20 ft.) shows peak rail displacement of 0.2 inches (5.0 mm) and tie displacements of 0.25 inches (6.4 mm). It is typically expected that the rail displaces more than the tie but due to a potential centerbound tie condition, the end of the tie bends when loaded resulting in greater displacement at the end of the tie. Additionally, the rail-tie gap location (Tie #1, 14 ft.) experiences more rail displacement than the tie-ballast gap location (Tie #2, 20 ft.), which is expected because the rail-tie gap location (Tie #1) is closer to the bridge abutment and likely experienced greater substructure settlements.

**Figure 4: Video Camera Measured Rail and Tie Displacements at: (a) Tie #1 (14 ft.) and (b) Tie #2 (20 ft.) for a Passing Freight Train on 21 October 2014.**

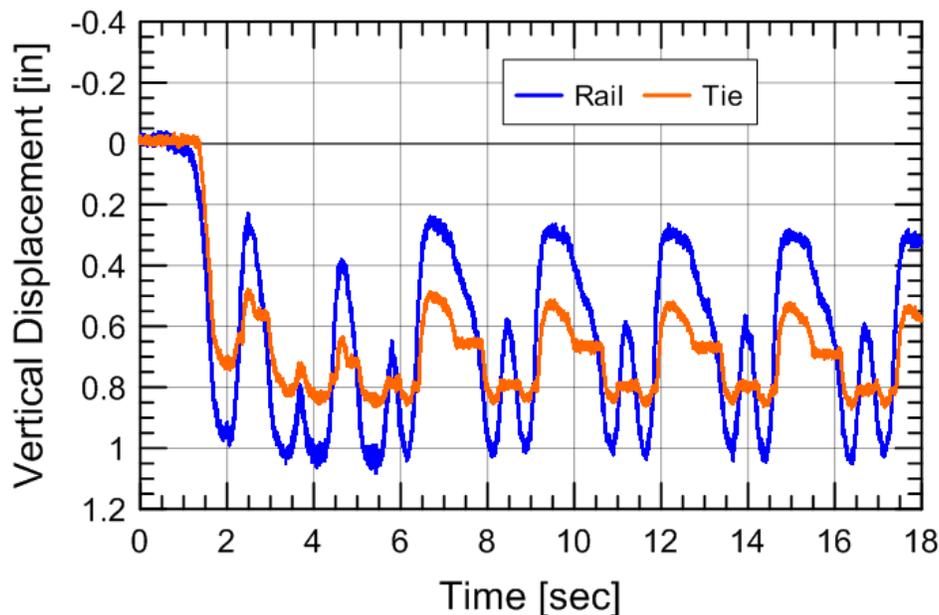
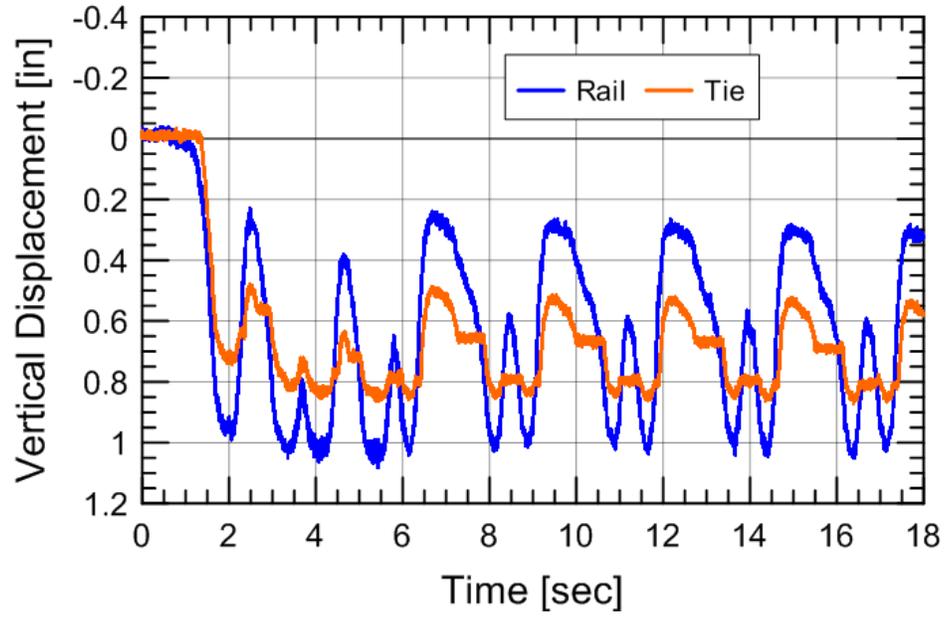
Figure 5 illustrates that the loading from the first train truck results in significant settlement of the rail and tie. The tie settles about 0.5 inches (13 mm) after the first truck and eventually reaches 0.7 inches (18 mm) by the end of the train. The rail shows about 0.45 inches (11 mm) of settlement by the end of the train. The reason the tie settles more than the rail is that a gap develops between the rail and tie because the upward reaction force of the rail after unloading pulls the spikes from the ties. As more trains pass and the ballast settles further, this repeated upward reaction force will continue to pull the spike from the tie and increase the rail-tie gap.

The initial truck loading produced about 0.7 to 0.8 inches (18 to 20 mm) of ballast settlement and video of the train shows ballast particles pushed out from underneath the tie. One explanation is not enough ballast particles were supporting the tie and rail to the specified elevation and therefore were not able to withstand the entire train loading. This caused the few ballast particles to either be pushed into the underlying ballast, pushed outside of the tie, or suffered from particle breakage. The presence of ballast fouling may have facilitated this process. The magnitude of ballast settlement may also be related to the pre-tamping ballast condition because ballast after tamping is observed to have a “memory” of its pre-tamping state (2). Either way, the first train immediately compacted and re-densified the ballast and resulted in about 0.8 or 0.9 inches (20 to 23 mm) of substructure settlement which can then cause the concentration of train loads and reinstitute the track deterioration process.

**Figure 5: Video Camera Measured Rail and Tie Displacements at Tie #1 (14 ft.) for a Passing Freight Train immediately after Handing Tamping on 22 October 2014.**

Another option would be attempting to limit the amount of initial ballast settlement, i.e. “compaction” phase, by ensuring the ballast is better compacted underneath the tie during tamping. If not, the first passing train will compact the ballast at the expense of track performance. If the settlement in this “compaction” phase is reduced, this will likely result in the track geometry being maintained for longer periods of time and require less frequent tamping. The additional time and money needed to compact the ballast underneath the tie can hopefully extend the tamping cycle by a few weeks or months and may eventually prove cost-effective.

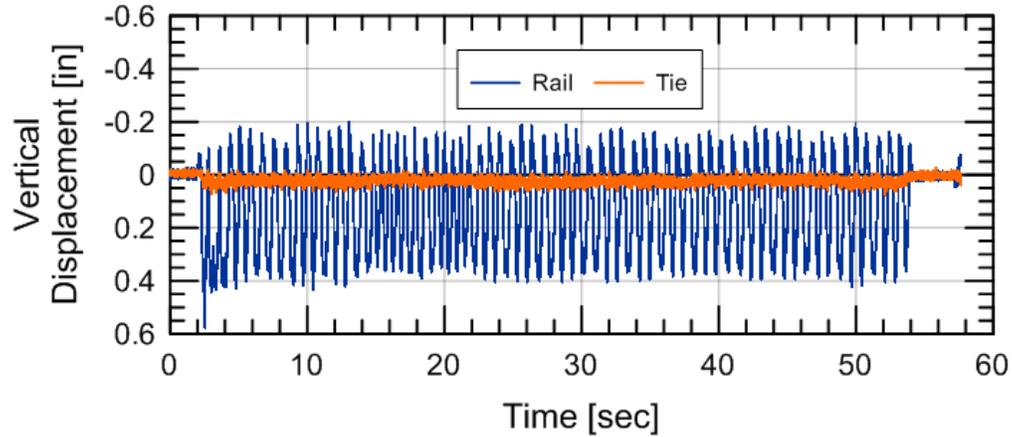
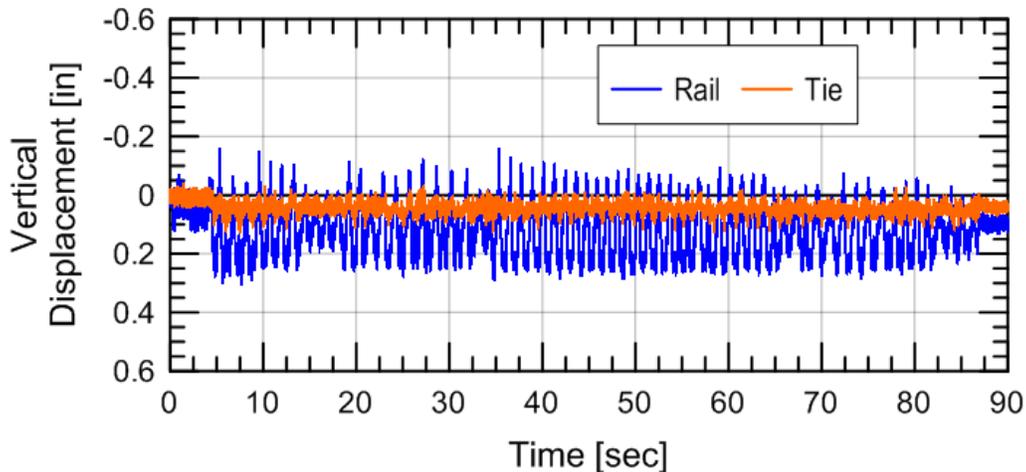
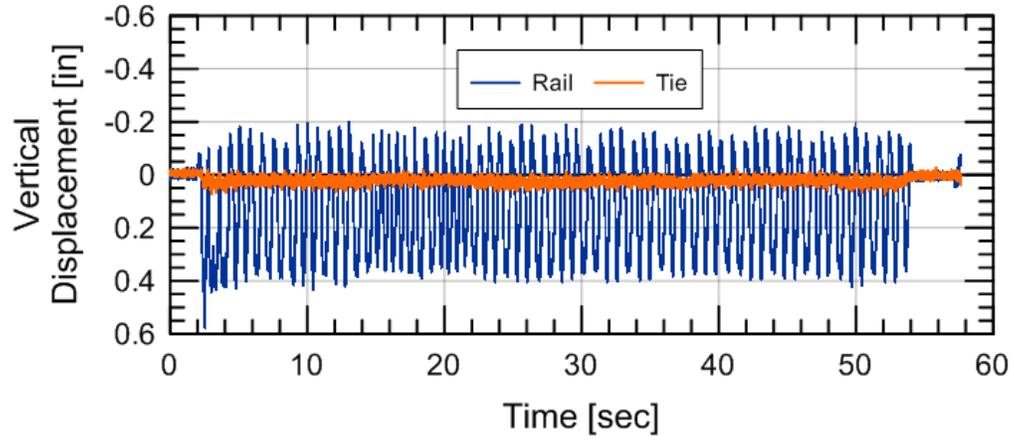
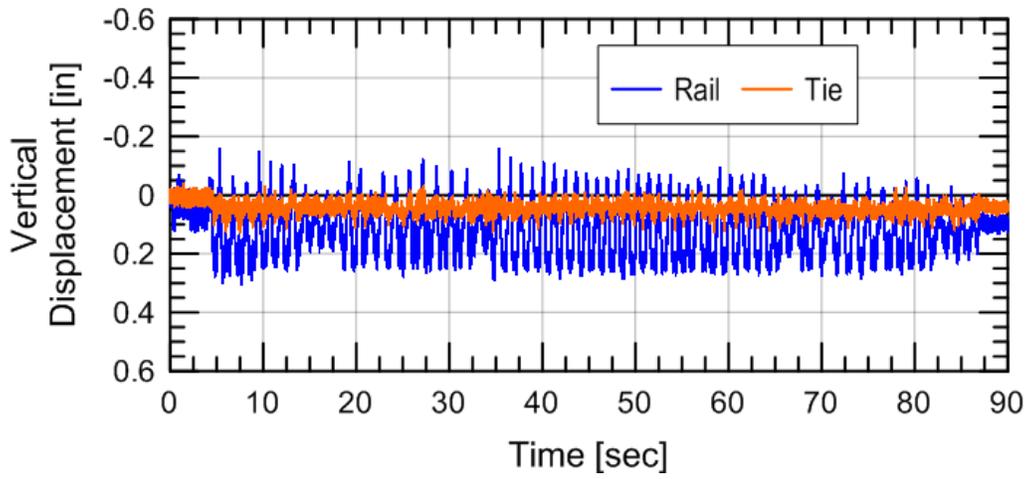
The first train produced the greatest amount of track settlement and the track seemed to reach equilibrium after about three to four trains. To evaluate how the track behaved after reaching equilibrium, the rail and tie displacement time histories from the sixth train after tamping is measured at Tie #1 (14 ft.) and displayed in Figure 6(b). This train is a southbound (exit off the bridge) loaded train moving at a velocity of 33 mph. By comparing the (a) pre-tamping and (b) post-tamping states, it is clear that post-tamping transient behavior quickly returns to its pre-tamping behavior after a few passing trains. Due to the continual upward force of the rail pulling the spike from the ties, the rail-tie gap reaches about 0.3 inches (8 mm) and will likely eventually increase to the 0.4 inch (10 mm) gap that existed pre-tamping.

**Figure 6: Video Camera Measured Rail and Tie Displacements at Tie #1 (14 ft) (a) before tamping on 21 October 2014 and (b) the 6<sup>th</sup> train after tamping on 22 October 2014.**

The cumulative rail and tie settlement is estimated to be around 0.55 inches and 0.8 inches, respectively, and no noticeable changes in behavior were observed at Tie #2 (14 ft.) for the remainder of the day.
