I-5 Skagit River Bridge Collapse Review

Abstract: On May 23, 2013, a truck-tractor with a flatbed semitrailer hauling an oversized container was traveling south on Interstate 5 (I-5) near Mount Vernon, Washington. While crossing the Skagit River, the oversized container struck portions of the through-truss bridge, which resulted in a 49-m (160-ft) simple-span section of the 339-m (1,112-ft) bridge collapsing into the river. This collapse occurred even though the oversized container had a permit authorizing the travel route and was being escorted by a pilot vehicle. This paper (1) identifies some key transportation issues related to this scenario, e.g., permitting, route databases, signage, buffer between posted and actual clearance, insurance coverage, and pilot car requirements/operation; and (2) presents a structural analysis of the impact that provides insight into the truss design, damage sequence, failure mode, and potential techniques to increase the robustness of this class of bridge. DOI: 10.1061/(ASCE)CF.1943-5509.0000913. © 2016 American Society of Civil Engineers.

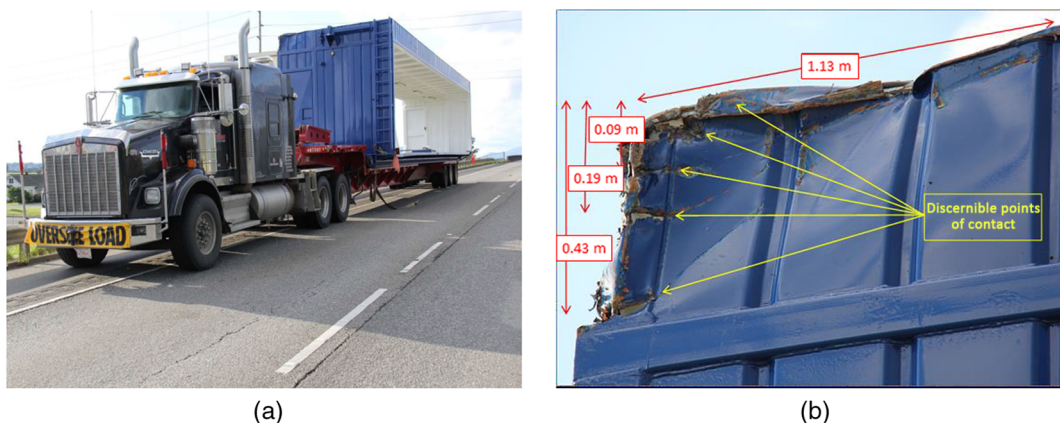
Fig. 1. Overheight truck photographs (reprinted from NTSB 2014): (a) overall view with container; (b) detail of damage to oversized container

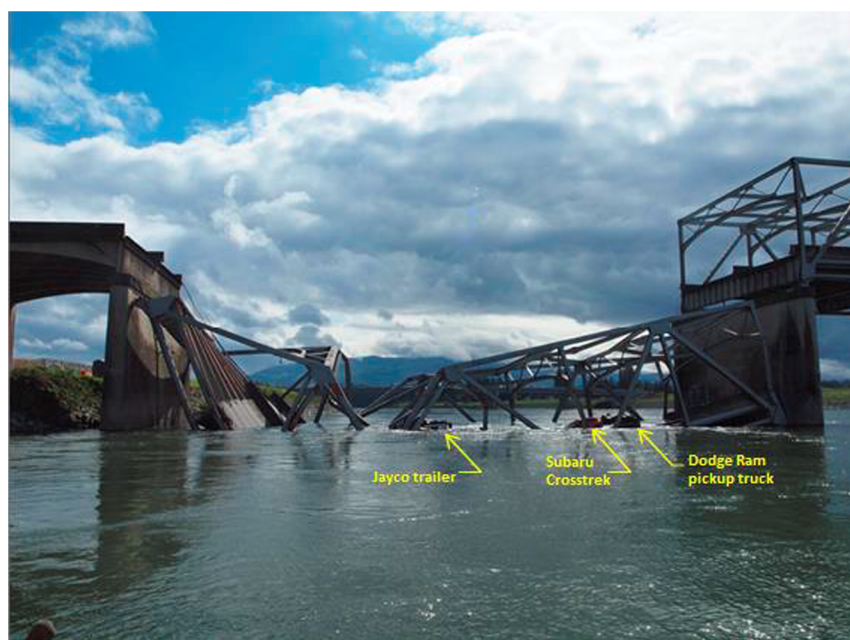
(Fig. 3). Eight vehicle occupants were involved in the collapse, and although three received minor injuries, there were no fatalities. The collapse impacted local communities and west coast transportation for about 6 months.

Fig. 3. Bridge Span 8 collapsed in Skagit River with vehicles involved identified (reprinted from NTSB 2014)

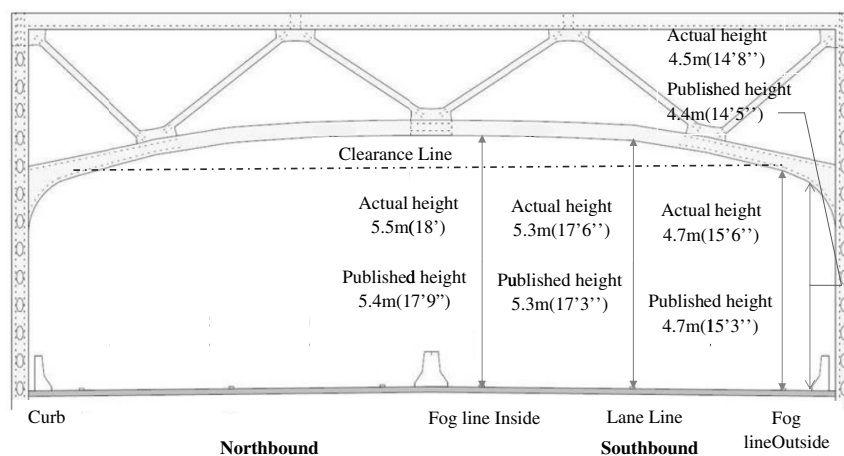
Fig. 4. Published vertical clearance values of portal frame for the I-5 Skagit River Bridge

clearance over the outside fog line [right edge of the right-most south travel lane, i.e., near the bridge edge, is only 4.4 m (14.44 ft), as shown in Fig. 4, while the actual vertical clearance at this location is slightly higher at 4.5 m (14.76 ft)].

Finally, the published vertical clearance over the lane line (line dividing the southbound approach into two lanes) is 5.30 m (17.39 ft), while the actual vertical clearance at this location is also slightly higher at 5.33 m (17 ft-6 in.). The truck shown in Fig. 1 had a permit for a maximum vertical clearance of 4.8 m (15.74 ft) and width of 3.5 m (11.5 ft), which clearly exceeded the published and actual heights at the right edge of the right-most south travel lane by over 0.3 m (1 ft).

Fig. 4 also shows the bridge had a variable vertical clearance so these different vertical clearances should be considered in the permitting process for oversized vehicles. A truck with 4.8 m (15.74 ft) vertical height exceeds the vertical clearance of the bridge over a portion of the right lane and all of the right shoulder, while it does not exceed the vertical clearance of the bridge over the left lane. If the truck was travelling in the left lane, the bridge impact probably would not have occurred. The permitting process and bridge signage should illustrate this variable vertical clearance, as discussed subsequently.

Fig. 4 shows the clearance line, which corresponds to a line above the entire width of the traveled lanes (not including sidewalk), that exceeds a minimum vertical clearance. The published clearance line is 4.7 m (15.41 ft), which is less than the vertical

height of the truck, i.e., 4.8 m (15.74 ft). As a result, if the permit was based on the clearance line, it would have indicated that the truck exceeded the height of the clearance line. As discussed later, all of the actual vertical dimensions in Fig. 4 are 76 mm (3 in.) greater than the published value to create a vertical clearance buffer of 76 mm (3 in.).

Fig. 4 also shows the vertical clearance at the outside fog line is only 4.5 m (14.76 ft). As a result, WSDOT did not have any signage posted prior to the bridge about vertical clearance because it only posts signage for vertical clearance less than 4.65 m (15.26 ft) as discussed subsequently. WSDOT published the vertical clearance at the outside fog line as 4.4 m (14.43 ft), which provided a 76-mm (3-in.) vertical clearance buffer. WSDOT also did post reduced lane width signage even though the southbound lanes narrowed from the roadway width of 3.7 m (12 ft) to 3.5 m (11.48 ft) on the bridge.

- Vertical clearance signage should convey variable clearances across and along the roadway. Variable clearance signage should appear well before the structure to allow lane changes.
- A vertical clearance buffer of greater than 76 mm (3 in.) should be used because changes in pavement thickness, weather conditions, and vehicle bounce will occur over time.
- The pilot vehicle driver should not use any electronic communication device that is not related to communication with the oversize vehicle driver.
- Pilot car height poles should be mounted vertically and be equipped with technology that immediately informs the escort and oversize vehicle drivers that a structural element has been contacted by the height pole, so the escort driver does not have to relay the information.

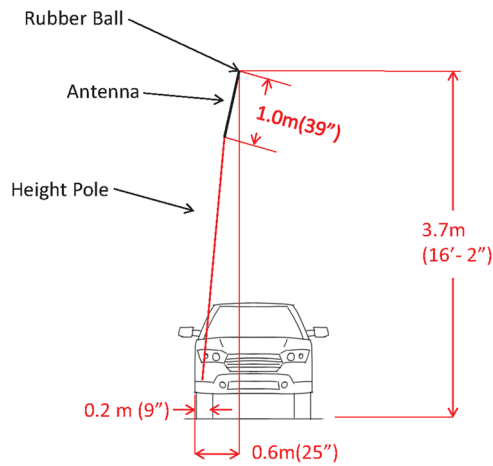
Fig. 6. Diagram of the I-5 bridge pilot/escort vehicle height

measured to be 4.9 m (16.08 ft) for a load height of 4.8 m (15.75 ft), which is 127 mm (5 in.) greater than the load height (Fig. 6). However, the pole was installed at an angle (Fig. 7) so it was not 127 mm (5 in.) higher than the load height of 4.8 m (15.75 ft) at the right edge of the load.

The *Pilot Car Escort Training Manual* (FHWA 2004) displays the mounted pole on the right side of the vehicle (as was done in the I-5 case, as shown in Fig. 6), however many state agencies do not require a specific location for it. Not only must the pole be at the right location, but it also needs to be installed vertically to capture the full height of the oversized load. As a result, NTSB (2014) recommends that AASHTO develop a procedure so pilot/escort vehicles replicate the maximum dimension of an oversized load.

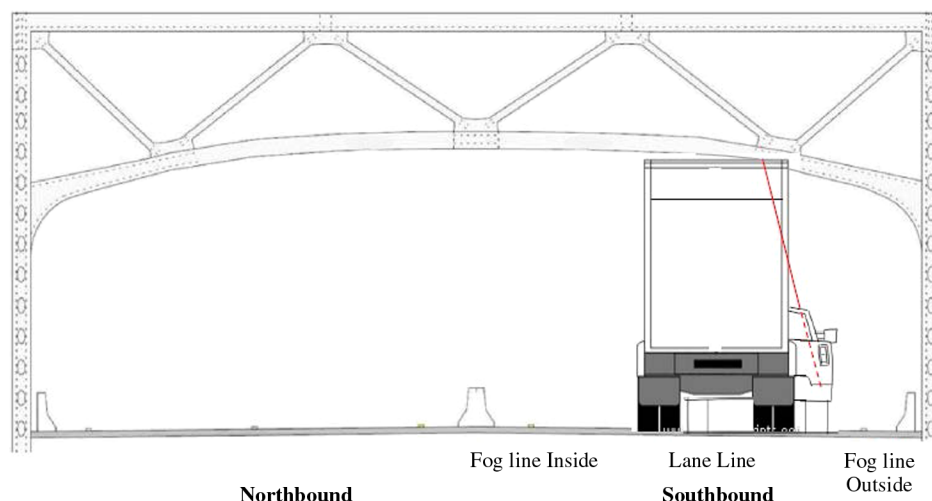
Fig. 7. Pilot vehicle vertical measurement compared to oversized load (after NTSB 2014)

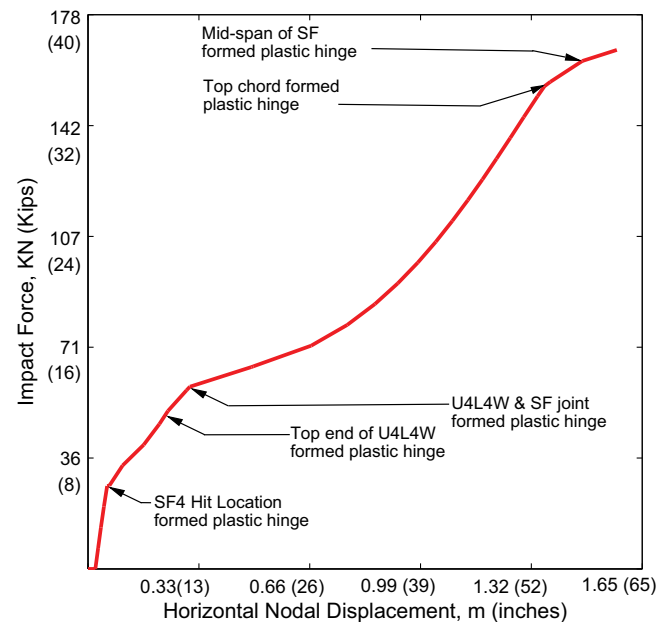
Fig. 11. Nonlinear static analysis response curve for impact location

was chosen because the actual dynamic impact force history is not known. Fig. 11 shows the characteristic nonlinear static analysis response curve for Span 8 when a horizontal force is applied at the impact location on Sway Frame 4. This curve plots the total horizontal force applied to the structure at the impact location against the corresponding horizontal displacement of the node at the impact location. Five major events that occurred during the analysis are indicated along the response curve, and normalized axial-flexural interaction histories are plotted for key locations in Fig. 12. The corresponding damage observed during a site visit is shown in Fig. 13.

In Fig. 11, the relative force values between the labeled events provide a means to approximate the sequence of damage. The separation in applied force between the first three major events and the last two is fairly large, indicating the first three likely occurred earlier in the actual failure sequence than the last two. The collapse sequence suggested by this analysis, which shows large sway frame deformation prior to failure of the attached upper chord, is in agreement with the NTSB (2014) conclusion about the span collapse sequence, as further discussed later. The initial behavior illustrated in Fig. 11 is nominally linear elastic prior to formation of a plastic hinge at the impact location on Sway Frame 4. Fig. 13(a) shows the impact location to illustrate the extensive local damage.

In the analysis, the stiffness reduces after plastic hinge formation at the impact location and is roughly constant until two additional plastic hinges form, after which the stiffness reduces again. The final collapse occurs when a plastic hinge forms in the top chord and this critical compression member then becomes unstable. Although this static analysis provides insight into the likely sequence of damage that led to collapse, the events actually occurred close together in time as the impact was followed by collapse just seconds later.

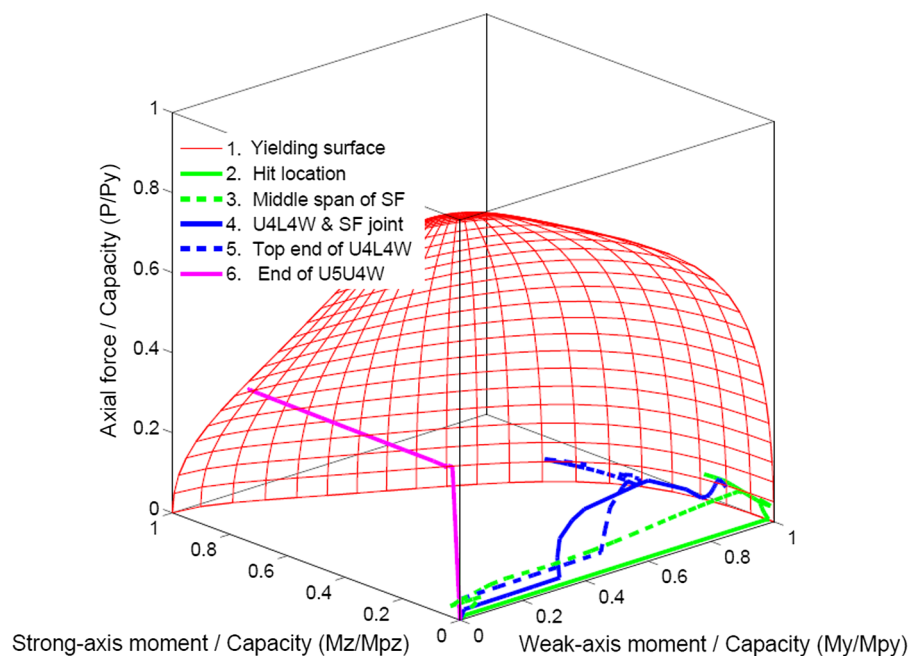
Fig. 12. Axial-flexural interaction diagrams

Axial-flexural histories are shown in Fig. 12 for the five critical locations that relate to the major events shown in Fig. 11, namely, the ends of upper chord segment U5-U4W, two points on the lower chord of SF4, and the ends of the vertical member U4-L4W. The axial force in vertical U4-L4W is small from both truss action and the applied horizontal impact force. Behavior of this vertical member is initially dominated by weak-axis bending moment,

indicated by M_y in Fig. 12, due to the horizontal force transferred from Sway Frame 4 (SF4). Subsequently, strong-axis bending moment, indicated by M_z in Fig. 12, starts to affect its behavior before the curve reaches the yield surface as the deformed sway frame pulls the attached vertical member inward and in the direction of the impact, inducing biaxial bending. Based on postcollapse examination, the top end of vertical U4-L4W yielded, deformed extensively, and then developed a flange fracture as shown in Fig. 13(b).

The axial-flexural interaction diagrams in Fig. 12 also indicate that the sway frame (SF) behavior is dominated by weak-axis bending (with the torsional effect of the eccentrically applied force incorporated by reducing weak axis flexural capacity). This agrees with field observations, as shown in Fig. 13(a), indicating the lower chord of SF4 deformed significantly at the impact location in the weak-axis direction, causing fracture and yielding at the bottom

Initial behavior of top chord U5-U4W is controlled by the axial force due to truss action. After two plastic hinges developed in the attached vertical member (U4-L4W), strong-axis bending then dominates (with little decrease in axial force) before the member reaches the yield surface as shown in Fig. 12. This is consistent with the damage shown in Fig. 13(a), where the upper chord is folded about its strong axis at the U4 joint and significant local yielding and buckling occurred in both the webs and flanges of this upper chord member.

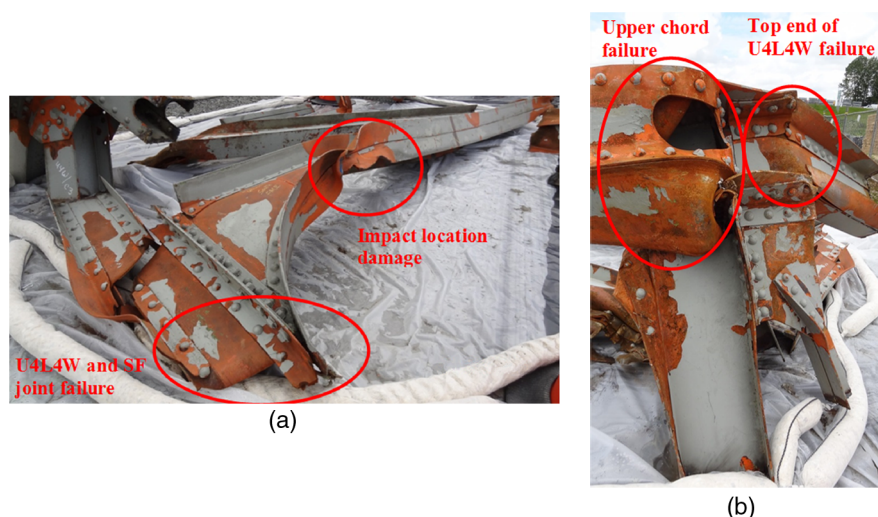
Fig. 13. Damaged components from Span 8 (images by Timothy D. Stark): (a) impact location on Sway Frame 4; (b) failure of top chord at U4 joint

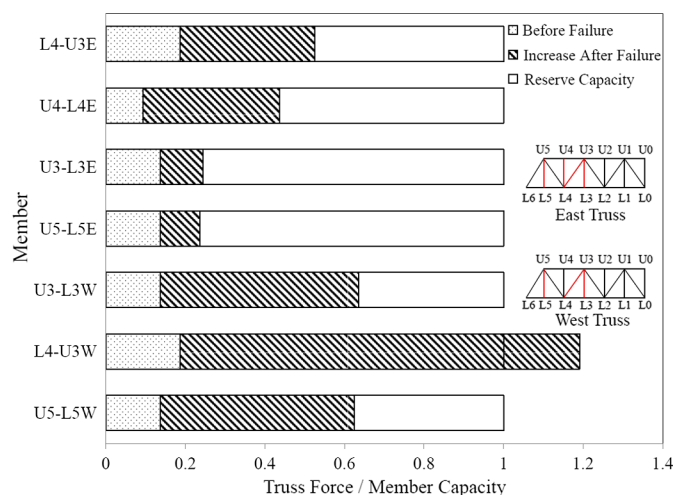
Fig. 14. Axial force demand-to-capacity ratios after failure of U3-U5W and L4-U4W

An elastic analysis was conducted for the truss load redistribution study, with the strength of the upper chord (L4-L3W and L5-L4W) and attached vertical member (U4-L4E) in the west truss set to zero to approximate failure of these members. Critical truss members subject to large increases in force after failure of the upper chord (U3-U5W) and vertical (L4-U4W) members are shown in Fig. 14 to illustrate the transition in truss forces. Fig. 14 illustrates that critical members are located adjacent to the failed members in the west truss or near the U4 joint in the east truss. As U3-U5W and L4-U4W lose their load-carrying capacity, force is redistributed and increases significantly in the west truss (impact side). As a result,

the axial force demands in the compression diagonal L4-U3W exceeded its nominal capacity.

Based on this simple load-redistribution study (Figs. 14 and 15) and related elastic deflection of the span (Fig. 16), the following collapse sequence is inferred:

1. Failure of top chord U3-U5W and vertical L4-U4W due to the impact load on SF4 causes the west truss to lose its function, so gravity load near Node L4 has to be carried by the bottom chord (L4-L3W and L5-L4W) and adjacent diagonal member (L4-U3W). This results in a large moment demand on these members, causing hinging of the bottom chord (L4-L3W and L5-L4W).

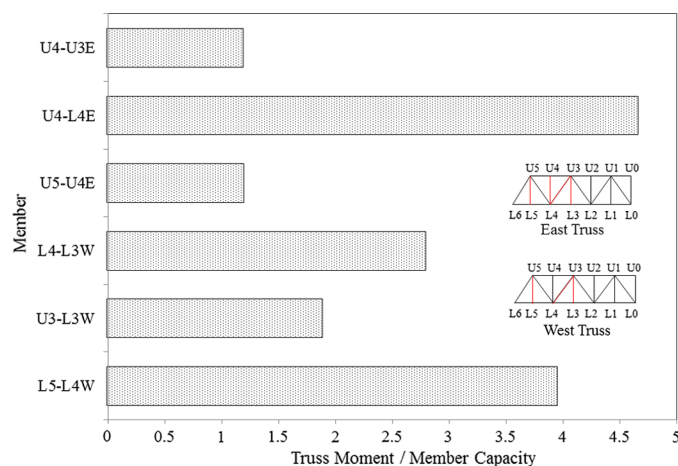
Fig. 15. Moment demand to capacity ratios after failure of U3-U5W and L4-U4W

Furthermore, change of moment in truss members following the failure of the upper chord is considered. Moment demands about two principal axes of all truss elements were compared with their associated nominal bending capacity. Fig. 15 plots the ratio of moment capacities and actual moments about the most critical principal axis for select members having demand in excess of capacity. The figure indicates the moment substantially increases in the bottom chords (L4-L3W and L5-L4W) and vertical (U4-L4E) members. This is a reasonable load path redistribution because once U3-U5W and L4-U4W lost their ability to carry load, demand would increase at the adjacent members and an alternative load path would be required at the other supporting end (at L4E) to carry the gravity load applied on node L4W. Fig. 16 illustrates elastic deformation of the 3D model when zero strength was assigned to the upper chord (U4-U3W and U5-U4W) and attached vertical member (U4-L4W) in the west truss. Significant downward deflections, along with severe distortion and twisting of the span, appear in the region of node L4W.

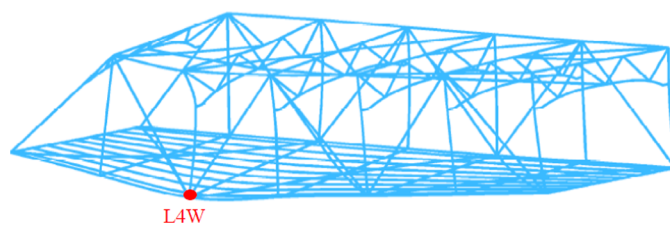
Fig. 16. Elastic deflection of Span 8 in the area of L4W after failure of U3-U5W and L4-U4W

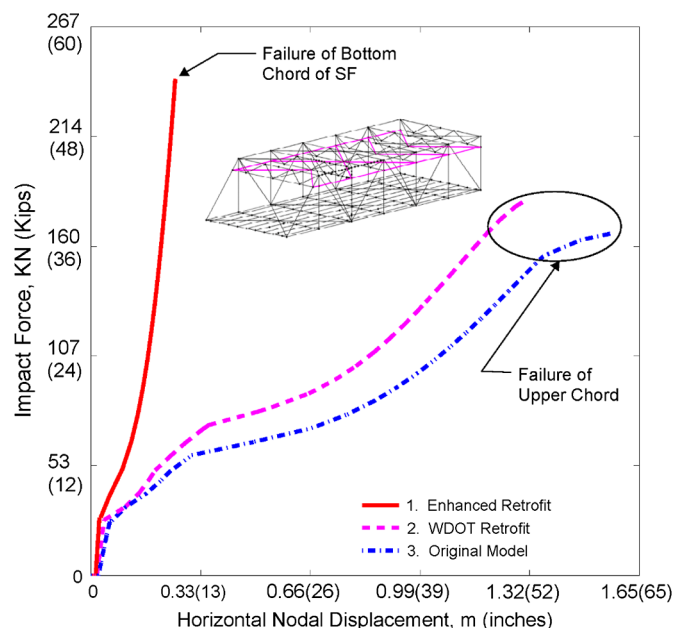
Fig. 17 shows the results of the nonlinear static analysis for the original truss design and two retrofit schemes. The response curve for impact location with the original truss design is similar to the response curve in Fig. 11. However, Fig. 17 shows the enhanced retrofit presented herein provides a better, i.e., less displacement, than the WSDOT retrofit. As expected, the WSDOT retrofit scheme does provide a better response curve than the original design.

Nonlinear static response analysis curves for the original model, the WSDOT retrofit model (sway frame with straight lower chord), and the proposed enhanced retrofit model show the original model and WSDOT retrofit model follow similar patterns of behavior,

Fig. 17. Nonlinear static analysis response curve for impact location with original truss and two retrofit schemes

and the structure eventually becomes unstable due to failure of the upper chord (Fig. 17). Hence, these two structures have similar behavior with regard to a collision at the lower chord of a sway frame (although the likelihood of such a collision has been significantly reduced by the WSDOT retrofit). On the other hand, the proposed enhanced retrofit has larger horizontal stiffness than the other two models after the first plastic hinge develops at the collision point and therefore deformation of the vertical member and attached upper chord are smaller than in the other two scenarios.

Following the truss span collapse on May 23, 2013, a temporary span was installed on June 19, 2013, for Span 8 to accommodate the I-5 traffic. The elliptically curved lower chords of the sway frames in the remaining truss spans were then replaced by straight members in August 2013. This retrofit created a uniform vertical clearance of 5.5 m (18 ft) across the remaining truss spans, which allows an oversized truck to easily travel in either lane (or even onto the shoulder) throughout the entire bridge so any consideration of traveling in an incorrect location for oversized trucks is eliminated. On the night of September 14, 2013, the temporary Span 8 was removed and a permanent replacement span installed.

Hypothetical alternative retrofits to strengthen the sway frames against impact damage were analyzed with a 3D model similar to the one described earlier for the primary study, but modified for different sway frame geometries. One option for protecting the upper chord is to stiffen and brace all sway frame vertical members in the longitudinal direction so that a horizontal impact force applied to a sway frame can be resolved into the truss without placing significant demand on the top chord. In the 3D retrofit model, longitudinal struts were placed between each vertical sway frame member in the plane of the bottom chords of the sway frames and lateral braces were placed at the lower level of the sway frames following the same pattern as the top lateral bracing system to stabilize the vertical members transversely.
