# Oso, Washington, Landslide of March 22, 2014: Dynamic Analysis

**Abstract:** This paper describes and explains the spectacular mobility of the 2014 Oso landslide, which was the cause of its fatal consequences. A geomorphic interpretation of the site conditions is used to reconstruct the landslide failure mechanism. Two numerical models are used to conduct an inverse runout analysis. The models implement a newly defined rheology appropriate for liquefied soils. It is shown that this landslide occurred in two phases, characterized by different material strengths. Although the temporal sequencing of the two phases remains somewhat ambiguous, it is clear that the distal phase underwent significant undrained strength loss (liquefaction) and travelled more than 1.4 km over a nearly horizontal surface. The proximal phase underwent brittle failure, with much less strength loss than the first phase. The parent material forming the slide mass was composed of insensitive, overconsolidated glaciolacustrine silt and clay, material not traditionally recognized as liquefiable. It is hypothesized that a substantial volume of liquefaction-prone soil was formed by colluvial softening of the paren

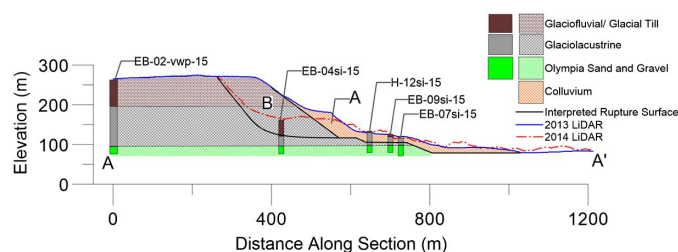
**Fig. 1.** Simplified stratigraphic section through the 2014 Oso landslide showing the borehole results presented by Badger (2015); the materials comprising Phases A and B are indicated; the solid line shows the proposed rupture surface, which agrees with available borehole data and surface observations; the locations of the two intermediate scarps correspond to observed prefailure scarps, and the depth of the rupture surface was determined from borehole data; the location of the boreholes and section line are shown in Fig. 2

The Phase B failure surface was interpreted as a compound surface with a nearly horizontal plane located in the glaciolacustrine unit (Fig. 1). A large intact block came to rest in the source zone of Phase A, although it was deformed along multiple inclined shears. The style of this deformation is indicative of a nearly horizontal plane located in the glaciolacustrine unit, typical of a bilinear compound slide (Hutchinson 1988). In front of this intact block, slabs of material *scalped* or dropped down, exhibiting marked extension while moving over a steeply inclined steplike surface segment (Fig. 5).

Hibert et al. (2015) estimated that the volume of the Phase B debris was 25% that of the Phase A debris, which contradicts the interpreted rupture surface in Fig. 1. The Hibert et al. (2015) estimate was based on the assumption that the peak acceleration of the centers of mass of the Phase A and Phase B material were the same. The results of the present paper suggest that this assumption is not appropriate, and that the acceleration of the Phase A material was significantly greater than that of the Phase B material.

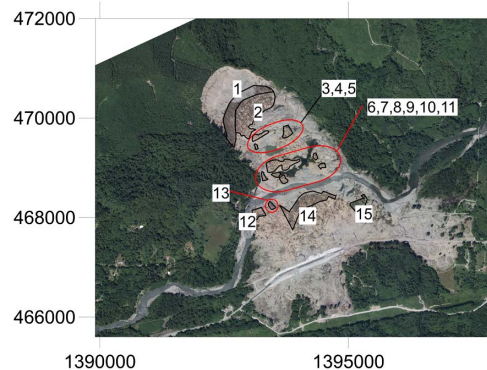
**Fig. 3.** Polygons of intact forest blocks in 2014 slide mass used to constrain the origin of different features of the debris; Polygons 1 and 2 have a combined area of 59,000 m<sup>2</sup>, corresponding to the pre-failure area of trees on the Whitman Bench (Fig. 4); Polygons 3–15 have a combined area of 50,000 m<sup>2</sup>, corresponding to the area of the trees in front of the Whitman Bench (Fig. 4) (background image courtesy of Esri Disaster Response Program and WSDOT)

The source area is understood here as the planar footprint of the source volume. Fig. 3 shows that the proximal source area features thick deposits, consisting largely of a relatively intact but heavily internally sheared block, covered by trees (Polygons 1 and 2 in Fig. 3). Apart from a series of scarps formed by internal shears, the forest floor is mostly intact on this block. This suggests that the proximal block remained relatively coherent during its movement, although the abundance of internal shear surfaces exposed by normal offsets testifies to strong internal shear deformation and suggests nonrotational shape of the sliding surface. Allowing for some spreading, the area of the forest floor that remained intact on this block was measured to be 59,000 m<sup>2</sup>. By overlaying the impact area of the 2014 landslide on a preslide orthophotograph taken in 2013, it is possible to determine where the trees present on this block must have originated. Fig. 4 shows that the intact block of trees derived from the surface of Whitman Bench located at the head of the slide and from a part of the prehistoric scarp (Polygon 16, which also has an area of 59,000 m<sup>2</sup>). The heavily forested area lying originally downslope of the Whitman Bench

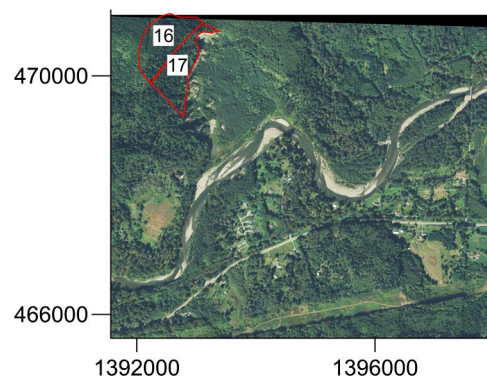
**Fig. 4.** Measurement of tree areas on pre-2014 orthophotograph; Polygons 16 and 17 have a measured area of 59,000 and 54,000 m<sup>2</sup>, respectively (background image from National Agriculture Imagery Program, data available from the U.S. Geological Survey)

crest (Polygon 17) consists of an ancient slide block, likely made up of previously displaced material (Stark et al. 2017).

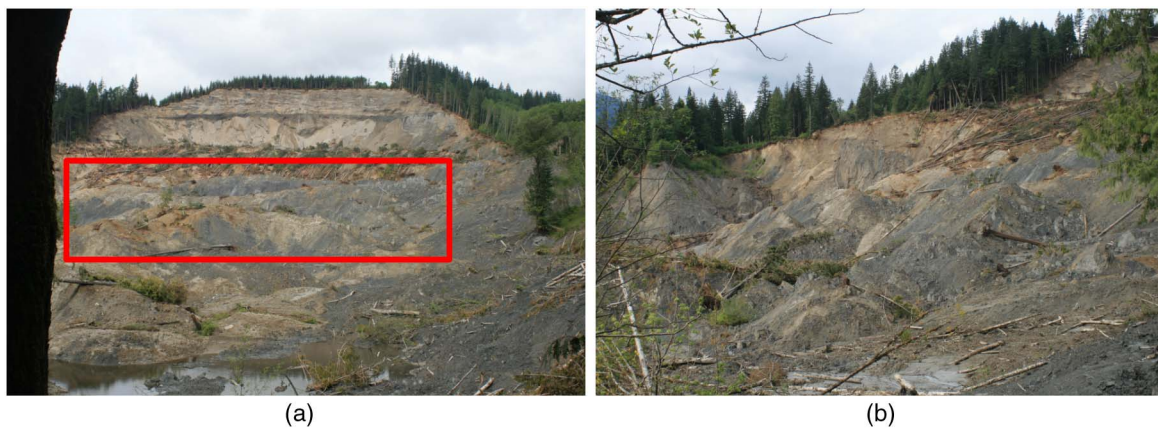
**Fig. 5.** (a) Postevent image of 2014 Oso flowslide source zone with intact blocks that appear to have undergone extension while traveling over an inclined surface (see square); (b) side view of the dropped-down blocks (images by Jordan Aaron)

To the southeast of this proximal block, the landslide deposits exhibit blocks of coherent material that appear to have dropped down while moving over a sloping surface (Fig. 5). This indicates that the material forming the proximal debris deposits underwent sliding failure on a compound sliding surface, which necessitated disruption on multiple internal shear surfaces. However, in contrast to the distal deposits, there is no evidence of liquefaction in this part of the debris.

The geometry of the Phase A failure surface was chosen to correspond with the mechanism described in Stark et al. (2017), in which a relatively small initial failure in the upper part of the slope induces a large strength loss in the colluvium accumulated at the toe of the slope. Multiple pieces of evidence support this interpretation. As discussed previously, the measured area of intact blocks of forest floor rafted onto the valley indicates that the valley floor deposits derived primarily from material originally located to the southeast of the Whitman Bench. In its prefailure position, this material was traversed by two scarps: the scarp associated with the ancient landslide and the scarp associated with the 2006 landslide. The locations of these scarps correspond to the dropped-down slabs of material identified in the 2014 debris field (Fig. 5),

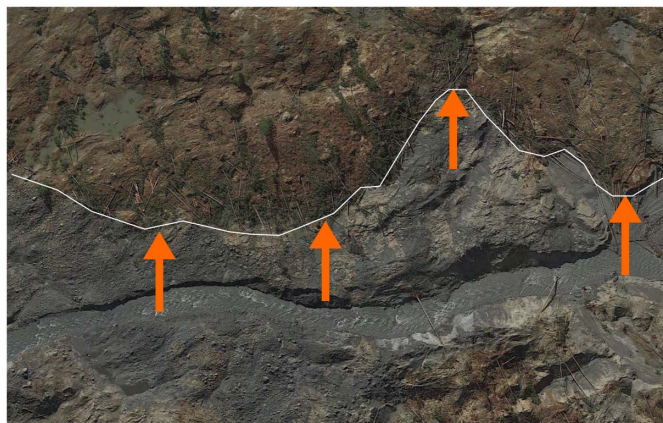
**Fig. 7.** Contact line separating debris involved in Phase A (upper part of the figure) and Phase B (map data: Google, Landsat/Copernicus)

Evidence that relatively little energy was transmitted between the two motion phases can be observed near a *contact line* just to the south of the present river channel (Fig. 7). The zone of debris

adjacent to the contact line is among the thinnest parts of the debris field (this is why the river overflowed the debris at this point). The morphology of the debris in this area shows no evidence of high compressional stresses having been transmitted through the zone such as faults, thickening or pressure ridges. On the contrary, the relatively smooth debris surface with shallow depressions is indicative of longitudinal extension and thinning. In Scenario 1, the contact zone represents the line where the leading front of Phase B arrived to overrun the previously deposited and now stationary debris of Stage A at the present location. In Scenario 3, the contact line may have formed on the lower slopes, as the toe of Phase B came to rest at the head of the colluvial accumulations. When the latter subsequently failed and a flowslide extended farther, the contact line with its toppled trees was transported down-slope to its present position on the floor of the valley. In neither case was significant force (and energy) transmitted by compression from Phase B to Phase A. Therefore the temporal sequence of the movement phases has little effect on the results of the dynamic analysis.

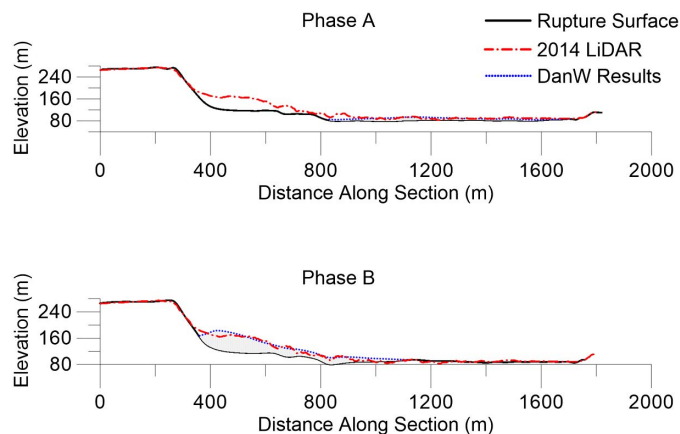
**Fig. 8.** Simulated flow depths for Phases A and B; results show good agreement with the deposit depths derived from the 2014 LiDAR

Fig. 8 summarizes the results of the 2D simulations, in which the two phases were assumed to be separated by a time gap. In particular, Fig. 8 shows a comparison between the final surface predicted by DANW and that derived from the 2014 LiDAR. Comparison of these two surfaces shows that DANW was able to reproduce the runout distance and deposit distribution. The blocky nature of the debris was not reproduced because DANW models the sliding mass as a homogeneous material. The distal end of the deposit was also thinner than indicated on the 2014 LiDAR, likely due to the neglect of rate-dependent resistance and entrainment of debris and vegetation by the flow front. A bulk friction angle of  $12^\circ$ , consistent with residual friction angles measured by Stark et al. (2017), was used to simulate the Phase B material.

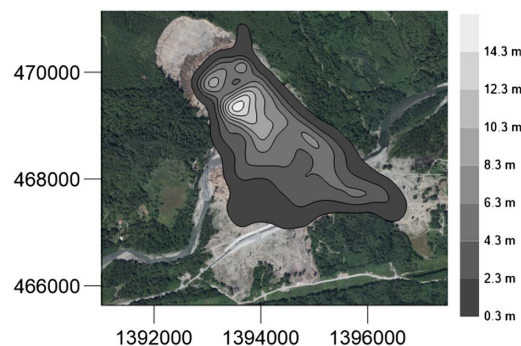
**Fig. 10.** Results of DAN3D simulation of first phase of movement with impact area and deposit distribution in agreement with field observations; no effort was made to reproduce the splash zone (background image courtesy of Esri Disaster Response Program and WSDOT)

Figs. 10 and 11 show the final deposit depths predicted by the 3D simulations for Phase A and Phase B, respectively. These results cannot be directly compared with Fig. 6 because these deposit depths were calculated based on the difference in elevation between the top of the deposit and the failure surface, whereas accumulation and depletion maps were calculated based on the difference between the pre-event ground surface and the top of the slide deposit. In areas where material was removed and then partially replaced, such as the source zone, deposit depths will be positive but the map will show depletion. To better facilitate comparisons between model results and field observations, a map showing the zones of accumulation and depletion predicted by DAN3D was created by adding the calculated deposit depths to the map of the failure surface and sliding/flow path (Fig. 12). These simulations treated the failure as two discrete events, using the same parameters as used in the 2D analyses. The model adequately reproduced the impact area and deposit distribution. Similar to the 2D analyses, the distal end of the predicted deposit was thinner than that observed in the field, for reasons stated previously. The model did not reproduce the deposits in the southwest corner (the *splash* area) because these deposits represent a small volume of material entrained in the valley that mixed with surface water and was projected ahead of the main debris mass. This process was not simulated with the present dynamic models.

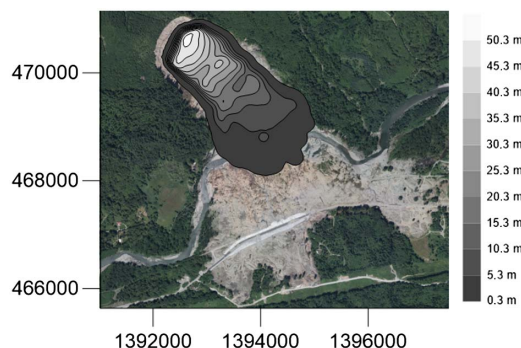
**Fig. 11.** Results of DAN3D simulations of Phase B overlaid on post-2014 event orthophotograph; the simulated deposits extend to the contact zone (background image courtesy of Esri Disaster Response Program and WSDOT)
