Case Study: Vertical Drain and Stability Analyses for a Compacted Embankment on Soft Soils

Timothy D. Stark, Ph.D., P.E., D.GE, F.ASCE¹; Perry J. Ricciardi, P.E., A.M.ASCE²; and Ryan D. Sisk, A.M.ASCE³

Abstract: This case study describes the failure of an interstate connecting-ramp embankment during construction and investigates the failure mechanism, performance of the prefabricated vertical drains (PVDs) installed to accelerate consolidation of the weak embankment foundation soils, embankment shear strength parameters, and design slope stability analyses. The weak, fine-grained foundation soil experienced less drainage, and thus less consolidation and strength gain, than expected via the PVDs because of an overestimate of the design horizontal coefficient of consolidation. As a result, the inverse analyses show the failure was caused by lower than expected shear strength of the foundation soils and an overestimate of the compacted embankment shear strength. The compacted embankment fill strength was characterized using an undrained shear strength, i.e., cohesion, without a tension crack, which inflated the calculated factor of safety. Recommendations to estimate embankment shea

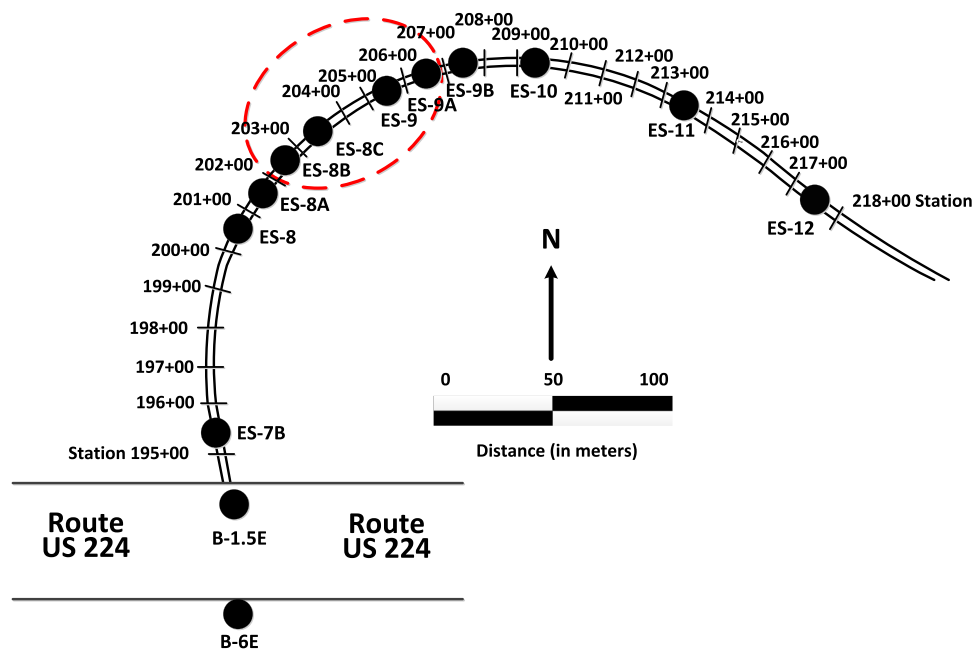
Fig. 1. Location of ES labelled borings along Ramp ES, with slope failure area marked by dashed circle

A total of 100 test borings were completed for this project. Twenty-four of these 100 borings were completed along the 1,705.8 m-long (520.0 ft) Ramp ES, with 13 near the failure area (Fig. 1). The borings extended to depths between 4.6 and 22.9 m (15–75 ft) below ground surface. The soil profile generally consisted of a thin (~0.3 m; 1 ft) layer of topsoil overlying various layers of fine-grained soil. The fine-grained soils were brown and/or gray, mottled, clayey silt or silty clay with lesser percentages of sand and gravel. Very soft to soft silty clays, sandy silts, and organic clays ranging from depths of 0.3 to 11.6 m (1–38 ft) had organic contents ranging from 3 to 84% as determined by ignition tests [ASTM D2974-14 (ASTM 2014a)]. The majority of this material was classified as an organic clay, not peat, under ASTM D4427-13 (ASTM 2013a), because peat classification requires an organic content greater than 75% under ASTM D2974-14.

peat based on the q_u values in Table 5, which are 35.2, 149.4, 46.9, 49.1, and 464.0 kPa, respectively. This helps explain why the slope failure did not occur near U.S. Route 224 where Borings B-1.5E and B-6E were drilled (Fig. 1).

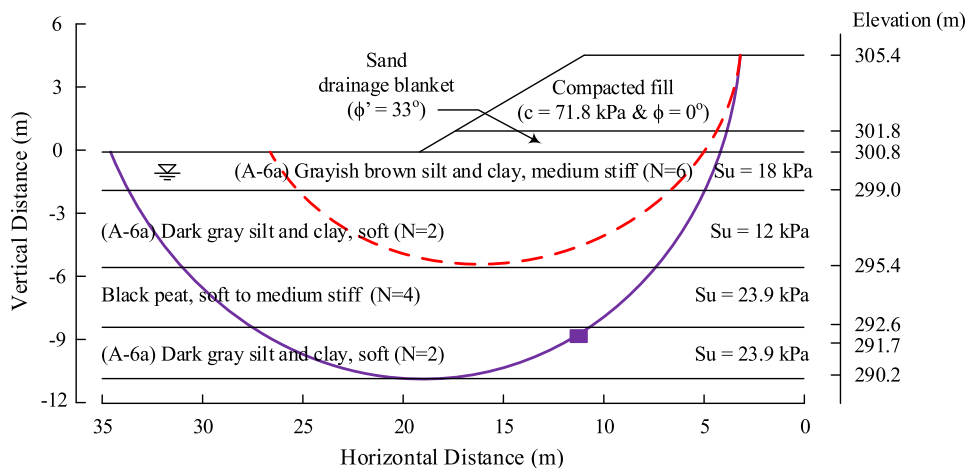
Fig. 2. Initial design cross section based on Boring ES-8A at Station 201+61, estimated undrained shear strengths, design critical failure surface (dashed circle), depth of movement at 15.2 m (50 ft) in slope inclinometer at Station 200+00 (solid block) at elevation +291.7 m, and observed failure surface (solid circle)

Fig. 2 shows the initial design cross section at Station 201+61, which is based on Boring ES-8A and was just outside of the failure

area (Fig. 1). The groundwater was found after drilling in Boring ES-8A at a depth of about 1 m (Fig. 2). This cross section was used to evaluate the stability of Ramp ES before and during construction by the designer and OGE. However, the Ramp ES slope failure occurred between Stations 202+00 and 205+00, so the subsurface conditions in the failure area were slightly different than the initial design cross section at Station 201+61. Fig. 3 shows the slightly different cross section for Station 203+58, which was closer to the center of the slide area, is based on Boring ES-8C (Fig. 1). The groundwater was found after drilling in Boring ES-8C at a depth of approximately 2 m (Fig. 3).

Table 3 presents the index and engineering properties for the weak foundation soil A-6a at Station 201+61 of Ramp ES based on Boring ES-8A (Fig. 2) and used for the initial design. In Boring ES-8A, the initial moisture content was at or above the liquid limit, which is an indication, and a warning, of the low shear strength of the A-6a foundation soil. The boring log for borings ES-8A is included in Appendix S1 for completeness.

For the initial design cross section at Station 201+61 based on Boring ES-8A (Fig. 2), the critical factor of safety using a circular failure surface search, shear strengths shown in Fig. 2, no tension crack, and one-half of the final embankment height or 4.6 m (15 ft) is 1.59, which indicates stability. However, this limit equilibrium analysis showed significant tension in the upper portion of the embankment, i.e., negative normal stresses on the base of several of the vertical slices in the embankment.

Performing the same analysis with a tension crack for the full embankment depth, i.e., 4.6 m (15 ft) as suggested by Eq. (14), yields a critical factor of safety of 0.91. Therefore if an appropriate tension crack had been included in the initial design stability analysis, failure would have been predicted. The embankment failed at a height of only 4.0 m (13 ft), so the same analysis was performed with a tension crack the full height of the constructed embankment, i.e., 4.0 m (13 ft), and the critical factor of safety was 1.02, which is in excellent agreement with the slope failure occurring at an embankment height of 4.0 m (13 ft).

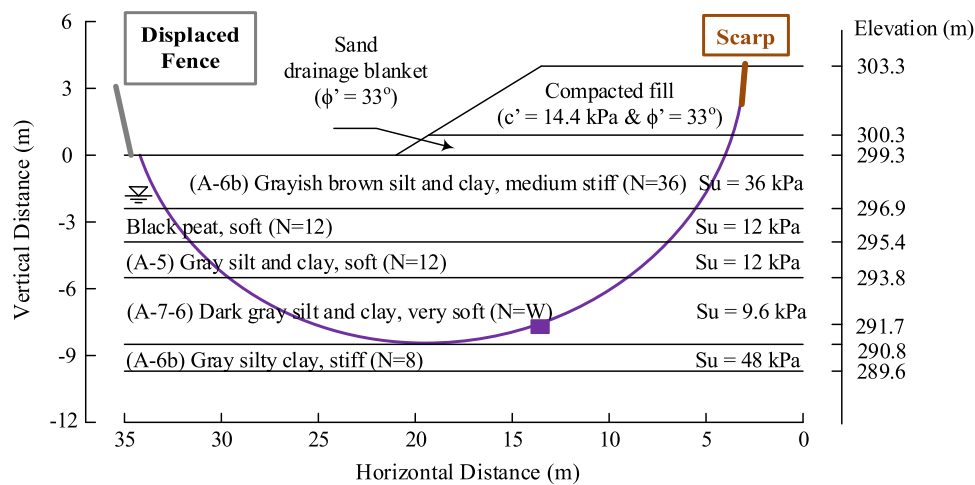
Fig. 3. Subsurface cross section for failed embankment based on Boring ES-8C at Station 203+58, estimated undrained shear strengths, depth of movement at 15.2 m (50 ft) in slope inclinometer at Station 200+00 (solid block) at Elevation +291.7 m, and observed failure surface (solid circle)

Table 4 presents the index and engineering properties for the weak foundation soil A-7-6 at Station 203+58 based on samples from Boring ES-8C (Fig. 3), which was in the failure area and used for the inverse analysis conducted herein. In Boring ES-8C, the initial moisture content was also at the liquid limit, which is an indication, and a warning, of the low shear strength of the A-7-6 foundation soil. The boring log for boring ES-8C is included in Appendix S2 for completeness.

To simulate the original embankment design, a singular value of undrained strength is used herein instead of estimating the undrained strength from an undrained strength ratio. As discussed subsequently, the increase in effective vertical stress, and thus shear strength, caused by consolidation due to the embankment fill is greatest at the embankment centerline and decreases toward the slope toe. As a result, the increase in shear strength due to consolidation along full length of the failure surface in Fig. 3 is probably small.

Although tension cracks developed from Stations 202+00 to 205+00 along Ramp ES, the actual slope failure was observed at Station 204+00, where movement of the right-of-way fence occurred (Fig. 7). To conduct an inverse analysis of the slope failure, a cross section was developed for Station 204+00 (Fig. 3) using Boring ES-8C, which was located nearby at Station 203+58. The cross section at Station 204+00 was analyzed herein using the Morgenstern and Price (1965) stability method included in the software package *SLOPEW* developed by Geo-Slope and the results were compared with the original design analysis performed using the cross section based on Boring ES-8A (Fig. 2). Comparing the cross sections at Station 201+61 based on Boring ES-8A (Fig. 2) and Station 204+00 based on Boring ES-8C (Fig. 3) revealed the following important differences in the cross sections:

Using the failure surface estimated from field observations, e.g., tension cracks, displaced fence, scarp, slope inclinometer, and so on (Fig. 3), the inverse stability analysis performed herein estimated that an effective stress cohesion (c') of 14.4 kPa (300 psf) is required with a ϕ' of 33° to produce a FS of approximately 1.0 at a fill height of 4.0 m (13 ft), i.e., the failure height. This inverse analysis was used to estimate the mobilized c' , because the value of ϕ' was estimated using Eq. (10) and has little influence on the calculated FS due to the failure surface being nearly vertical through the embankment (Duncan and Stark 1992) and the low normal stresses acting on the failure surface through the embankment

For the postfailure cross section at Station 203+58 based on Boring ES-8C (Fig. 3), the critical factor of safety using a circular search, the shear strengths in Fig. 3, no tension crack, and an embankment height of 4.0 m (13 ft) is 1.44, which also indicates stability, but this factor of safety is less than the 1.59 calculated for Station 201+61. Performing the same analysis with a tension crack, the full embankment depth, i.e., 4.0 m (13 ft), yielded a critical circular factor of safety of 1.06, which also is in agreement with the slope failure. Because this factor of safety is above unity, the same analysis with a tension crack the full embankment depth, i.e., 4.0 m (13 ft), and a noncircular failure surface was also conducted, and the critical factor of safety was 0.98, which is in better agreement with the slope failure occurring at 4.0 m (13 ft). In summary, the embankment fill did not mobilize significant shear resistance to improve the overall factor of safety due to strain incompatibility and tensile stresses and cracking developing in the fill, which contributed to the slope failure.

where $c_{\text{foundation}}$ = average foundation undrained shear strength, which was 17.9 kPa at Station 203+58 (Fig. 3) in the failed area, as calculated subsequently; $K_{\text{foundation}}$ = foundation modulus number, which was estimated to range from 40 to 150 using $PI < 30$, average $c_{\text{foundation}}$ of 17.9 kPa, and a correlation in Chirapuntu and Duncan (1976); K_{fill} = embankment fill modulus number, which was estimated to range from 150 to 600 using a soil type SC, an optimum water content, and data in Chirapuntu and Duncan (1976); γ_{fill} = embankment fill unit weight, which was 21.2 kN/m³ (135 pcf); W = width of Ramp ES embankment, which was 27.6 m with a crest width of 11.6 m; and D = depth of the soft foundation soils, which was 8.5 m (Fig. 3).

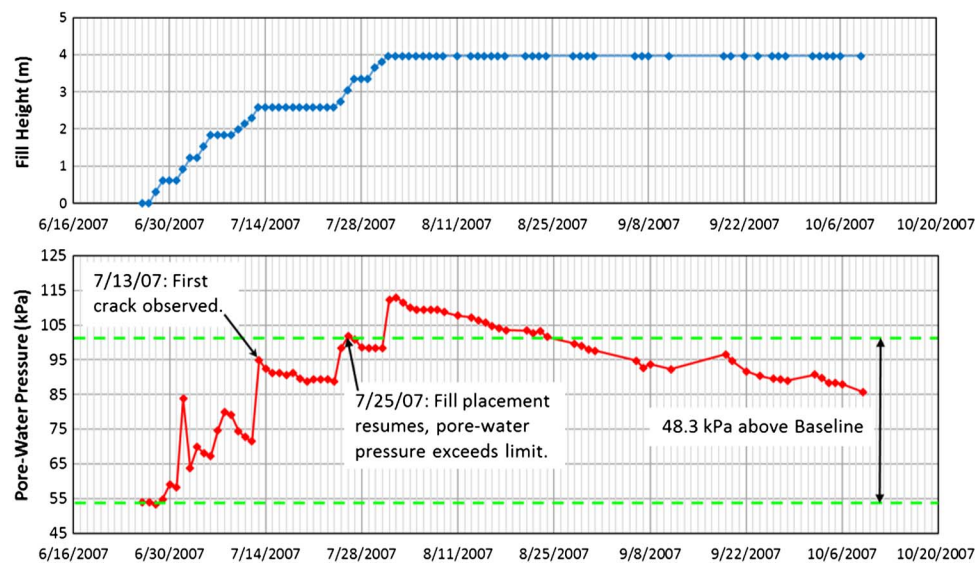
Fig. 4. Fill height, baseline pore-water pressure, and pore-water pressure versus time at Station 204+00 at elevation 295.7 m (Fig. 3)

Fig. 4 shows the as-built fill height and piezometer readings versus time at Station 204+00, which was in the slope failure area between Stations 202+00 to 205+00. As expected, the pore-water pressures steadily increased with increasing fill height. The cause of the sudden increase in pore-water pressure to 83.8 kPa on June 30, 2007 (Fig. 4) is not known. However, this isolated increase occurred early in the embankment filling and appears anomalous because the reading on the next day (July 1, 2007) was only 63.8 kPa, or approximately 20 kPa (25%) lower.

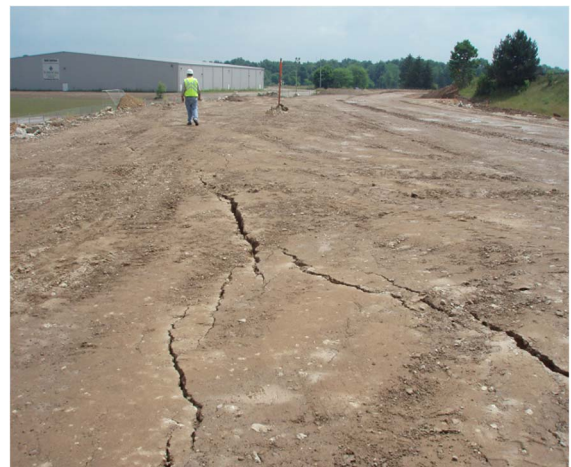
Fig. 5. Initial tension cracks in Ramp ES embankment on July 13, 2007 (image courtesy of Ohio Department of Transportation)

Between July 13, 2007 and July 24, 2007, embankment fill placement ceased while a geotechnical evaluation was completed by ODOT. On July 24, 2007, ODOT decided that embankment fill placement could resume but recommended that survey (PK) nails be installed along the embankment toe to monitor rotational movement. Between July 24, 2007 and August 1, 2007, the survey nails installed along the embankment toe showed uplift in the failure area, which was probably initial evidence of rotational movement.

By August 1, 2007, the embankment work reached a height of 4.0 m (13 ft). However, on August 1, 2007 additional tension cracks were noticed in the same location as the July 13, 2007 cracks along the embankment crest. Also on August 1, 2007, the pore-water pressure in the foundation soils exceeded 110 kPa (16 psi), which was 56.5 kPa (8.2 psi) above the baseline pressure (54 kPa; 7.8 psi), or 8.2 kPa (1.2 psi) above the allowable pore-water pressure increase of 48.3 kPa (7 psi).

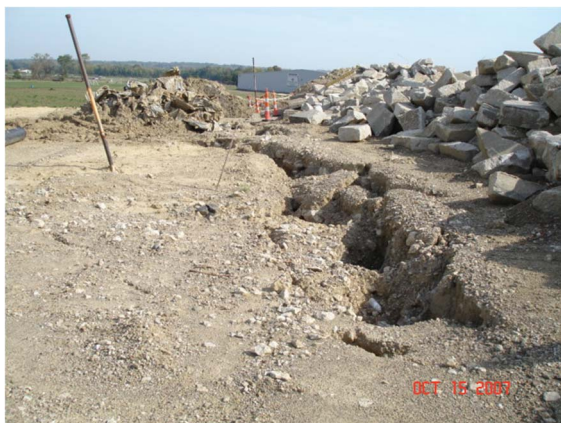
Fig. 6. Cracking in Ramp ES embankment on October 15, 2007 after some erosion (image by Timothy D. Stark)

On August 2, 2007, embankment construction was stopped and ODOT began reassessing the embankment stability and developing alternatives for the planned embankment construction. Between August 2, 2007 and August 6, 2007 embankment tension cracking along the crest progressed. Finally, on August 6, 2007, the northern half of the embankment rotated vertically downward 0.46 m (1.5 ft) and the foundation soils near the northern toe of the slope rose up. Fig. 6 shows the tension cracks along Ramp ES embankment on October 15, 2007 during a site visit by the first author. Fig. 6 also shows some of the broken concrete pavement pieces included in the fill material. Fig. 7 shows displacement of the nearby right-of-way fence on October 15, 2007, indicating that a deep-seated rotational foundation movement had occurred. Throughout embankment construction, there was little evidence of flow from the PVDs or the sand blanket. However, on August 6, 2007, water was observed draining from the sand blanket even though it had not been observed previously.

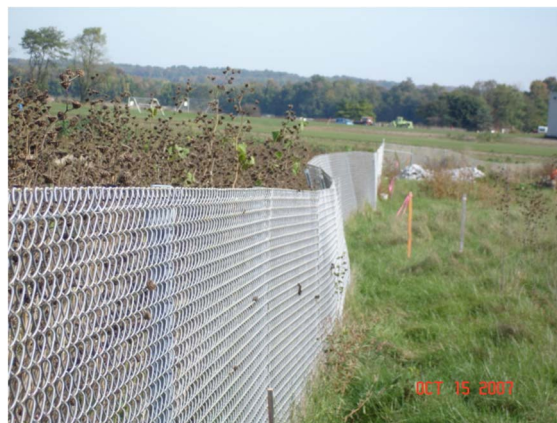
Fig. 7. Lateral movement of right-of-way fence near toe of Ramp ES embankment on October 15, 2007 (image by Timothy D. Stark)

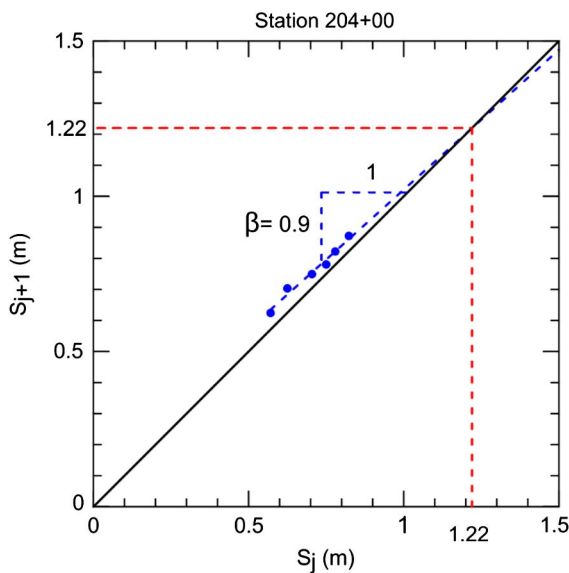
Fig. 8. Asaoka (1978) graphical method using settlements at different times for Station 204+00

Fig. 8 shows the Asaoka (1978) plot of s_{j+1} against s_j for Station 204+00. The C_h values in Table 10 for Stations 202+00 to 204+00 (6.4–8.4 m²/year) are well below the value of 18.6 m²/year (200 ft²/year) used in the initial design. Station 204+00, the center of the slope failure, produced the lowest value of mobilized C_h , i.e., 6.4 m²/year (68.6 ft²/year). This provides an explanation for the foundation soils not gaining sufficient undrained shear strength to maintain embankment stability. If the Asaoka (1978) method is used during construction and it is determined that the consolidation and strength gain is not occurring

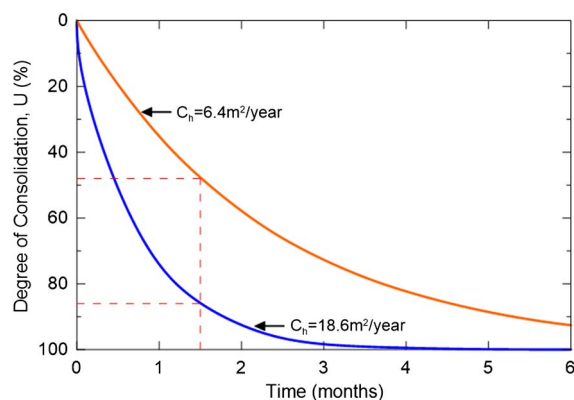
Fig. 9. Degree of consolidation versus time for Station 204+00 for the design and mobilized values of C_h

Fig. 9 shows the predicted increase in degree of consolidation with time for the C_h estimated using the Asaoka (1978) method at Station 204+00 (6.4 m²/year) and the initial design value of 18.6 m²/year (200 ft²/year). Failure of the Ramp ES embankment occurred approximately 1.5 months after placement of the embankment fill began, which corresponds to approximately 86% consolidation if C_h had been 18.6 m²/year (200 ft²/year) (Fig. 9). If C_h had been 18.6 m²/year (200 ft²/year), the undrained strength would have been sufficient to prevent embankment failure. However, using a time of 1.5 months and the mobilized value of C_h of

$6.4 \text{ m}^2/\text{year}$ ($68.6 \text{ ft}^2/\text{year}$) from the Asaoka (1978) method at Station 204+00 yields a degree of consolidation of less than 50% consolidation, which helps explain the slope failure and low mobilized undrained shear strength of the foundation soils at the time of failure.
