# Closure to the Discussions of:

## “CASE STUDY: OSO Landslide of 22 March 2014 — Material Properties and Failure Mechanism” by

Timothy D. Stark<sup>1</sup>, Ahmed K. Baghdady<sup>2</sup>, Oldrich Hungr<sup>3</sup>, and Jordan Aaron<sup>4</sup>

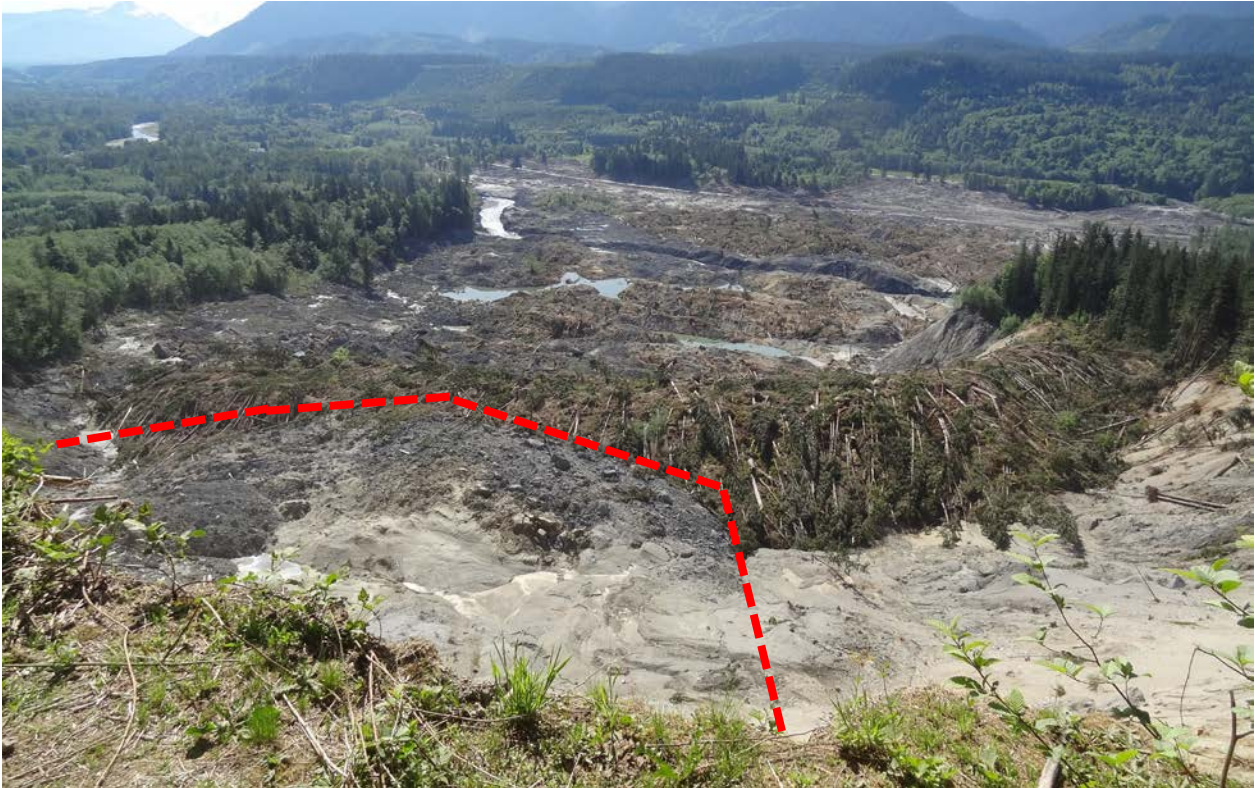
18  
19 **Figure 1: Photograph on 22 May 2014 from headscarp looking down on small debris**  
20 **avalanche cited by the Iverson Discussion (see dashed red line) as cause of**  
21 **second 22 March 2014 recorded ground motion. (Photograph by T.D. Stark;**  
22 **DSC09275.jpg)**

114 glacial till in the upper portion of the slope (see **Figure 2**) and unsaturated varved silts and clays  
115 of the advanced glaciolacustrine deposit in the lower portion of the slope. More importantly, the  
116 undisturbed native soils involved in the slide are glacially overconsolidated, unsaturated, and not  
117 statically liquefiable as required by the D-claw analysis. Only the pre-existing, disturbed, and  
118 water filled colluvium along the slope toe was susceptible to a significant undrained strength loss  
119 and exhibited liquefiable or flow behavior during the 2014 landslide. The unsaturated materials  
120 remained frictional in strength (see **Figures 1 and 2**).

123 The Iverson et al. (2015) single-phase mechanism requires the low elevation and high  
124 elevation stages of their single-phase landslide to occur within the first recorded ground motion,  
125 i.e., about two minutes duration, even though both recorded ground motions on 22 March 2014  
126 are of similar magnitude and duration (see **Figure 3**). The two recorded ground motions on 22  
127 March 2014 are separated by about two minutes, which would mean no small debris avalanches  
128 occurred until two minutes after the single-phase event postulated by Iverson. This also means  
129 there would only be one small debris avalanche from the nearly vertical headscarp after the single-  
130 phase event because no other similar ground motions have been recorded since the Oso landslide.  
131 The writers find this to be unlikely because there were small avalanches still occurring during the  
132 first writers' site visit about two months after the slide on 22 May 2014 (see **Figures 1 and 2**).

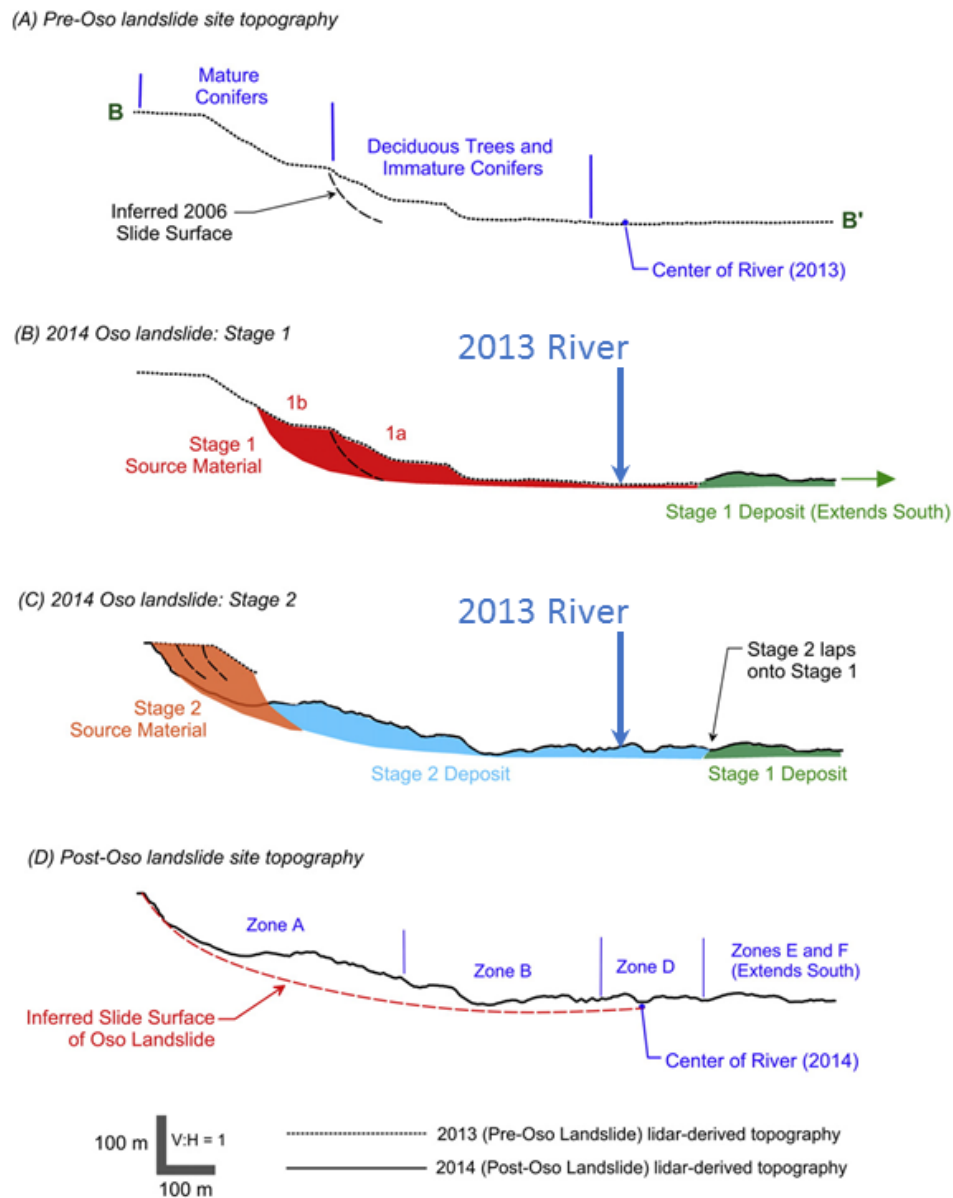
268 **Figure 5: Hypothesized failure mechanism from Wartman et al. (2016) (image courtesy**  
 269 **of Journal of Geomorphology).**

247 Keaton et al. (2014) revised their deep-seated circular failure mechanism in **Figure 4** to a  
248 more similar failure mechanism as Stark et al. (2017) in Wartman et al. (2016) (see **Figure 5**).  
249 Comparing the revised hypothetical failure surfaces in **Figure 5** with Figure 9 of Stark et al. (2017)  
250 shows there are still significant differences between the revised schematic failure mechanism in  
251 Wartman et al. (2016) and the Stark et al. (2017) schematic failure mechanism, some of which are  
252 briefly summarized below:

- 253 • Wartman et al. (2016) now use a three (3) stage failure mechanism instead of a two  
254 (2) stage mechanism as in Stark et al. (2017).
- 255 • The Wartman et al. (2016) failure surfaces are still much deeper, about 50 m deeper,  
256 than the Stark et al. (2017) Phase I failure surface, which does not comport with the  
257 Phase I slide mass impacting the water-filled colluvium and causing a large  
258 undrained strength loss.
- 259 • Stage 1a in Wartman et al. (2016) is shallower than in Keaton et al. (2014) and may  
260 be able to disturb some of the water filled colluvium along the slope toe and cause

261 an undrained strength loss as proposed by Stark et al. (2017), which is a key  
 262 difference between the Keaton et al. (2014) and Wartman et al. (2016) failure  
 263 mechanisms. However, the Stage 1a slide mass still appears to be deep-seated and  
 264 located in the dense sands and gravels of the Olympia Formation, which is unlikely  
 265 as described above.

- 271 • For the Wartman et al. (2016) mechanism to be similar to the writers' mechanism,  
272 the bottom of the Stage 1b failure surface would have to be higher so it can daylight  
273 near the top of the Stage 1a slide mass and thus generate less shear resistance and  
274 also override a portion of the Stage 1a slide mass. **Figure 5** shows the Stage 1b  
275 failure surface also passes through the dense sands and gravels of the Olympia  
276 Formation, which makes it difficult for a portion of Stage 1b to override Stage 1a  
277 because it is well below the ground surface.
