Slope and Settlement Movements of an MSW Landfill during Elevated Temperatures

Navid H. Jafari¹ and Timothy D. Stark²

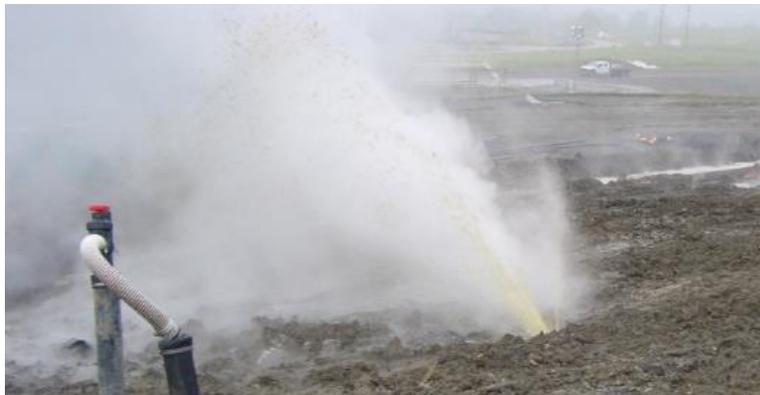
FIG. 2 Leachate outbreak of 2 to 4 m at MSW landfill side slope (photo courtesy of Ohio EPA)

When gas and leachate migrate to landfill side slope and are impeded by the cover system (soil or geomembrane), gas pressures and leachate can accumulate and cause leachate outbreaks. The elevated leachate and gas pressures occasionally manifest as “leachate geysers” (Fig. 2) and can eject 9 to 11 m into the air (Stark et al. 2012). These leachate geysers also can be encountered when borings are drilled in the waste for gas wells or exploratory purposes. In some instances, the soil cover system is replaced with a geomembrane to control odors. Although the liner encapsulates the surface, outbreaks can still occur at seams and gas wellhead connections.
