## Minnesota geomembrane durability study

August 1st, 2016 / By: Timothy D. Stark (<http://geosyntheticsmagazine.com/writer/timothy-d-stark/>) / News (<http://geosyntheticsmagazine.com/category/news/>), Updates (<http://geosyntheticsmagazine.com/category/news/updates/>)

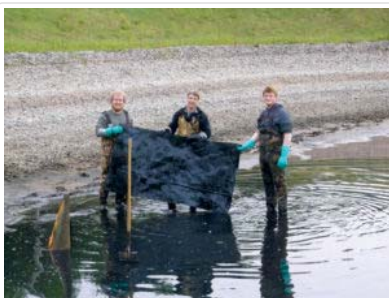
Steve Koski (L) and Austin Dusek (R), both with the Minnesota DNR, and Prof. Tim Stark (center), University of Illinois, holding one of the geomembrane samples cut from the longer sample that still remains on the bottom of the sedimentation basin under 6 inches of sand cover. This sample was delivered to the UIUC labs

for testing. Photo by Zach Wenz,  
Minnesota DNR

Geomembrane samples were previously collected after years 2, 4, 5, and 10 in the basin. On May 25, 2016, the 20-year samples were retrieved by the author. Samples are being tested at the FGI's laboratory at the University of Illinois at Urbana-Champaign (UIUC).

Additional sample cutting is planned for the 25- and 30-year marks. Tests are conducted using in situ water content and desiccated specimens and include tensile properties, tear resistance, low temperature/brittleness temperature, dimensional stability, water extraction, and volatile loss. The resulting properties are compared to the initial material specification to quantify any changes in the engineering properties over 20 years.
