Morro Reservoir Rehabilitation Project

by Timothy D. Stark, Ph.D., P.E., D.GE, F.ASCE; Douglas Hiltz, S.E. & Jennifer Miller, M.S.

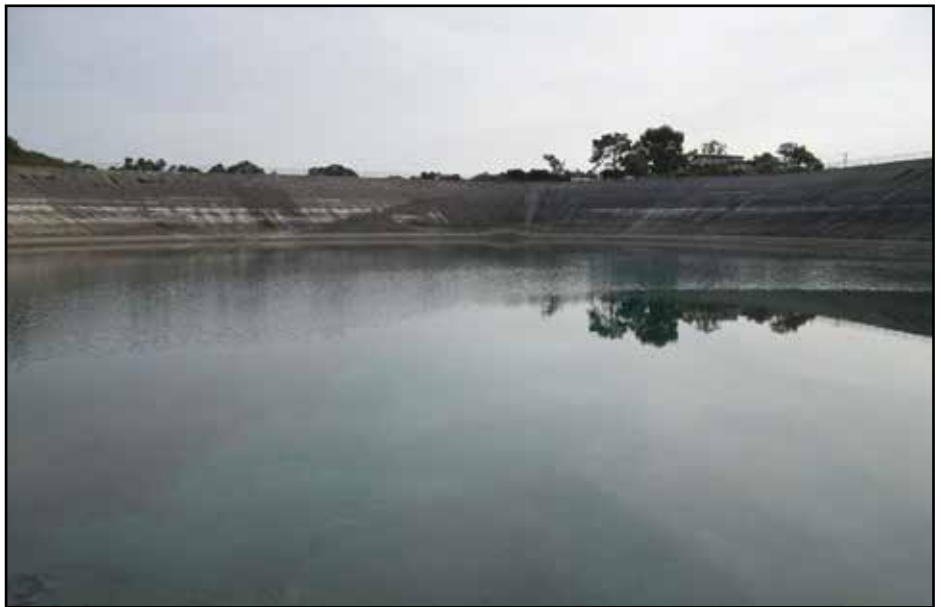
Reservoir in service draining prior to project.

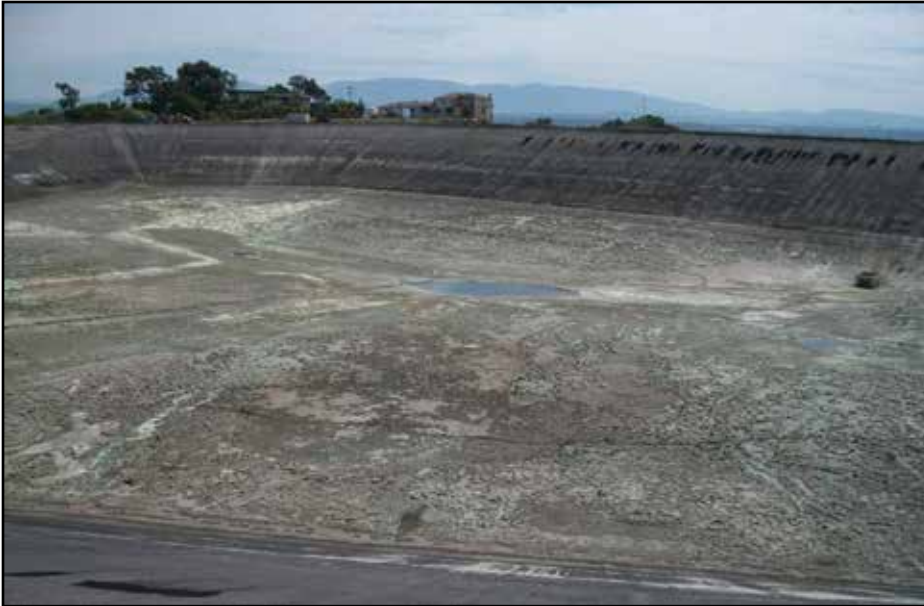
Figure 1. Reservoir drained immediately prior to starting construction.

cess. Prior to the recent improvements, the upper portions of the hydraulic asphalt concrete (HAC) lining system had weathered and cracked due to age and exposure (see Figure 1). Significant leakage through the leak collection system under the HAC lining system was reported at higher water surface levels, which limited reservoir operations and storage.

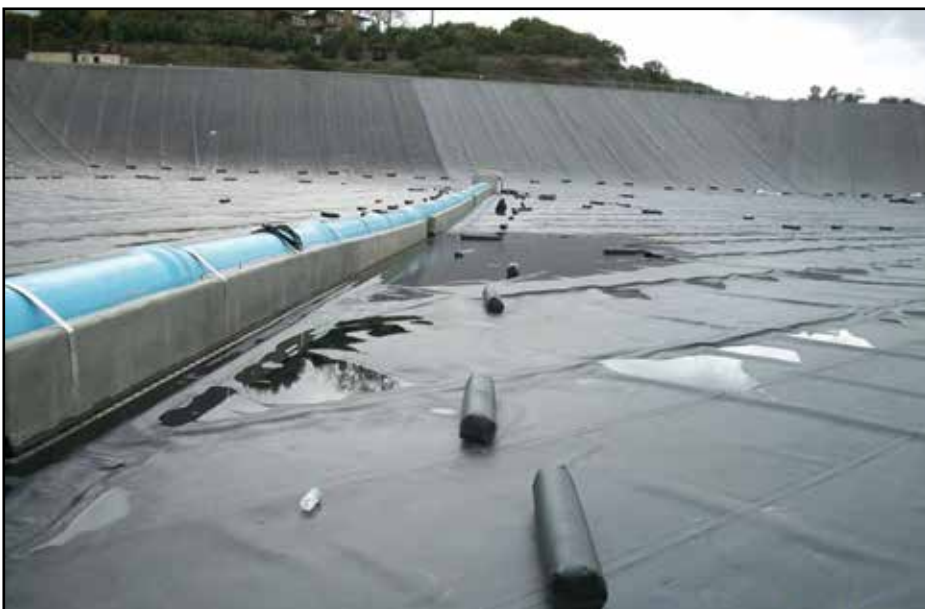
Figure 2. Geomembrane liner and inlet pipe extension during construction.

From 2010 through 2012, the reservoir underwent a major rehabilitation project which included a new composite geosynthetic liner system (see Figure 2) and a floating cover (see Figure 3) to protect the potable water. A washwater system was also provided to enable cleaning of the floating cover. The washwater system includes a trailer mounted booster pump system, connection point to onsite tank, buried PVC piping around the reservoir, and warf heads spaced around the reservoir perimeter. A gravity drain system consist-

membrane liner was installed to reduce/minimize seepage into soils below reservoir, eliminate possible exchange between potable water and groundwater, and preserve water quality. The new composite geosynthetic liner system was installed on the reservoir floor and side slopes to maximize the allowable reservoir drawdown rate and provide the most operational flexibility. To allow for the most operational fluctuations drawdown, a leak collection system was installed below the new geomembrane liner system to convey leakage water away from

The reservoir composite geomembrane liner system includes a Chlorosulfonated Polyethylene (CSPE) geomembrane liner manufactured by Burke Industries. The geomembrane component of the liner system is a 60-mil, 5-ply CSPE geomembrane. The liner is anchored to underwater structures with stainless steel anchors and stainless steel batten bars. The liner termi-

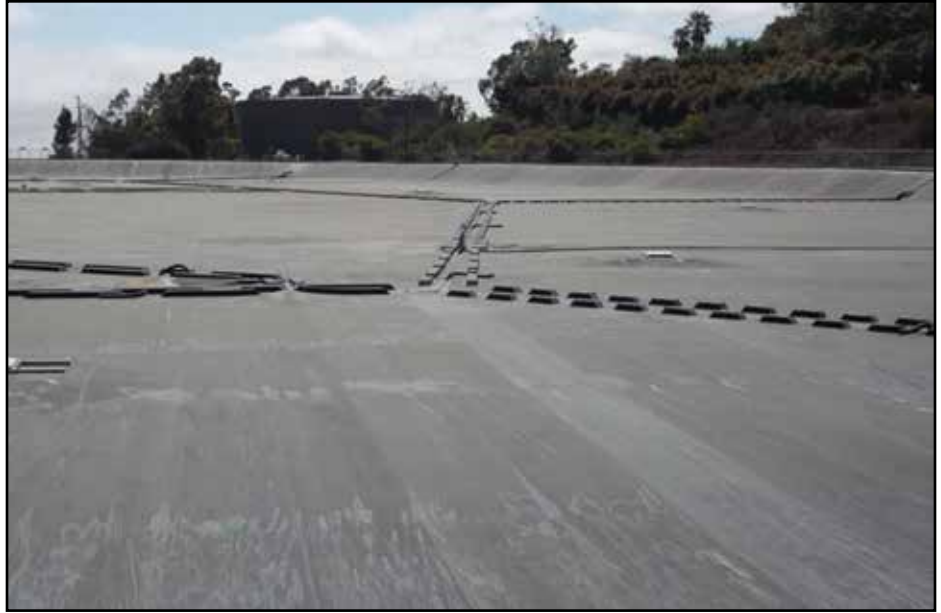
Figure 3. Floating cover rainwater collection troughs in service.

A new concrete curb was constructed along the reservoir perimeter (see Figure 3) inboard of the reservoir perimeter road to prevent site water from flowing into the reservoir and provided a means to anchor the new composite geomembrane liner system and floating cover system at the reservoir top of slope. The composite geo-

The rainwater removal system was designed in accordance with AWWA California-Nevada section Reservoir Floating Cover Guidelines and site specific rainfall criteria. The rainwater removal system consists of four submersible pumps located in

the rainwater removal troughs. The pumps discharge hoses are laid on the floating cover and routed to gravity drain collection points located at the top of slope.
