Protecting geomembranes from animal damage

By Andrew Mills and Timothy D. Stark

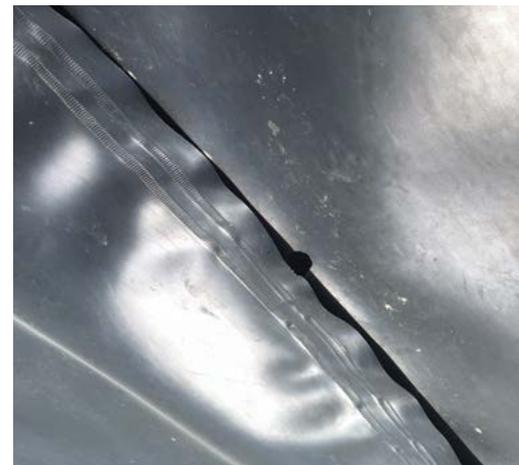
FIGURE 1 Close-up of damage to PVC geomembrane from deer hooves

Resisting animal and insect attacks on geomembranes is an interesting problem. Geomembrane installers and manufacturers have had numerous geomembranes damaged by bears, deer, coyotes, birds, beavers, and ground squirrels (Figures 1 and 2). In most cases, the damage is incidental to something else the animal is seeking. Deer damage the liner with their hooves trying to climb out. Bears dig through the liner to try and find something on the other side (organic matter left under a liner in a retrofit, for example). Coyotes burrow under the liner on slopes to create a den that doesn't freeze.

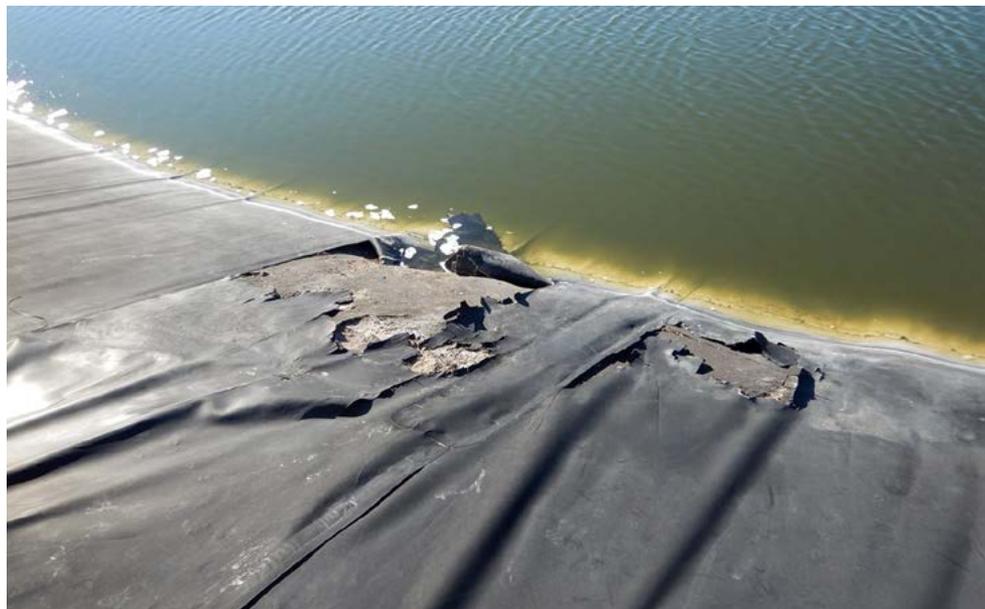
FIGURE 2 Beaver damage to geomembrane liner
