NON-INVASIVE MONITORING OF TRACK SYSTEM GAPS

H.B. Thompson II
Federal Rail Administration
Washington D.C

T.R. Sussmann, Jr.
University of Hartford and
John A. Volpe Transportation Center
Cambridge, MA

T.D. Stark and S.T. Wilk
University of Illinois at Urbana-Champaign
Urbana, IL

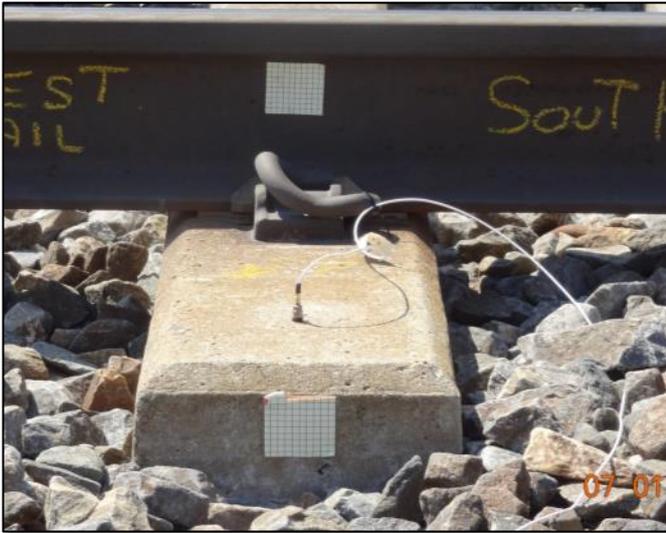
Figure 2: Photograph of a miniature accelerometer installed on a concrete tie

Usually eight (8) accelerometers are installed to non-invasively monitor track performance over a certain track length. Being only 13 mm long (one half inch), weighing less than 3 grams (0.1 ounces), and requiring only a drop of superglue to bond to the tie, these accelerometers result in a quick and non-invasive monitoring system that does not interfere with train operations (see Figure 2). This makes accelerometers suitable for short-term monitoring, i.e., a single train pass or day, as well as long-term monitoring during wet and inclement weather conditions because weather resistant accelerometers are available.

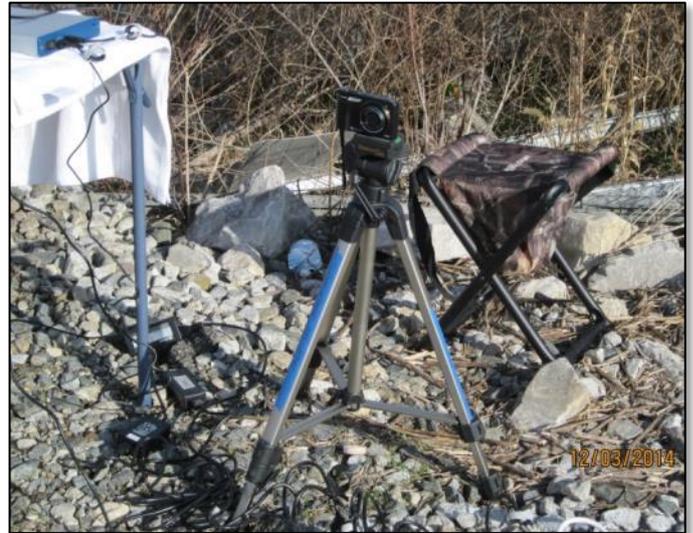
Figure 3: Photograph of the high-speed video camera

Transient time histories of the rail and tie also are important for estimating the rail-tie and tie-ballast gaps and can be non-invasively measured using high-speed video cameras, see Figure 3. High-speed video cameras were selected because of the mobility of the video cameras, the only required contact with the track system is the placing removable markers on the rail and tie, and the recorded video provides a visual account of track movement. The cameras typically record at a frequency of 240 frames per second and are capable up to 1000 frames per second which is enough to capture and quantify the track movement even for high-speed passenger trains.

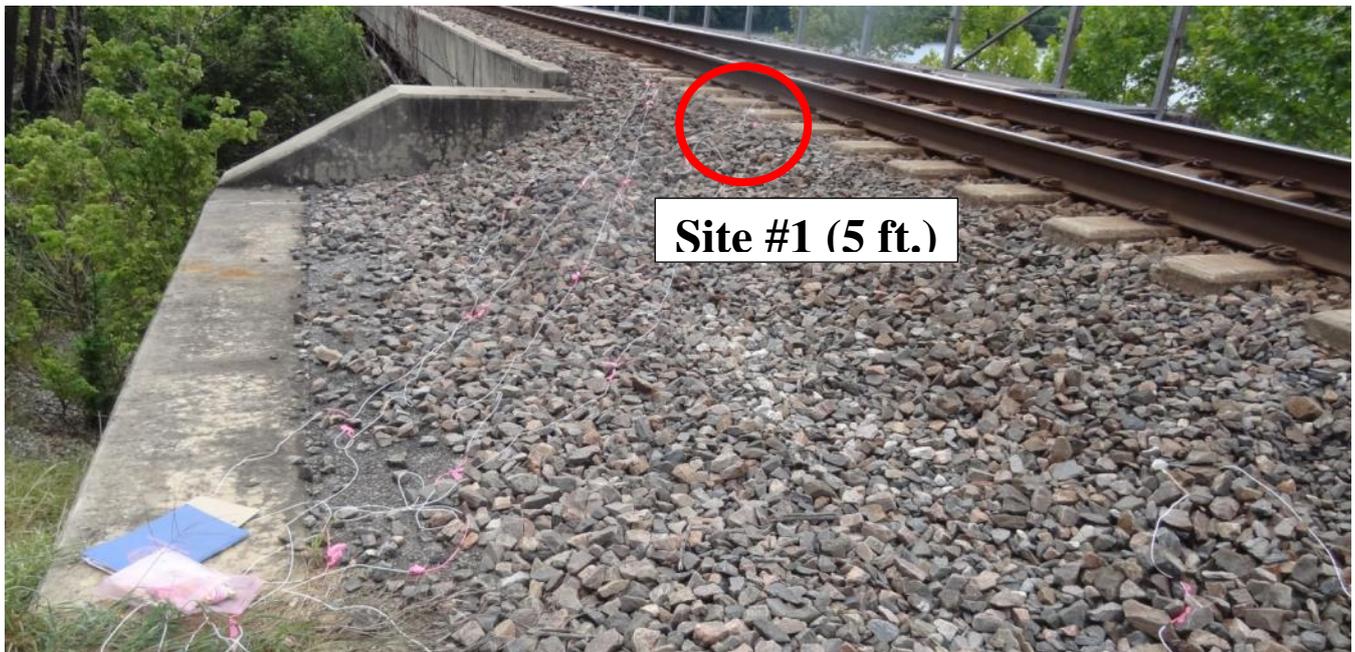
Figure 4: Photograph of the east end bridge transition zone at Site #1.

The instrumented site involves the east end of a railway bridge transition in the United States. The track is considered Class 3 for operations and traffic consists of both loaded and unloaded freight trains moving at about 40 km/hr (25 mph). Since construction in 1998, the track has been performing well with no required maintenance (Rose, 2013). This lack of maintenance is attributed to the combination of: (1) a ballasted bridge deck, (2) a parallel concrete wing wall that extends 9 ties (17 ft.) on the south side of the track (not included on the north side), and (3) an HMA layer underneath the ballast. These three design techniques are shown in Figure 4 and help reduce the differential transient and permanent vertical displacements between the bridge and transition zone as illustrated by the recorded acceleration time histories. This lack of differential movement helps prevent the development of significant tie-ballast gaps and substructure settlement in the transition zone, which can result in high applied loads within the track system.

Instrumentation occurred on 28 July 2014 and involved the installation of eight accelerometers with six of the accelerometers installed on the opposite ends of three concrete ties. The first concrete tie was located on the bridge, the second tie located 1.5 m (5 ft.) from the bridge abutment in the transition zone, and the third tie located 6 m (20 ft.) from the bridge abutment near the open track. The transition zone tie location (1.5 m/5 ft.) was selected because despite the overall good behavior of the transition zone, a single poorly supported tie was identified 1.5 m from the bridge abutment. The open track tie 6 m (20 ft.) from the bridge abutment was selected because it was well supported and could be used for comparison purposes. Due to space constraints, only the results of the accelerometers installed on the south end of the concrete ties at 1.5 m (5 ft.) and 6 m (20 ft.) from the bridge abutment are presented herein. These locations will be referred to a Site #1 (5 ft.) and Site #1 (20 ft.), respectively.
