RESEARCHERS SURVEY RATTLESNAKE RIDGE LANDSLIDE

📅 Mar 15, 2018

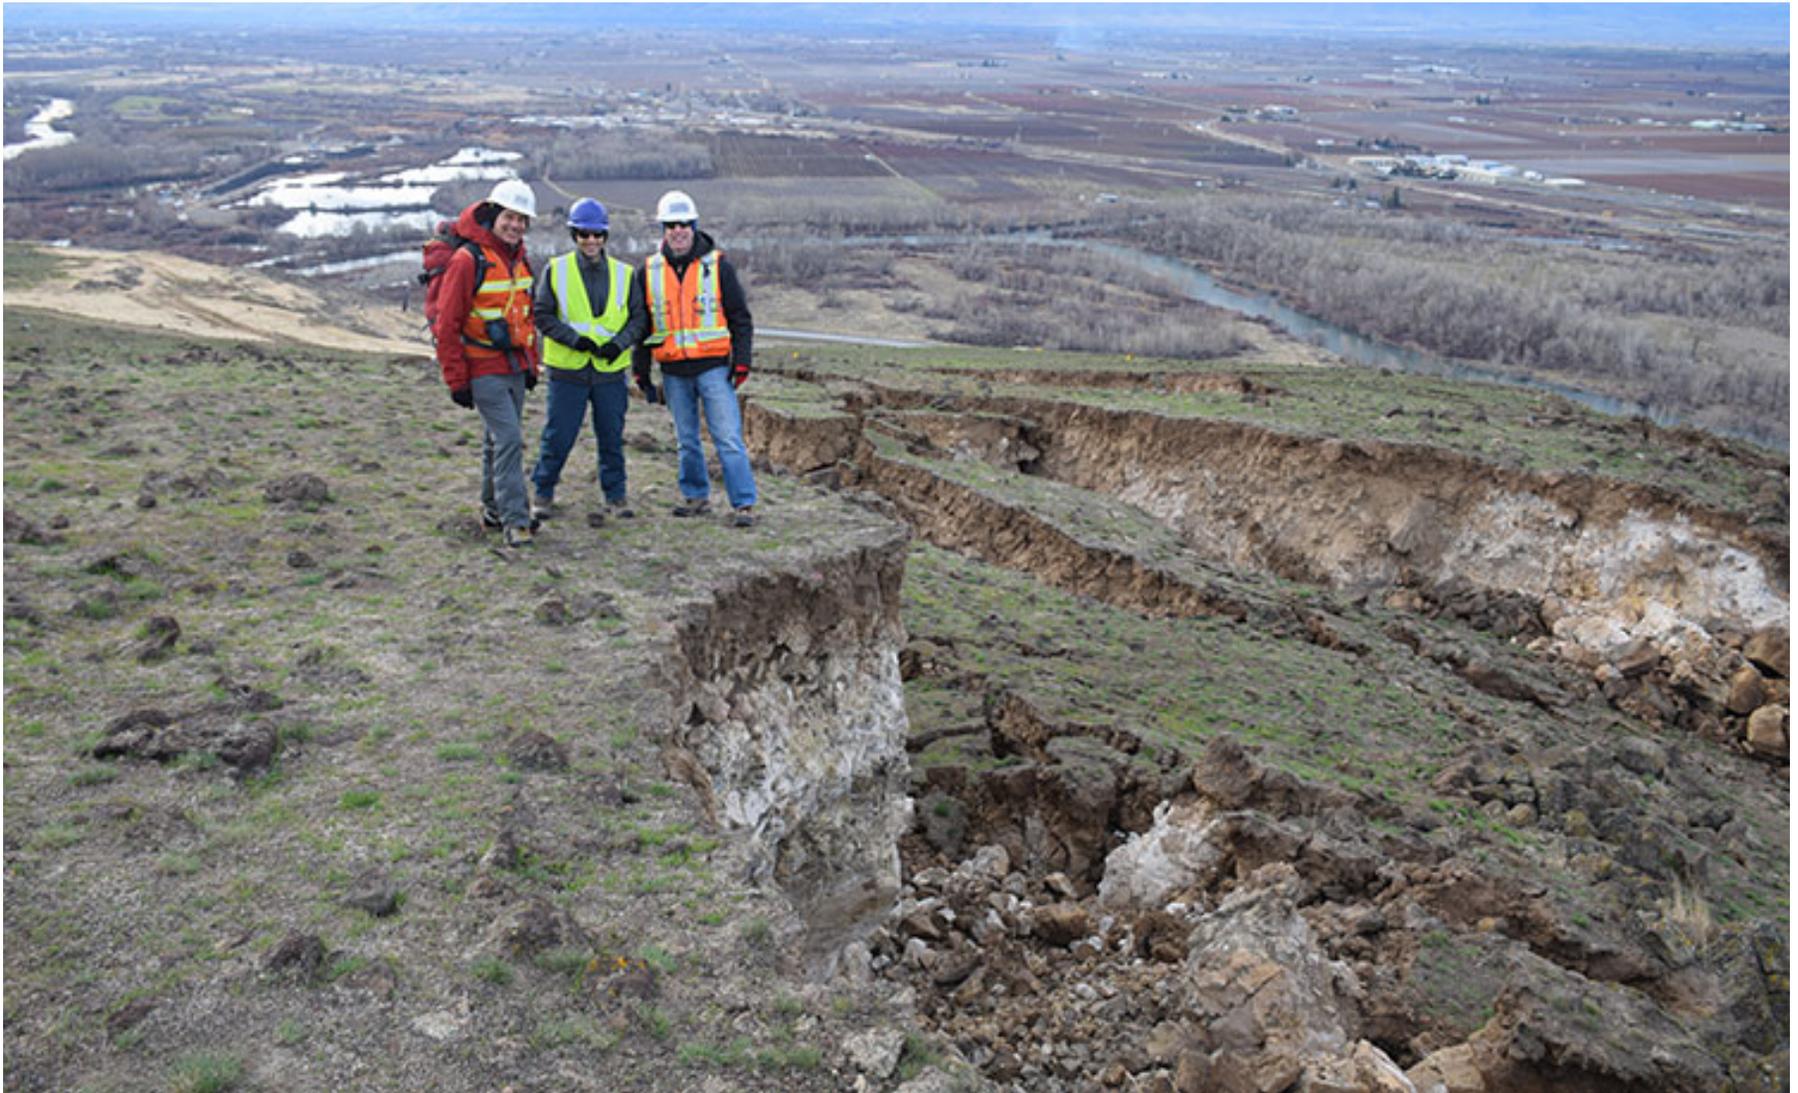
Above: Chris Robertson (left), Navid H. Jafari (center) and Timothy D. Stark observe tension cracks along the scarp and graben of the massive Rattlesnake Ridge Landslide near Yakima, Wash.

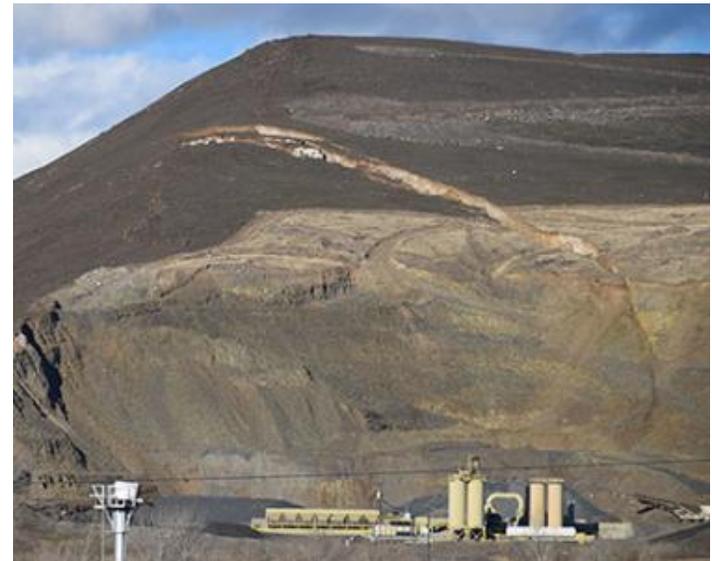
The landslide became apparent in October 2017 when cracks were noticed along the ridgeline, located above a nearby quarry. The slow-moving slide has an estimated volume in excess of 5.2 million cubic yards affecting 20 acres of the hillside. Measurements indicate that the slide has moved more than 25 feet since monitoring began and continues to move at a rate of approximately 1.7 feet per week, primarily towards the quarry.

(/sites/default/files/RattlesnakeRidge_Fig01_crop.jpg)
The cracks above the quarry equipment are clearly visible from a distance.

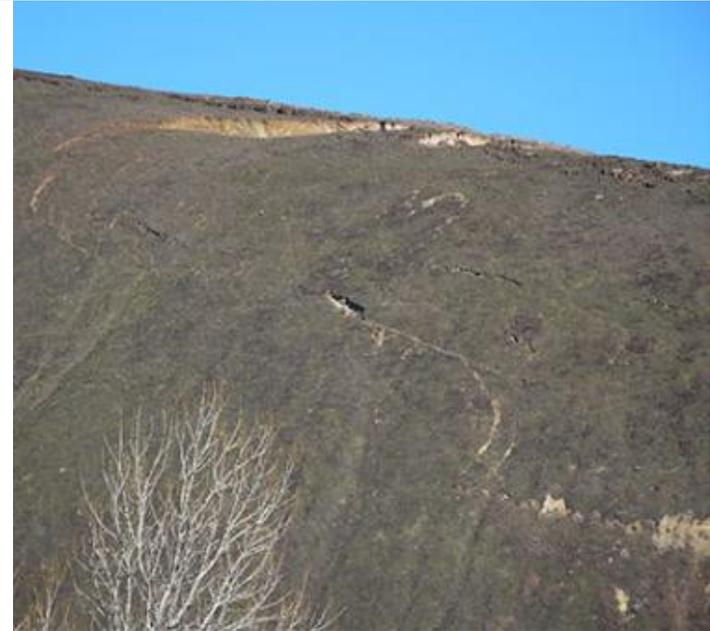
“The stepped failure surface is unusual because typically the failure surface will follow a weak layer and then cuts steeply through the stronger overlying materials to reduce the shear resistance.” Stark said. “However, this shear surface jumped upslope until it located another weak layer and traversed the slope at a relatively flat angle until it cut upslope to the scarp.”

Stark said these features suggest that strong three-dimensional (3-D) effects are impacting the shape, direction and failure surface geometry of the landslide.

*(/sites/default/files/RattlesnakeRidge_Fig04.jpg)
The complex failure surface extends upslope from the quarry in a fairly linear fashion, then abruptly turns upslope to another weak layer until it reaches the scarp at the top of the slope.*

Stark plans to use the landslide as part of a research project on 3-D slope stability (https://www.nsf.gov/awardsearch/showAward?AWD_ID=1562010&HistoricalAwards=false) funded by the National Science Foundation. The collected samples will be tested to measure the fully softened and residual shear strengths for use in 2-D and 3-D slope stability analyses.
