Displacement analysis of a landslide

ABSTRACT: An analysis procedure for calculating displacement of a landslide is presented. The proposed procedure is based on continuum-mechanics principles and can be used to calculate: (a) factor-of-safety against the onset of failure, and (b) potential displacements of the slide mass after the onset of failure. The proposed procedure is used to calculate displacements of a landslide in the hills surrounding a reservoir. The calculated displacements compare favorably with the field measurements.

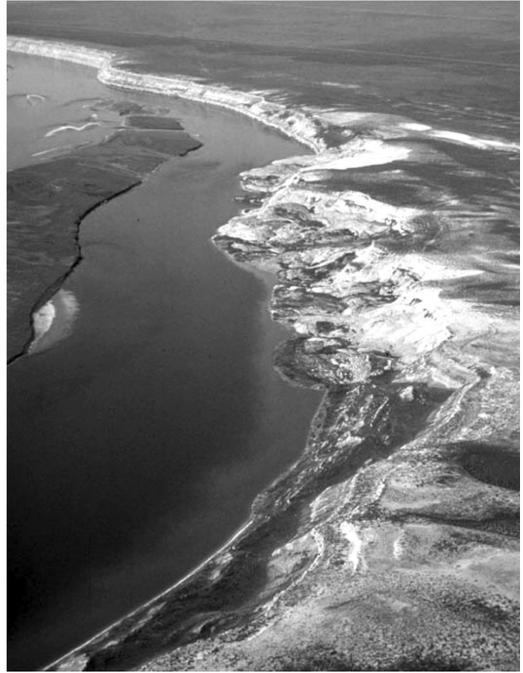
Locke Island landslide, 1985 view, looking northwest. (Locke Island is at far left).

The proposed procedure has also been used successfully in studying stability and deformation of the Locke Island landslide in South-central Washington State (Chugh & Schuster 2003). The Locke island landslide (a group of interconnected individual landslides) with an estimated volume of 20 million cubic meter of displaced material is the largest of a group of landslides in the 30-mile-long White Bluffs area along the northeast bank of the Columbia River in South-central Washington State. Early 1980s estimate

on magnitude of movement at the toe of individual landslides was in terms of one-third of the way (≈ 150 m) across the northeast channel of the river; by 2002, this distance had increased to about 200 m. Using the procedures presented in the paper, Chugh & Schuster (2003) were able to confirm instability where failures had occurred in the field and stability where failures had not occurred in the field; and the computed displacement results compared favorably with the field observations. It was an interesting/challenging application of the proposed procedure to a complex landslide.

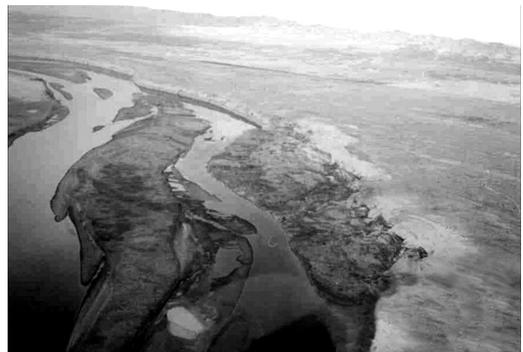
Locke Island landslide, 2001 view, looking northwest. (Locke Island is at left-center).
