# Reanalysis of a municipal landfill slope failure near Cincinnati, Ohio, USA

Ashok K. Chugh, Timothy D. Stark, and Kees A. DeJong

**Abstract:** The March 1996 slope failure in a municipal solid waste landfill near Cincinnati, Ohio, USA, is reanalyzed using continuum-mechanics-based procedures implemented in the computer programs FLAC and FLAC3D. A failure mechanism, based on the field observations of the failure, is used for the analyses. The failure mechanism is also implemented in a limit-equilibrium-based slope stability analysis computer program, SSTAB2, to simulate the observed translational character of the failure. The reanalysis results (failure surface, factor-of-safety (FoS), and displacement) from the continuum models are in general agreement with the field data. The FoS values from SSTAB2, FLAC, and FLAC3D range in the expected order. Overall, the reanalysis results supplement previously reported failure analyses. This paper serves two functions: (1) it documents the results of reanalysis using a different (from the previously published) failure mechanism hypothesis for the 1996 landfill slope failure near Cincinnati, Ohio; and (2) it demonstrates the use of 2-D and

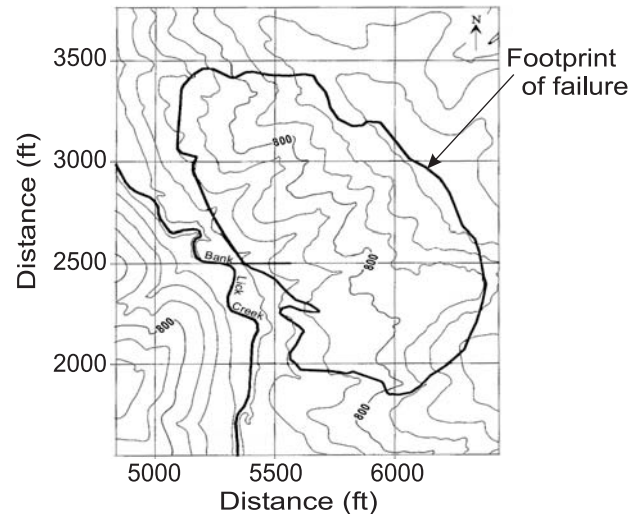
**Fig. 2.** Contour maps of the landfill site with footprint of failure superimposed (contour interval: 20 ft; 1 ft = 0.30 m).

(a) Prior to the placement of landfill (1940s)

(b) Prior to the slope failure (1996)

(c) After the slope failure (1996)

Figure 2 shows the site contour maps of the landfill site: (i) prior to commencement of the landfill in the 1940s; (ii) prior to the wasteslide in 1996 including the deep excavation below the toe of the landfill (for lateral expansion of the facility and increased air space); and (iii) after the landfill failure.

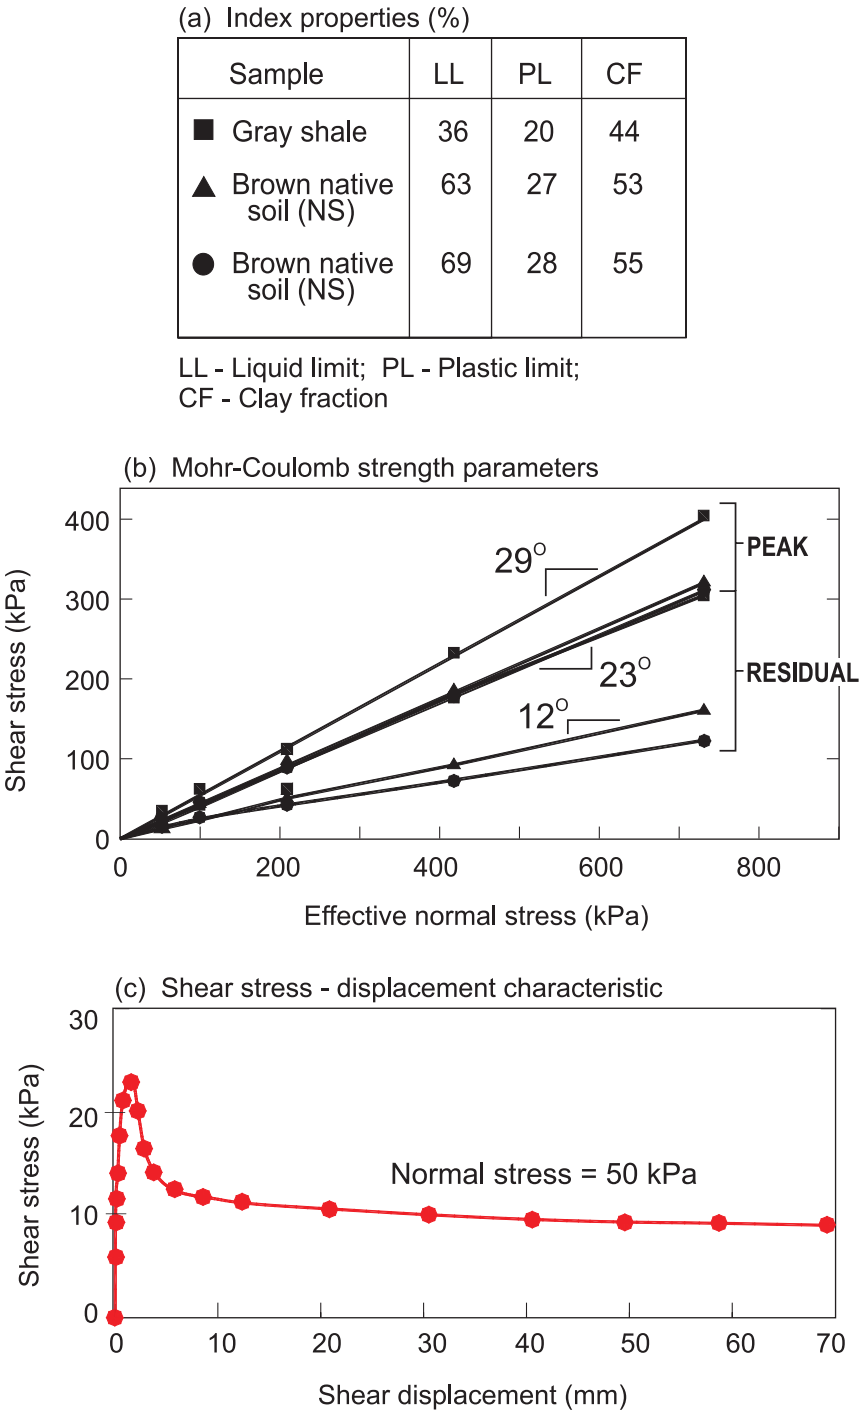
**Fig. 3.** Laboratory test data on the brown native soil (NS) and gray shale at the landfill site (Eid et al. 2000, reproduced with permission of ASCE).

From large-scale laboratory and field tests results and back-analysis of failed waste slopes, Eid et al. (2000) recommended the following material properties. For the MSW: density ( $\rho$ ) equal to  $1040 \text{ kg/m}^3$ , friction angle ( $\phi$ ) equal to  $35^\circ$ , and cohesion ( $c$ ) equal to  $4.0 \times 10^4 \text{ Pa}$ ; and for the brown native soil (NS):  $\rho = 2010 \text{ kg/m}^3$ ,  $\phi = 23^\circ$  (fully softened) and  $12^\circ$  (residual), and  $c = 0$ . Figure 3 shows a summary of the test data results.

- (5) From laboratory tests — The transition from peak to residual shear strength of the NS occurred in a brittle fashion, Fig. 3c.

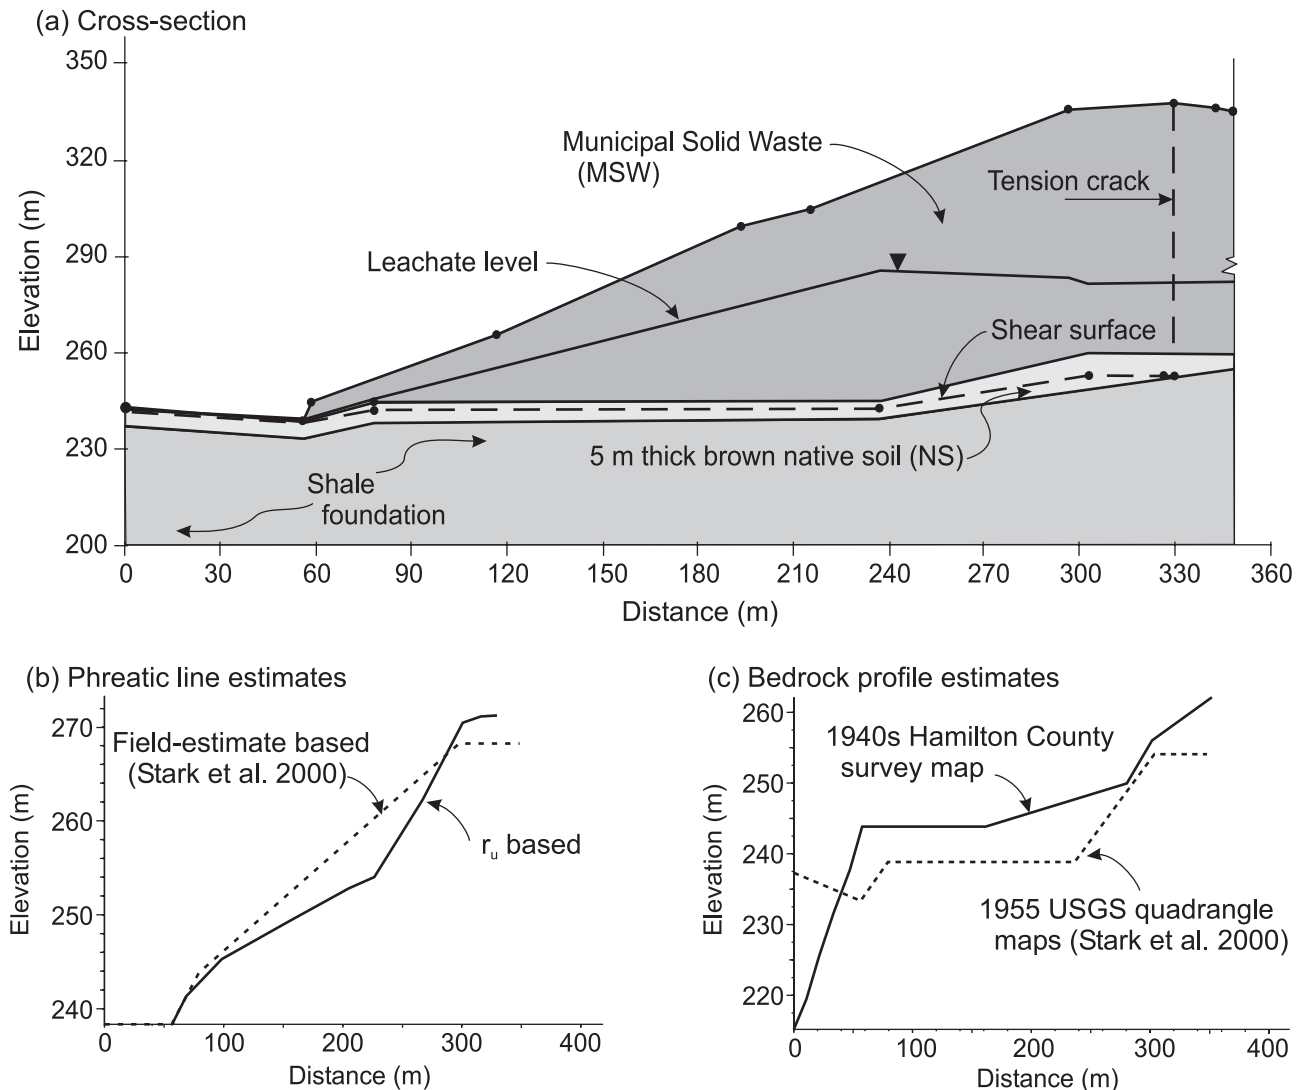
**Fig. 7.** 2-D limit-equilibrium model of the landfill at  $y \approx 138$  m for FoS calculations (typical).

Figure 7a shows a typical SSTAB2 model of the 10 cross-sections that participated in the 1996 wasteslide. This cross-section is located at  $y = 138 \text{ m}$  (Figs. 5 and 6). For each of the 10 cross-sections analyzed, the value of  $r_u$ , and (FoS,  $\delta$ )

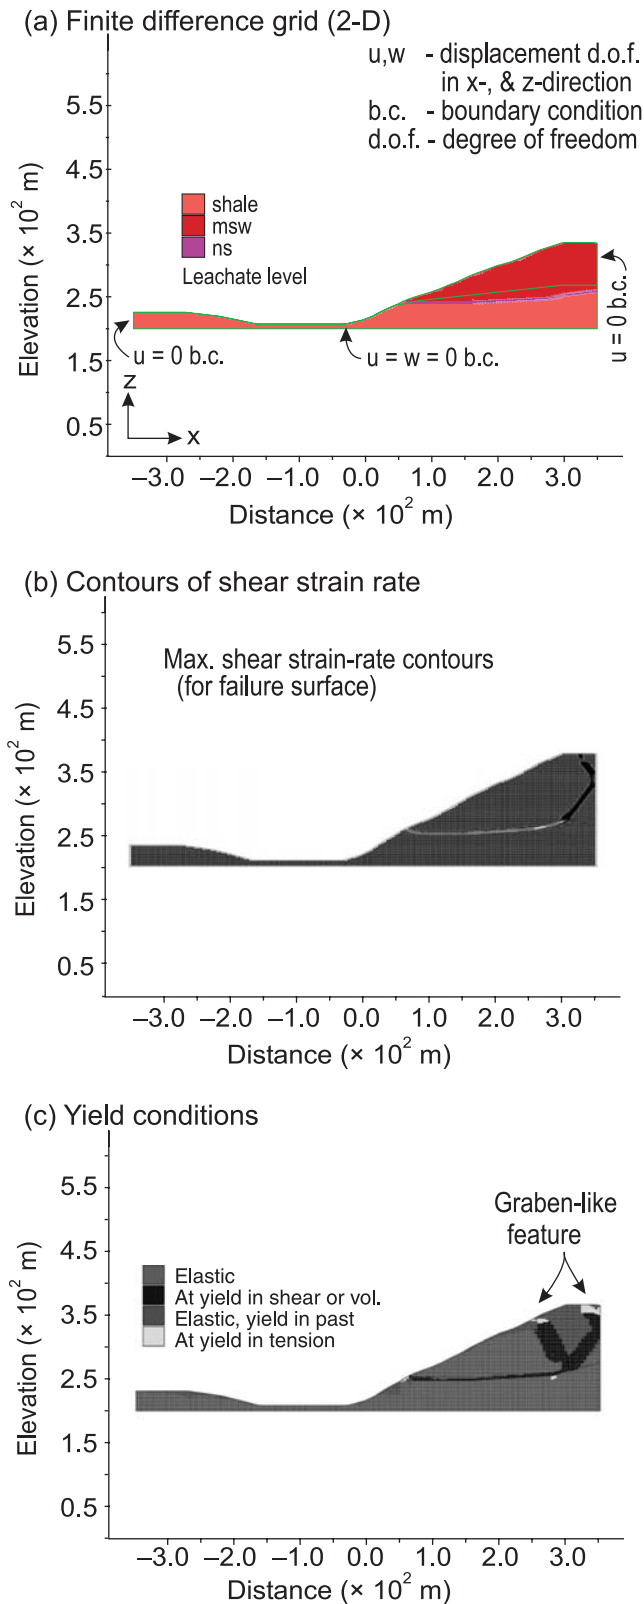
**Fig. 8.** 2-D continuum model of the landfill at  $y \approx 138$  m for FoS calculations.

Figure 8a shows a typical FLAC model of a cross-section of the landfill at  $y = 138 \text{ m}$  (Figs. 5 and 6), the associated leachate level, and the boundary conditions imposed; Fig. 8b shows the calculated shear surface location and geometry (steep path through the MSW and near level in the NS); Fig. 8c shows the computed elastic, yield in shear and tension state results (a graben-like feature appears). The shear strain-rate and elastic-plastic-tension state plots for each of the 10 participating cross-section locations are shown in Appendix A in Figs. A2 and A3, respectively. All of these results are encouraging as they compare favorably with the field observed shear surface geometry and the graben formation that formed on the day of the wasteslide. For each of the 10 cross-sections that participated in the wasteslide, the computed FoS results and comments on comparisons between computed and observed shear surface geometry and appearance of graben-like feature are included in Table 2. The FoS values are generally higher than those obtained using SSTAB2, and this is in accordance with the accepted trend that the simpler the solution procedure, the lower the computed FoS with all other variables being equal (this is in accord with the comment on FoS results using 2-D and 3-D slope stability analyses in Duncan 1996). In general, the computed location and geometry of the failure surface (steep head-scarp in the MSW and a near horizontal translational surface in the NS) and appearance of graben-like features compare well with the corresponding details of the landfill failure observed in the field.

0 boundary condition for the MSW (at the vertical boundary located at the far end of the  $x$ -axis, Fig. 8a) and apply the  $x$ -reaction values as nodal forces along the freed boundary; (v) solve for equilibrium to verify step (iv); (vi) reduce the friction angle,  $\phi$ , along the interface from  $12^\circ$  to  $11^\circ$ , solve for equilibrium within a maximum of 100 000 computational steps, and save the results; and (vii) repeat step (vi) by reducing the interface friction angle in steps of  $1^\circ$ . For each of the 10 cross-sections analyzed, the values of computed displacement at the toe and head of the slide mass corresponding to  $\phi = 6^\circ$  along the interface are shown in Table 2. For illustration, the displacement history at  $y = 138$  m cross-section is shown in Fig. 11a, and positions of the displaced mass are shown in Figs. 11b and 11c for  $\phi = 7^\circ$  (initiation of noticeable movement) and for  $\phi = 6^\circ$  (final displaced location), respectively. Similar plots of displaced mass configuration for  $\phi = 6^\circ$  with elastic-plastic-tension state at each of the 10 participating cross-section locations are shown in Appendix A, Fig. A6. The abrupt movement of the landfill (calculated in going from  $\phi = 7^\circ$  to  $\phi = 6^\circ$ ) is interpreted to be indicative of a brittle (sudden) failure and agrees well with the rapid rate of failure observed in the field and the brittle behavior of the NS observed in laboratory testing.

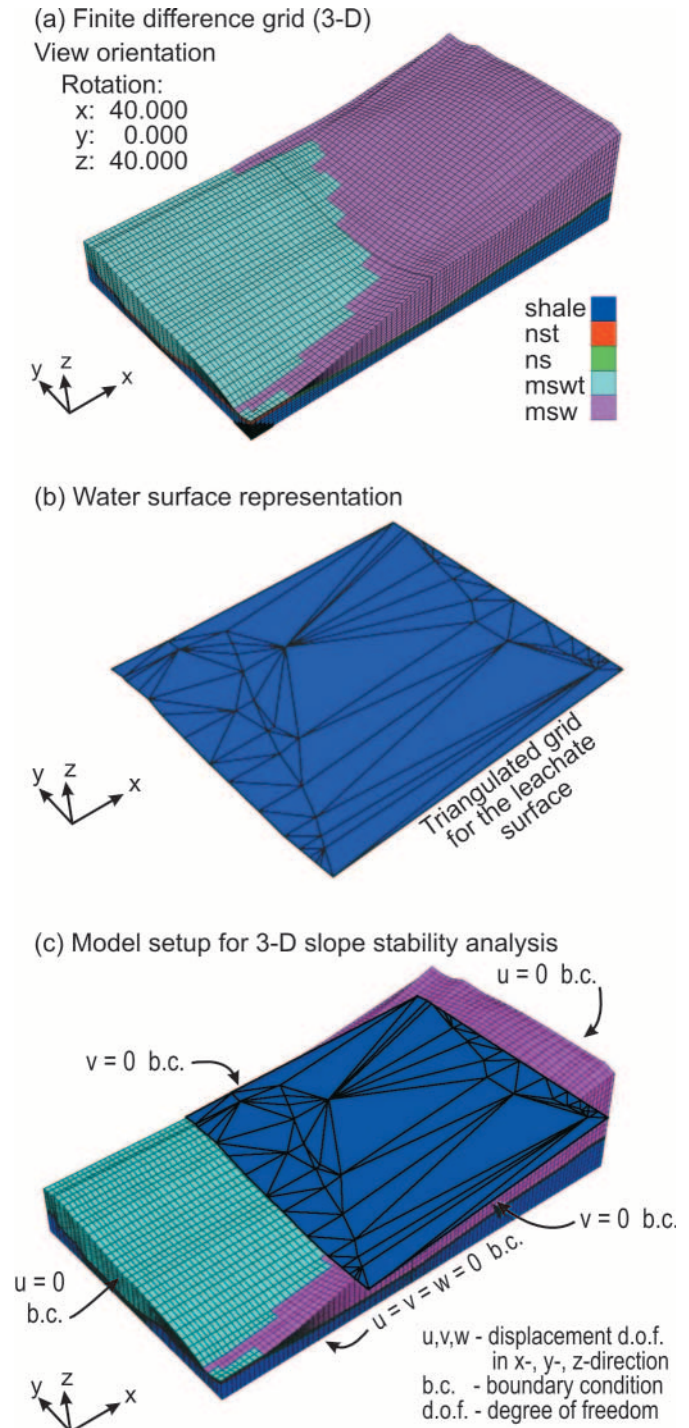
**Fig. 9.** 3-D continuum model for the landfill for FoS calculations. nst; artificial ns; ns, native soil; mswt, artificial msw; msw, municipal solid waste.

FLAC3D is a 3-D counterpart of the FLAC 2-D continuum-mechanics based procedure described above. Figure 9 shows the FLAC3D model of the waste slope, the boundary condi-

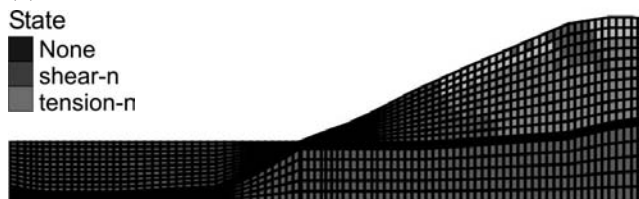
**Fig. 10.** 3-D slope stability results: at the cross-section location  $y \approx 138$  m (typical).

(a) Planar view of the 3-D model.

(b) Contours of shear strain rate

(c) Yield conditions

of the real MSW and NS at the toe are essentially level and are merging into a relatively steep (downward) and thick head-deposit of the artificial MSW overlying a thin layer of artificial NS in the deep excavation; see Fig. 10a. Thus, the failure in the real MSW and real NS is expected to complete itself in the level stretch of the NS as it happened in the field.

The computed FoS for the waste slope is 1.30 as shown in Table 2. For a NS friction angle of  $8^\circ$ , the 3-D continuum FoS is 1.03. Figure 10 shows the details of the 3-D analysis (model, and plots of shear strain-rate and plastic state) at an  $xz$  plane (vertical section) located at  $y = 138$  m (Figs. 5 and 6). In the 3-D model shown in Fig. 9a, the added MSW and NS in the excavation on the downslope side of the MSW are identified as mswt and nst, respectively. Once again, the shear surface geometry and graben-like features shown in Figs. 10b and 10c, respectively, agree well with the field observations. The shear strain-rate, and elastic-plastic-tension state plots for each of the 10 participating cross-section locations are shown in Appendix A in Figs. A4 and A5, respectively.

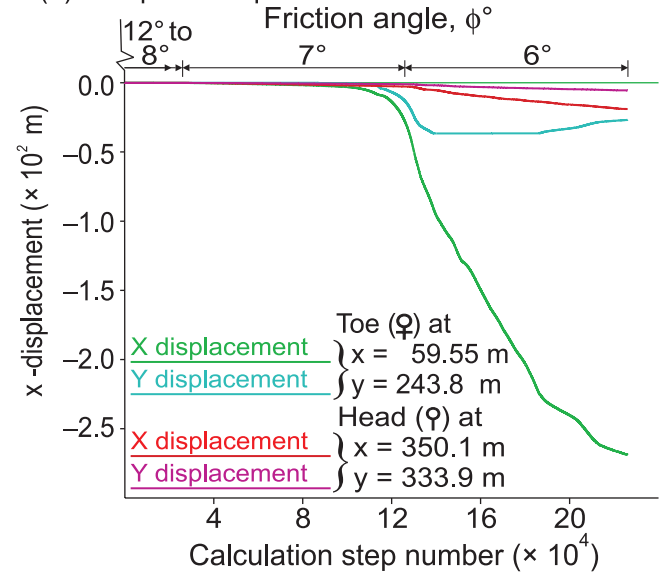
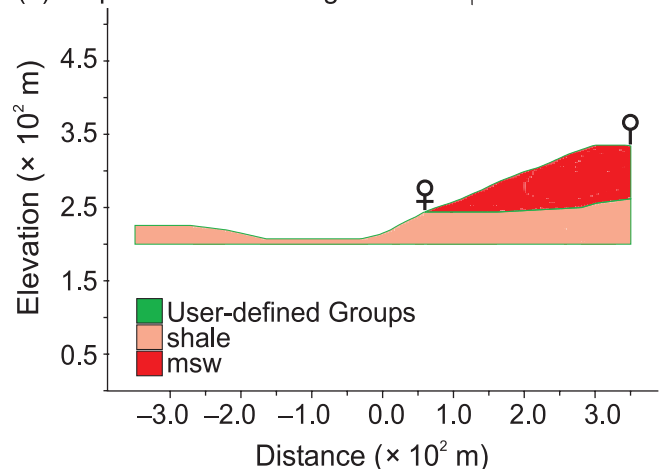
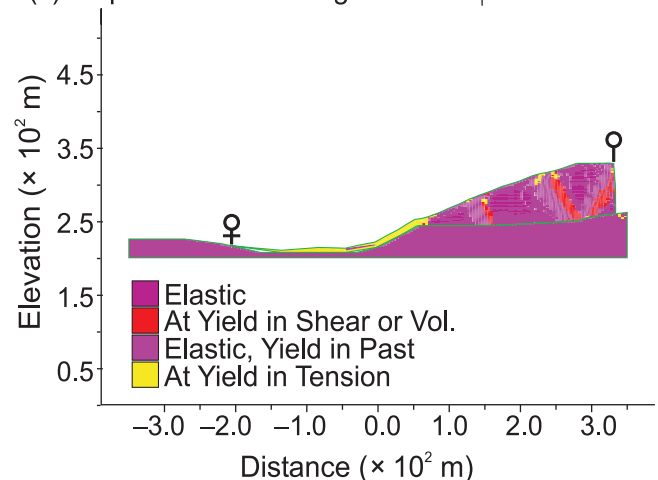
**Fig. 11.** Computed displacement for the cross-section at  $y \approx 138$  m (typical).

(a) Computed displacements

(b) Displaced mass configuration at  $\phi = 7^\circ$

(c) Displaced mass configuration at  $\phi = 6^\circ$

The maximum computed horizontal ( $x$ ) displacement occurs at the  $y = 138$  m location. The maximum nonzero computed vertical ( $z$ ) displacement occurs at the  $y = 164$  m location. At the  $y = 138$  m location, the  $x$ -displacement is 269 m, and the  $z$ -displacement is 27 m—the maximum  $x$ -displacement (at the toe) in the field is 263 m and the associated  $z$ -displacement is 30 m. At  $y = 164$  m location, the  $x$ - and  $z$ -displacements (at the head)

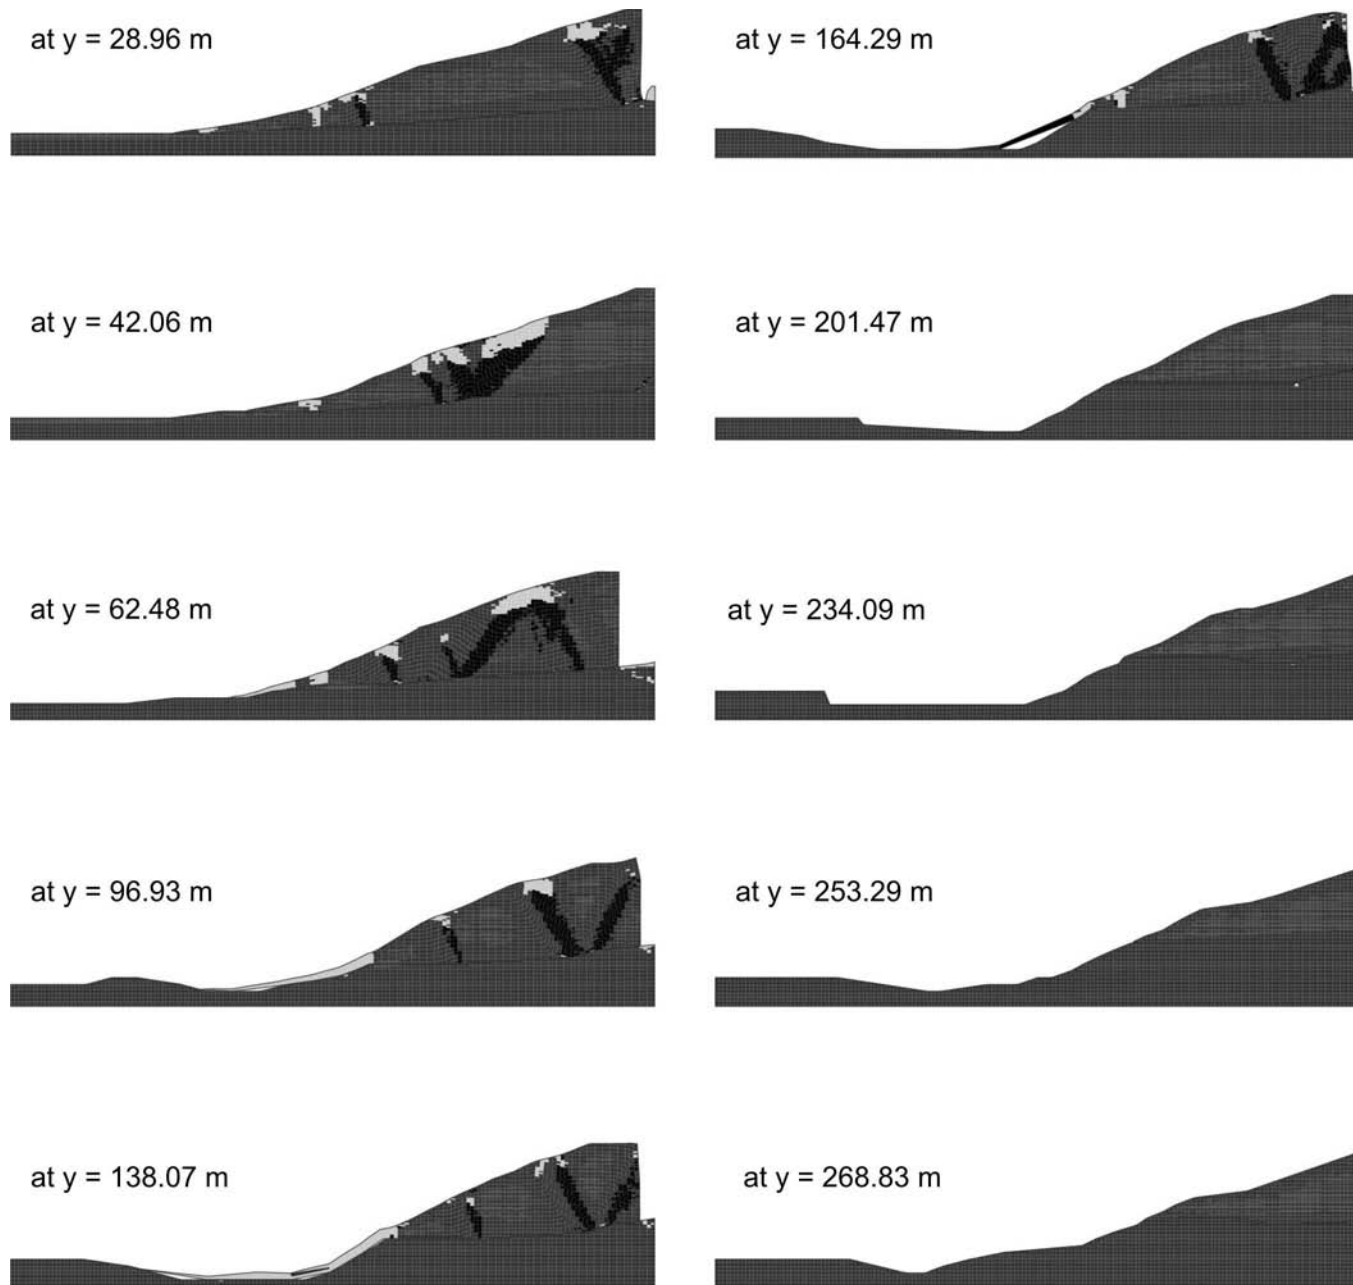
**Fig. A6.** 2-D continuum model results of displaced mass configuration at  $\phi = 6^\circ$ .
