# Design of a landfill final cover system

T. D. Stark<sup>1</sup> and E. J. Newman<sup>2</sup>

**REFERENCE:** Stark, T. D. & Newman, E. J. (2010). Design of a landfill final cover system. *Geosynthetics International* 17, No. 3, 124–131. [doi: 10.1680/gein.2010.17.3.124]

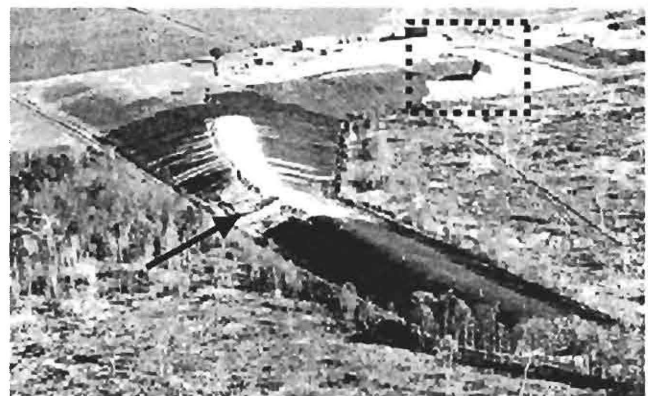
**Figure 4. Aerial view of panhandle and southwestern slope**

Before proceeding too far down the panhandle, a portion of the roadway slid to the north off the narrowest portion of the panhandle crest (see arrow in Figure 4). The slide movement clearly occurred at the geonet/PVC geomembrane interface (see Figure 5) because the overlying single-sided drainage composite tore (see Figure 6) and this left the PVC geomembrane exposed, and essentially undamaged, on the slope. The drainage composite tore because there was no constructed seam in the drainage composite near the crest of the slope where the tensile forces were the highest.

The contractor started placing cover soil from the bottom to the top of the south slope. As fill was being placed up the south slope, tension started developing in the single-sided drainage composite at the top of the landfill. This tension manifested itself by failure of some of the plastic ties holding the panels of the drainage composite together and exposing the PVC geomembrane. As a result, soil placement did not reach the top of the south slope before the drainage composite started pulling apart (see box in Figure 4) and sliding off the top of the landfill.

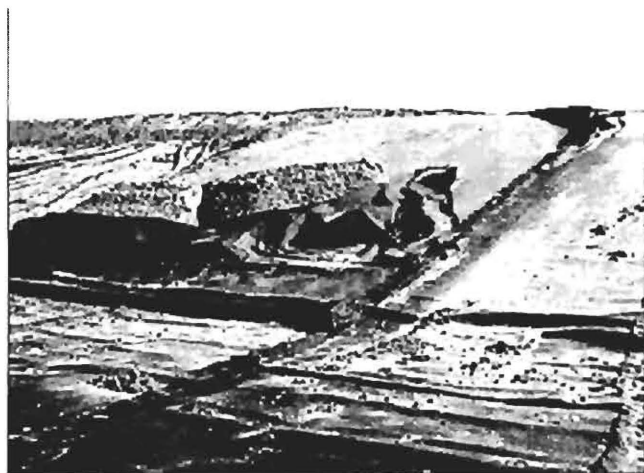
Figure 5. Panhandle slide showing exposed surface of the PVC geomembrane

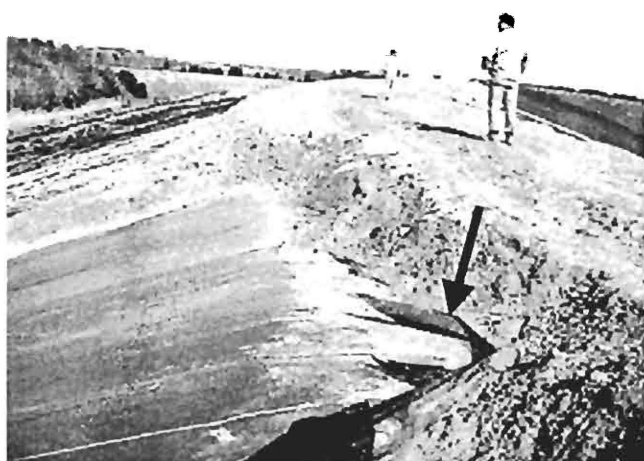
Figure 6. Panhandle slide showing torn single-sided drainage composite (see arrow) and intact geomembrane

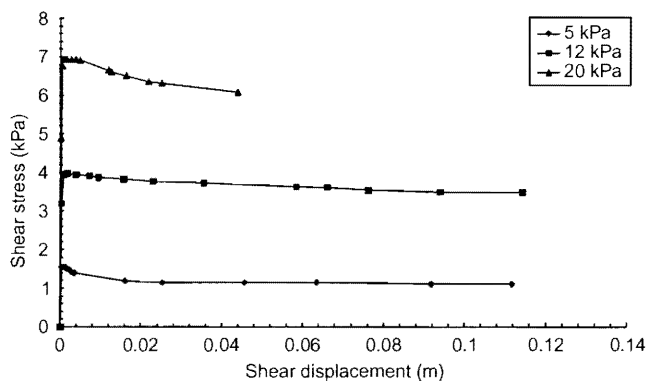
Figure 8 presents the shear stress–displacement relationships from the 0.5 mm PVC geomembrane/single-sided drainage composite ring shear interface tests. Using these relationships, the peak and residual failure envelopes for the geonet/PVC geomembrane interface were constructed and are shown in Figure 9. A residual failure envelope is also plotted, not a large displacement failure

Figure 8. Torsional ring shear test results on geonet/PVC geomembrane interface
