Design and Performance of Three Remediated Bridge Approaches

This paper presents the design and performance of three remediated freight bridge approaches in Maryland. Prior to remediation, an open-deck timber bridge spanning the Anacostia River had an un-remediated northern approach and a southern approach constructed with an existing slurry/grout fill material. In 2014 and 2015, the existing bridge was converted to a concrete ballasted deck bridge while remediating the north approach with a 6 inch (150 mm) thick Geoweb layer backfilled with crushed aggregate (CR-6) and overlain by 12 inches (300 mm) of ballast. A second concrete ballast deck bridge was constructed just east of the existing bridge with the north approach having an 8 inch (200 mm) thick hot-mixed asphalt (HMA) layer overlain by 12 inches (300 mm) of ballast and the southern approach was constructed with 6 inch (150 mm) thick Geoweb backfilled with CR-6. The objective of the remedial measures was to balance transient and permanent displacements between the bridge and approach by increasing track support in the approach and allowing some track displacement on the bridge.

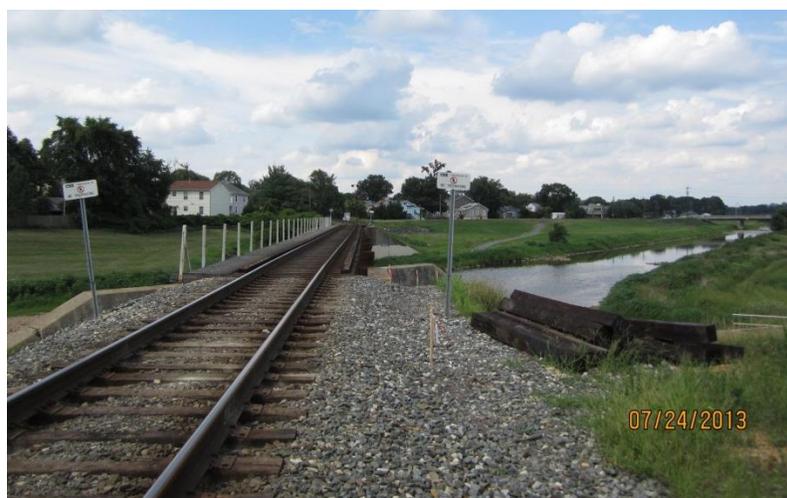
Figure 1: Photograph of original open-deck timber bridge prior to re-construction in 2013

The CSX bridge selected for remediation is located in Hyattsville, MD and spans the Anacostia River between CFP 120.4 and CFP 120.5 on the Baltimore Division, Capital Subdivision – Alexandria Extension. The existing Class 2 single mainline track had an annual tonnage of 30 million gross tons (MGT). The track structure includes an open deck bridge (see Figure 1) and an existing grout filled subgrade on the southern approach of the existing bridge, which was installed at an unknown date. The existing track experienced reoccurring track geometry defects associated with track profile, cross level, and warp defects at the approaches.

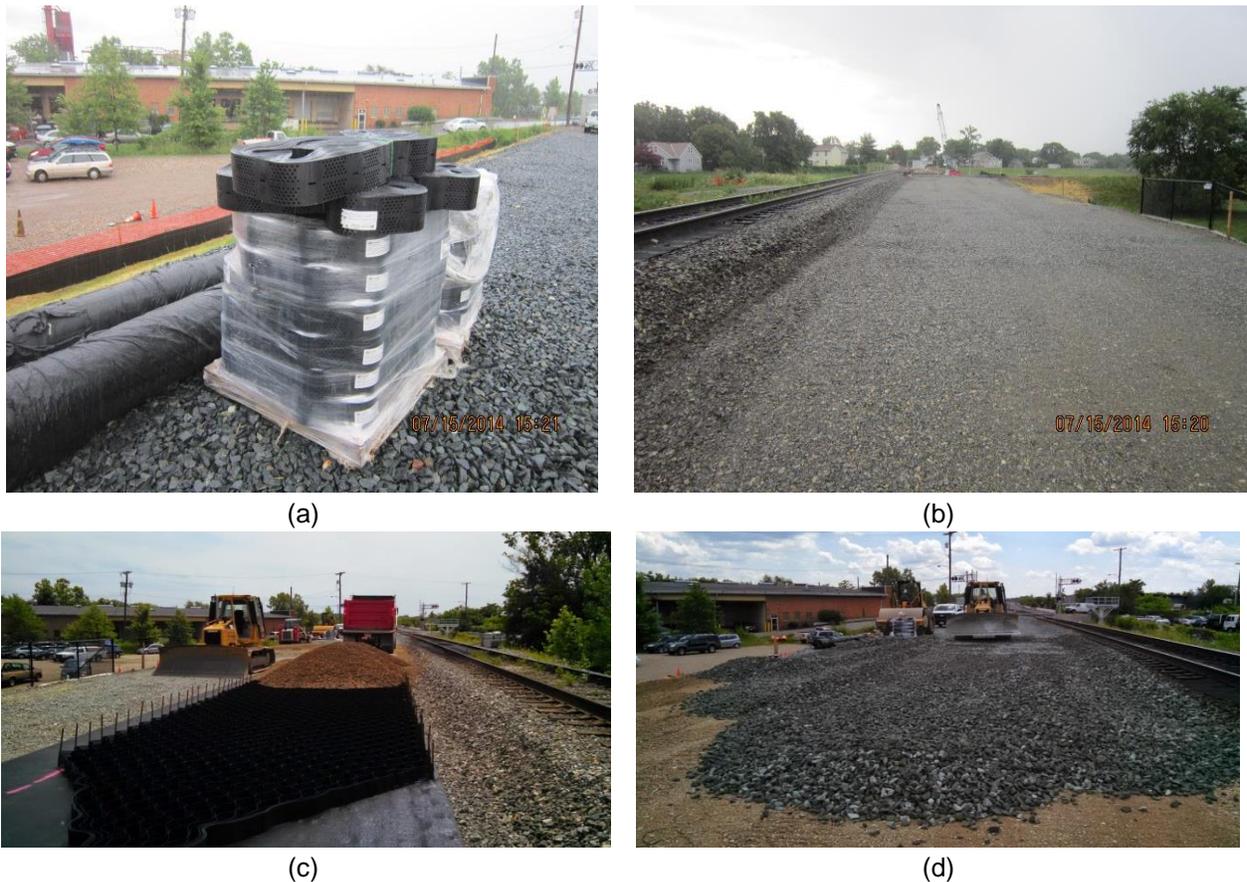
Figure 3: Various stages of approach reconstruction: (a) Geoweb, (b) crushed aggregate (CR-6) subgrade, (c) Geoweb installation, and (d) ballast installation.

The bridge upgrade and new Geoweb/HMA installation occurred in July 2014 and March 2015, respectively. The Geoweb installation involves the following components from bottom to top:

- Install 6 inch (150 mm) thick layer of CSX approved crushed aggregate for the subgrade
- Install nonwoven geotextile to provide separation between the subgrade and Geoweb
- Install 6 inch (150 mm) thick Geoweb
- Fill Geoweb with properly compacted and CSX approved crushed aggregate limited to three feet (0.9 meters) infills to prevent distortion
- Install 12 inches (300 mm) of standard AREMA #4a granite ballast

Figure 3 shows various stages of Geoweb installation at this bridge. In particular, Figure 3(a) shows the Geoweb material arriving on site, Figure 3(b) shows the crushed aggregate (CR-6) subgrade, Figures 3(c) shows the Geoweb installation and aggregate compaction, and Figure 3(d) shows installation of the 12 inch (300 mm) ballast section. The Geoweb extends for 50 ft. (15.3 m) from the bridge abutment. The HMA extended for 250 ft (76.3 m).

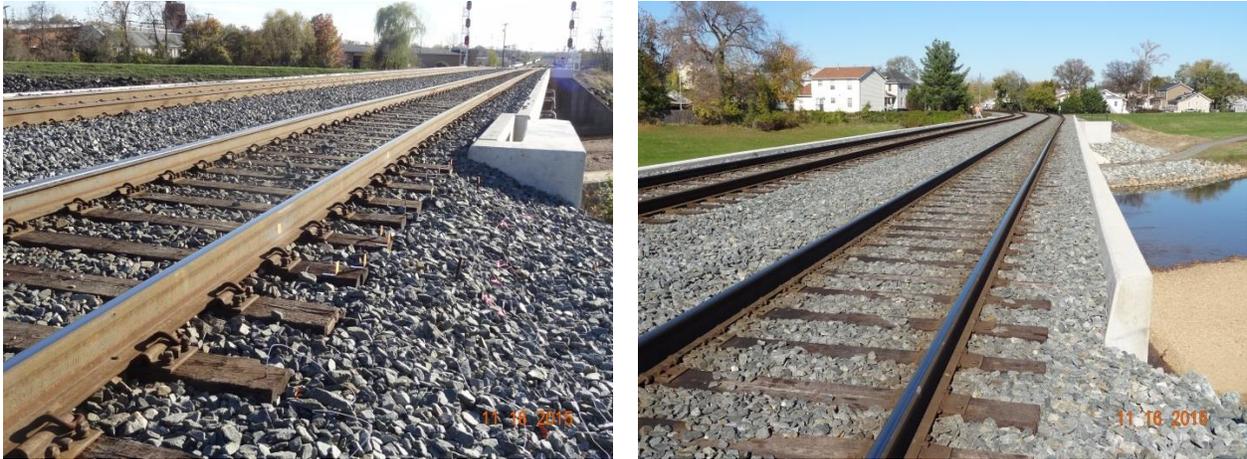
Figure 4: Photographs of remediated bridge: (a) looking south and (b) looking north

Figure 4 shows the remediated double mainline track. The track was returned to service in May 2015 and no track surface defects have been reported since remediation.

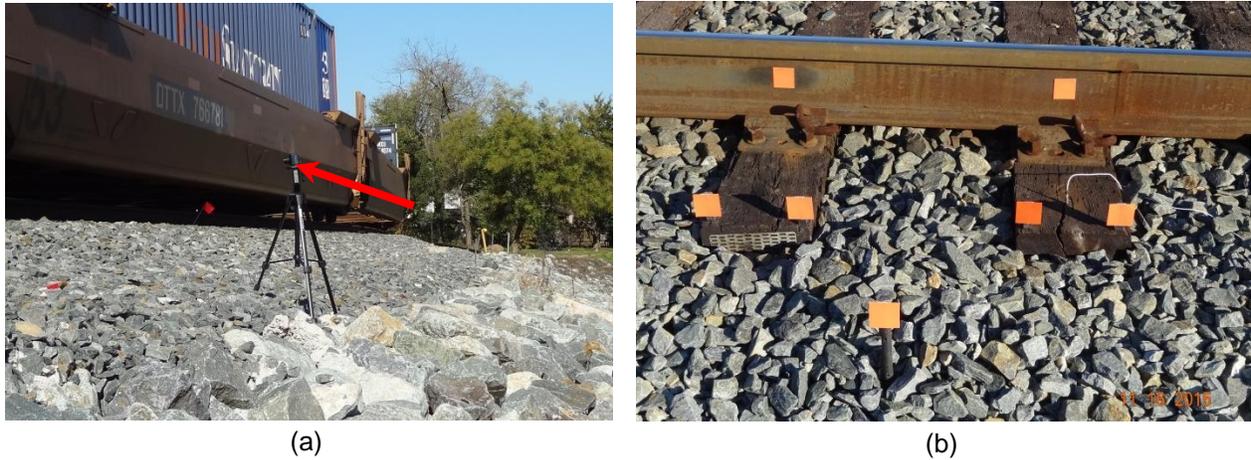
Figure 5: Photograph showing: (a) high-speed video camera (see arrow) and (b) orange plastic targets attached to rail, ties, and driven stake in foreground.

Three high-speed video cameras were placed about 20 feet (6 meters) from the track shoulder as shown in Figure 5(a) and measured transient vertical displacements by tracking the centroid of orange plastic targets attached to the rail and tie (see Figure 5(b)). To reduce the influence of ground and wind vibration, a target is also placed on an 18 inch (150 mm) long stake driven into the ballast two feet (0.6 meters) from the tie edge. The camera records at 240 frames per second (fps), which is fast enough to capture the full track displacement time history because the majority of track displacement occurs within a frequency of 1 to 5 Hz [14].

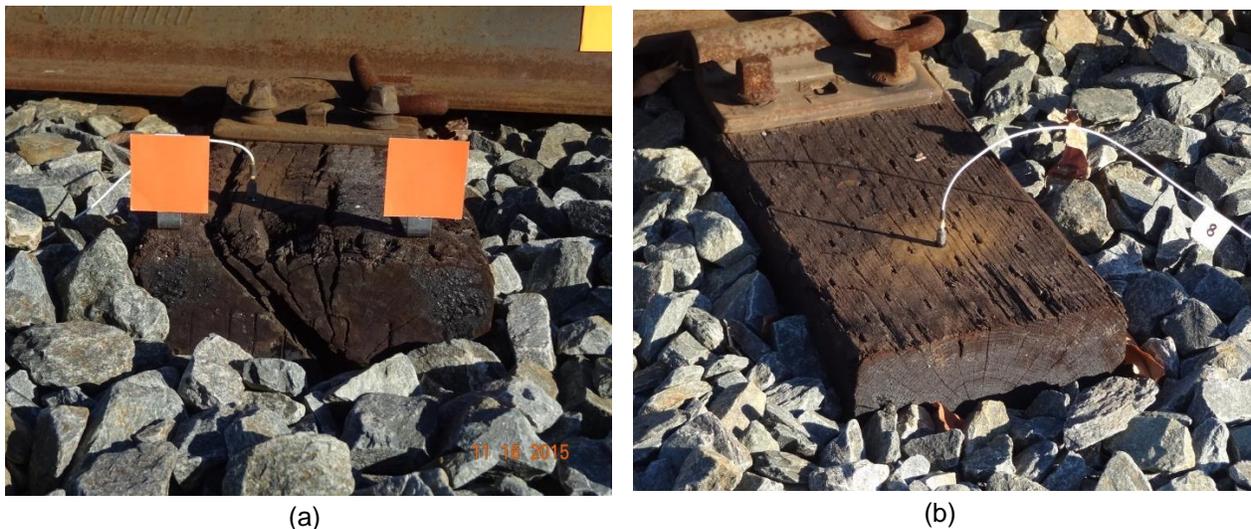
Figure 6: Photograph showing Approach #1: (a) video camera targets and piezo-electric accelerometer attached to Tie #1 near the bridge abutment and (b) accelerometer attached to Tie #8 in the open track.

Eight piezo-electric accelerometers were attached to the timber ties with superglue and are shown in Figure 6. Tie accelerations are a more qualitative measurement than rail and tie displacements, but are sensitive to movements, vibrations, and impact loads within the track so they provide insight into how the track is transmitting the applied loads to the ballast. For example, track with good support and a smooth load transfer from the wheel to the ballast, i.e. minimal relative movement between track components, typically exhibits tie accelerations less than 5g [6]. However, increased tie accelerations have been observed from wheel flats (>200g), rail joints (~150g), rail-tie impacts (~100g), tie-ballast impacts (~40g),
