Ruling on IHNC Floodwall Failures during Hurricane Katrina

Timothy D. Stark, Ph.D., P.E., J.D., F.ASCE

N. H. Jafari, S.M.ASCE

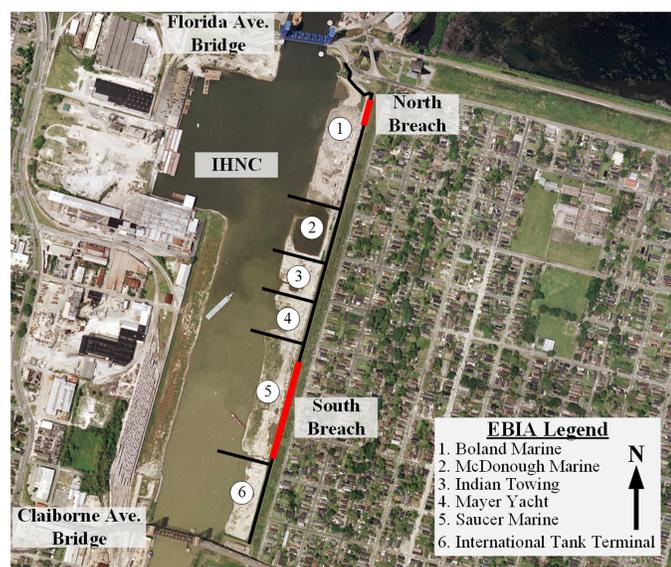
Fig. 1. Overview of IHNC, six EBIA properties, and location of floodwall breaches [background image courtesy of Gulf Coast Aerial Mapping (GCAM), with permission]

The IHNC in Fig. 1 runs essentially north-south with the southern end connecting to the Mississippi River and the northern end connecting with Lake Pontchartrain. The Mississippi River level is higher than the normal level of Lake Pontchartrain, so a lock structure to control flow and water level between the river and lake is located south of the Claiborne Avenue Bridge. During Hurricane Katrina, two failures of the floodwall shown in Fig. 1 occurred between the Florida Avenue Bridge at the north and the Claiborne Avenue Bridge at the south. This section of floodwall parallels the IHNC, is immediately west of the Lower Ninth Ward, and is the focus of this paper.

The six properties in the EBIA are named for former occupants and consist of from the north (Florida Avenue Bridge) to the south (Claiborne Avenue Bridge) (Fig. 1): Boland Marine, McDonough Marine, Indian Towing, Mayer Yacht, Saucer Marine, and International Tank Terminal. The Boland Marine and Saucer Marine sites are the location of the North and South Breaches of the floodwall, respectively, during Hurricane Katrina and are the focus in this paper. Boland Marine was used for ship repairs for nearly 20 years from the 1970s to the 1990s, and Saucer Marine was used for ship building operations for about four decades. The other EBIA property of great importance is McDonough Marine, which is located between the North and South Breaches. The floodwall along this property did not fail during Hurricane Katrina. As a result, this area is referred to as the No Breach area and was the site of a large soil borrow pit that was used to backfill most of the excavations created during the removal of infrastructure and contaminated soil in the EBIA by WGI. The McDonough Marine area was selected for the borrow pit because it contained the least amount of contaminated soil and thus a greater source of uncontaminated organic clay to backfill various WGI excavations created during the EBIA restoration.

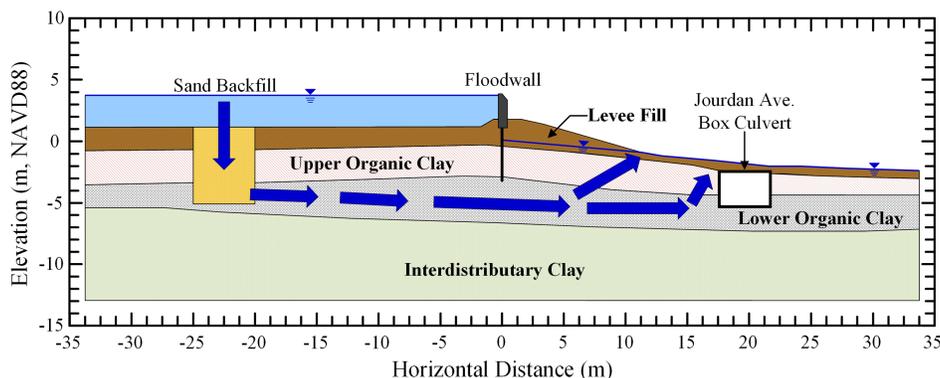
Fig. 2. Cross section of I-wall at North Breach with alleged excavation below sheet pile tip backfilled with sandy backfill material and storm surge-induced seepage depicted below sheet pile undermining the land side of levee and floodwall

Dunbar and Britsch (2008)²² provide additional details on site geology and formation of these soil stratigraphic units along the IHNC. Fig. 2 shows a generalized cross section for the IHNC I-wall with these clay layers. The upper and lower organic clays were deposited in swamp and marsh environments, respectively, and are classified as an organic clay according to the Unified Soil Classification System using ASTM D2216²³ (ASTM 2010c), D2487²⁴ (ASTM 2011a), D2974²⁵, and D4427²⁶. These clay layers do not classify as a fibrous peat using ASTM D2974 (ASTM 2012b) and D4427 (ASTM 2010a), because the organic content is less than 75% and a large percentage of gray fine-grained material is present as a result of the frequent flooding and deposition of clay material. The plaintiff experts opined that these clay layers were peat deposits in an attempt to prove the existence of a high hydraulic conductivity layer below the sheet pile tip that could rapidly transmit underseepage as a result of the storm surge.

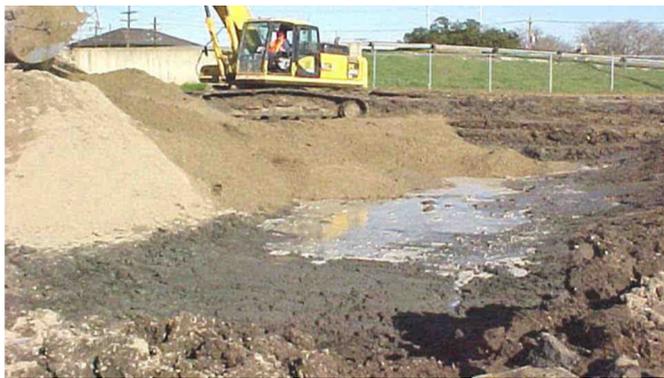
Fig. 3. Shallow excavations being backfilled with sandy material resulting from a shortage of clayey soil from borrow pit located on McDonough Marine [image courtesy of Washington Group International (WGI), with permission]

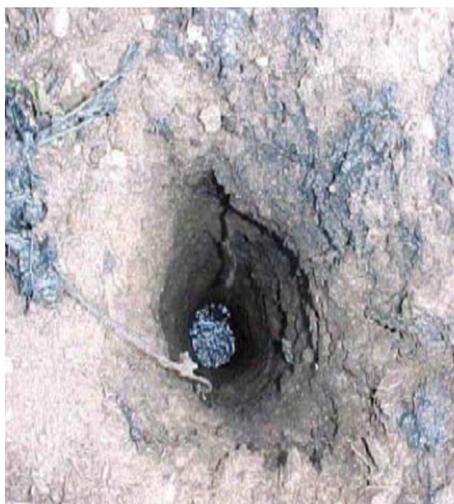
However, extraction of the over 1,100 pilings did receive some traction during trial. Fig. 4 shows the resulting vertical hole from the extraction of a pile in the EBIA. Plaintiffs' expert Dr. Jonathan David Rogers of the Missouri University of Science and Technology contended that removal of over 1,100 pilings created numerous hydraulic connections to the lower organic clay below the sheet pile tip that also facilitated underseepage. The pilings were less than 0.3 m (1 ft) in diameter and had lengths of 6.1–21.1 m (20–69 ft). Most of the pilings were removed before 2005, which was well in advance of Hurricane Katrina on 29 August 2005. After substantial testimony about the extracted pilings, the Court concluded in its 12 April 2013 ruling¹³:

Fig. 4. Vertical hole resulting from extraction of piling, some of which was not backfilled [image courtesy of Washington Group International (WGI), with permission]

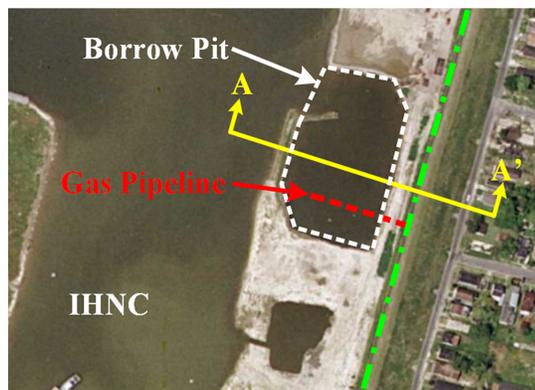
Fig. 5 shows an aerial view of the water-filled borrow pit before Hurricane Katrina, and Fig. 6 shows "Cross Section A-A" through the borrow pit at the location shown in Fig. 5. Fig. 6 illustrates the depth of the borrow pit excavation, its close proximity to the

Fig. 5. Aerial photograph of large water-filled soil borrow pit excavation within 23 m of the floodwall (see diagonal dashed line) before Hurricane Katrina between the North and South Breaches (29°58' 41.50"N, 90°01'14.14"W) [background image courtesy of Gulf Coast Aerial Mapping (GCAM), with permission]

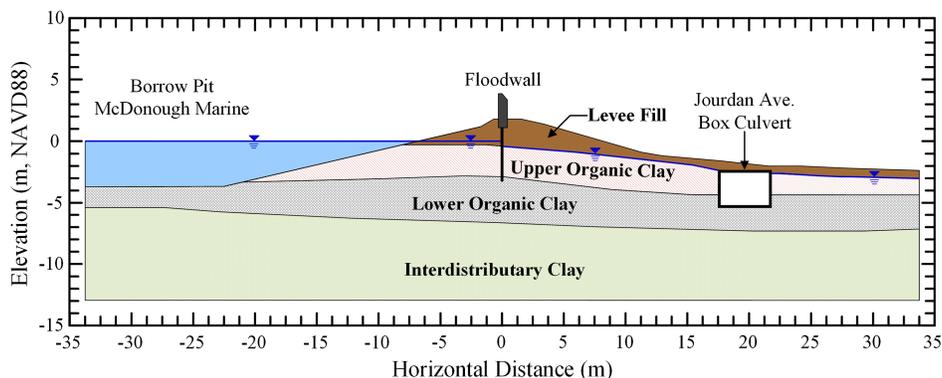
Fig. 6. Floodwall cross section through borrow pit used for transient seepage analyses

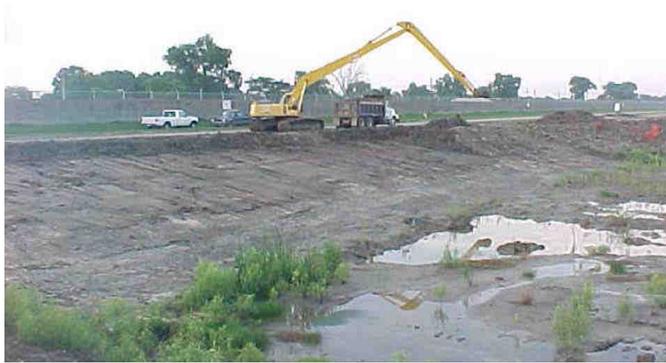
floodwall, the upper (swamp) and lower (marsh) organic clays underlying the floodwall, and cypress stumps and other organic materials (Fig. 7) that the plaintiffs' experts opined increased the hydraulic conductivity of the lower organic clay. Some of the other facts about the borrow pit for proving that landside underseepage and hydraulic uplift pressures were not a "substantial factor"⁴⁴ in either floodwall breach are as follows:

- Large [approximately 9,300 m² (100,000 ft²)] excavation area;
- Excavation has a 3H:1V sideslope on the floodwall side of the excavation (Fig. 7);
- Similar subsurface conditions, including upper (swamp) and lower (marsh) organic clays and cypress stumps and other organic material (Fig. 7), as below the North and South Breaches;
- Excavation pierced the lower organic clay so there was direct hydraulic connection below the sheet pile tip before Hurricane Katrina;
- Closest (23 m; 75 ft) large excavation to the floodwall;
- A utility, i.e., gas pipeline, was removed and backfilled in the borrow pit area and did not result in floodwall failure (Fig. 5);
- Filled with ponded water instead of sandy backfill by WGI (Fig. 2) before Hurricane Katrina; and
- Excavation extended 0.3 m (1 ft) near the floodwall to 2.1 m (7 ft) below the sheet pile tip, which was an important issue at trial.

Fig. 7. Excavation of soil borrow pit near floodwall and 3.5 m deep showing organic clays that underlie the floodwall [image courtesy of Washington Group International (WGI), with permission]
