GEOTECHNICAL RECONNAISSANCE OF THE 2011 FLOOD ON THE LOWER MISSISSIPPI RIVER

June 18, 2012

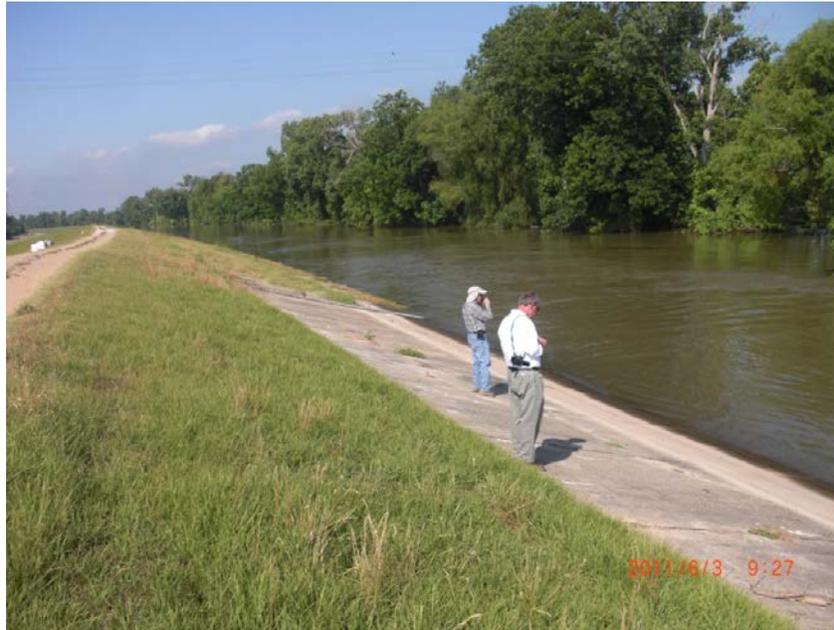
Figure 2.1 Mississippi River levee at Duncan Point

Scour or erosion on the flood side is another potential problem. The high flow rate in the river together with river traffic possibly being closer to the levee during a flood (since the width of the river increases) can erode the flood side of the levee. In areas susceptible to scour, armoring such as large stones or concrete slabs (see Fig. 2.1), have been added on the flood side (Fig 2.3).

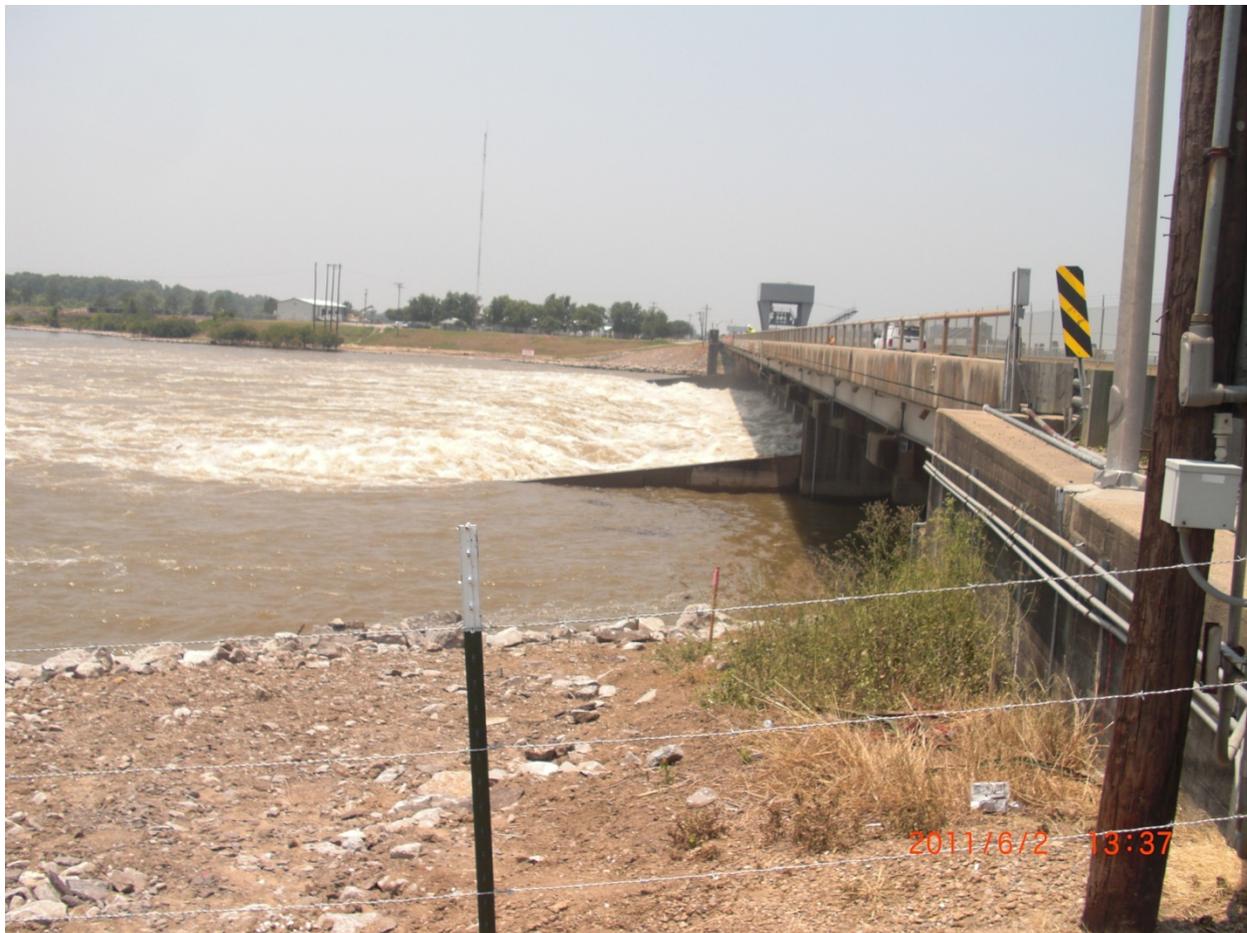
Figure 2.7 Discharge to Atchafalaya Basin through Old River Low Sill Structure, view looking West-Northwest, July 2, 2011

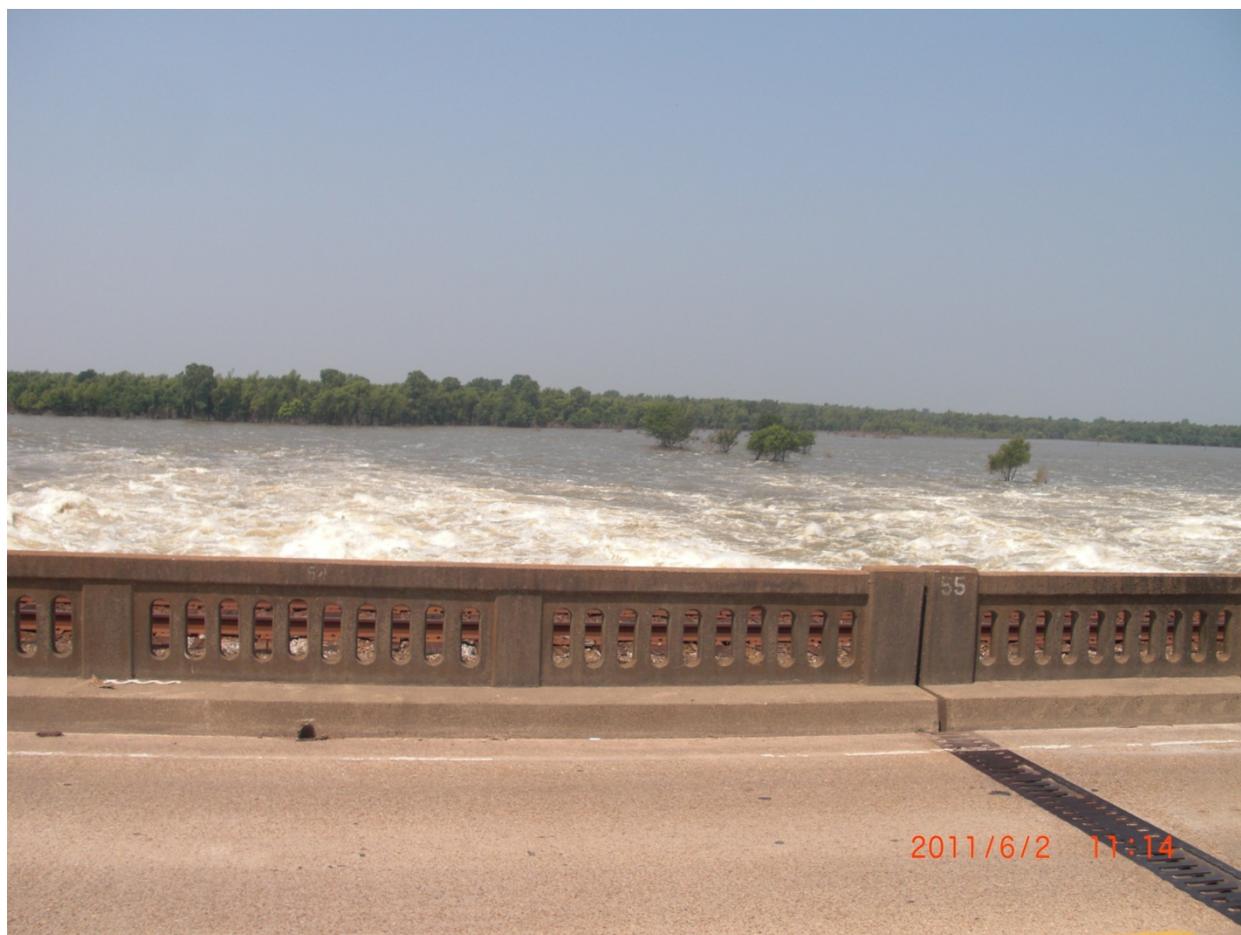
The Morganza Spillway is opened only in extreme flood events. It is a gated structure that was completed in 1954 and has been opened only twice since then, 1973 and 2011 (Fig. 2.8). The spillway directs up to 600,000 cfs off the main channel of the Mississippi River into the Morganza Floodway and ultimately into the Atchafalaya River. The Morganza Floodway is a 20-mile long, 5-mile wide area that contains farms and some sparse development. The inhabitants in this floodway are aware that will be flooded periodically and are warned in advance of opening the spillway. Improvements were made to the Morganza Spillway after erosion occurred during the 1973 flood.

Figure 2.8 Discharge through Morganza Spillway into the Morganza Floodway, view looking South-Southwest, July 2, 2011

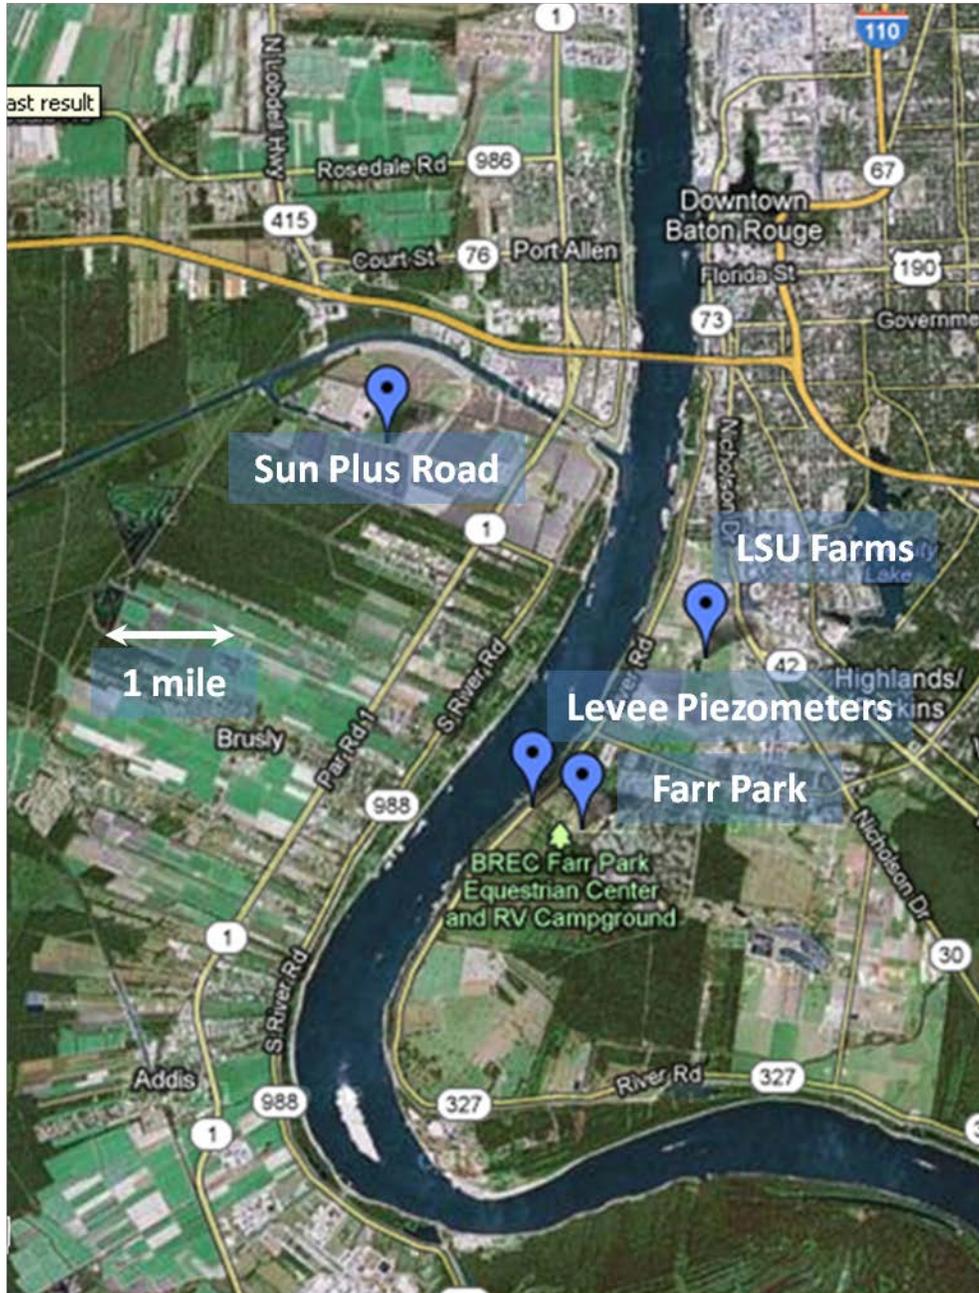
Figure 4.7 shows an aerial map of the Duncan Point area and several sites visited by the GEER Team. The site described in this section is labeled “Levee Piezometers” in Figure 4.7. Other sites visited by the GEER Team and described subsequently are LSU Farms, Farr Park, and Sun Plus Road.

Figure 4.7 Aerial view of Duncan Point area near Baton Rouge, Louisiana on Mississippi River Right Levee near River Mile 225 (Imagery ©2012 TerraMetrics, Map Data ©2012 Google)

Figure 4.7 presents an aerial map of the Duncan Point area and the sites labeled LSU Farms, Farr Park, and Sun Plus Road are locations of distant sand boils that were visited by the GEER Team. The following paragraphs provide a brief description of each site and the observed distant sand boils.

The third and most interesting distant sand boil location observed is on Sun Plus Road, which is located in a farm field nearly 2 miles from the Mississippi River Levee and about 1,500 feet from the spur of a navigation canal (Figure 4.7). At this location, there is a six-foot diameter sand boil eroding fine sand from below the fine-grained blanket which is supporting the farming operation (Figure 4.14). In addition, water was observed existing about 3 inches below the crest of the gravel road in Figure 4.14(a), which is above the level of the sand boil in the foreground. It is possible that the gravel embankment for the road extends below the natural fine-grained blanket and provides a vertical conduit for the underseepage to rise to within three inches of the roadway crest.

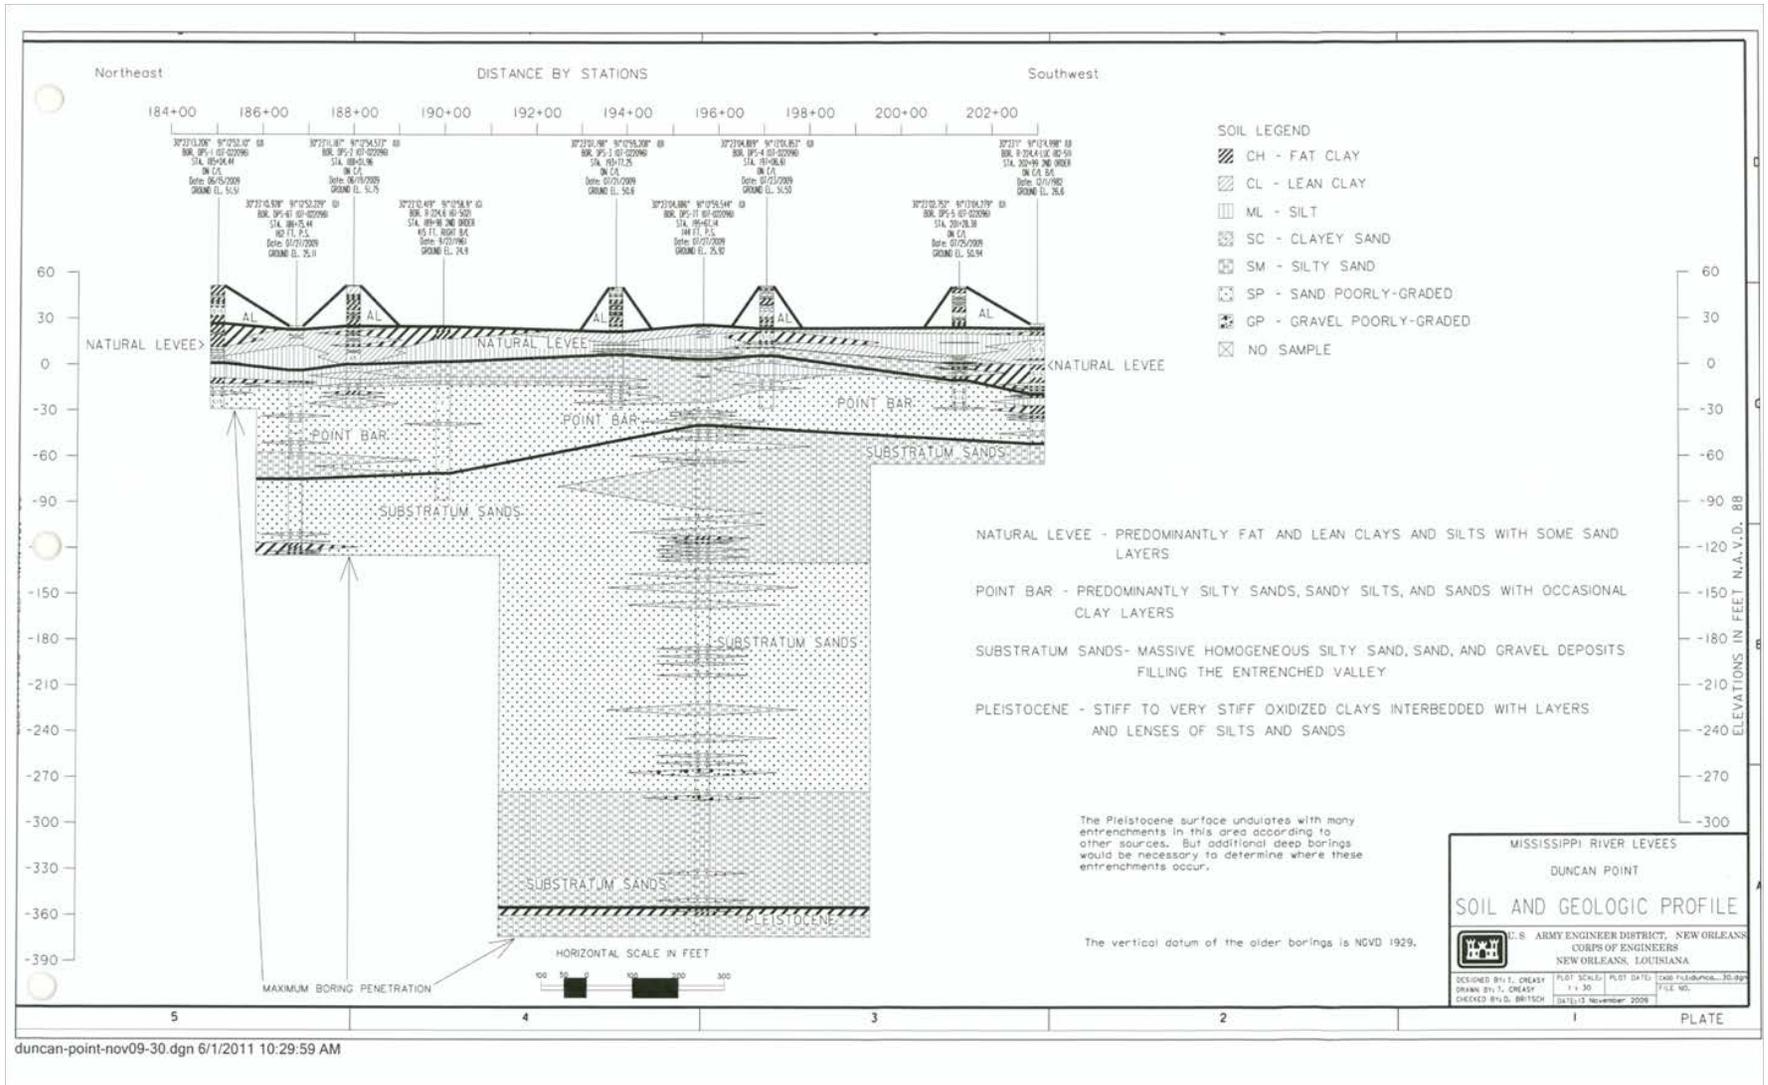
In 2010 an interim stabilization berm was constructed along about 1000 feet at the protected side levee toe. However, due to observed seepage during the 2011 flood, this berm was extended using sand bags as described below. In addition to the sand bags, the Pontchartrain Levee District excavated several seepage relief trenches on the protected side slope of the levee to relieve some of the seepage pressures.

Because Duncan Point is an area of recurring seepage and sand boils, the Corps has heavily investigated this area and also installed piezometers with tip elevations of -5, -35, -80, -150, and -300 feet referenced to the NAVD88 datum. All of the piezometers, except the one with a tip elevation of -300 ft, fluctuate with the Mississippi River level. Figure 4.8 presents a generalized cross-section of the levee and foundation soils at the Duncan Point location. Seepage reoccurs here because the “natural levee” (see Figure 4.8), i.e., the natural fine-grained blanket, is thinner at this location which results in a higher exit gradient and increases the chance for sand boils. The piezometric measurements show a head drop of six to twelve ft across the fine-grained blanket. This head drop is based on a maximum river elevation of 44 ft (levee crest and toe elevations are about 52 and 25 ft as shown in Figure 4.8). The piezometers in Figure 4.9 had to be extended during this flood event from elevation 32 ft to 38 ft because water was pouring out the piezometers onto the levee toe. Extending the piezometers from elevation 32 ft to 38 ft ceased the flow of water indicating that the piezometric level at the downstream toe is between 32 ft and 38 ft, or seven to 13 feet above the levee toe.

Figure 4.8 Typical cross-section through Duncan Point Levee near Baton Rouge, Louisiana on Mississippi River Left Levee at River Mile 225 (provided by USACE)
