CONSTRUCTION CONSIDERATIONS FOR GEOSYNTHETIC LINER SYSTEM STABILITY

By: Pedro Amaya, Timothy D. Stark, and Brian Queen

ABSTRACT: Construction conditions experienced during the installation of a landfill geocomposite liner system lead to two slides of a 3H:1V internal slope being developed for final disposal of Flue Gas Desulfurization byproduct material (FGD). The approved geocomposite liner consisted of 18-inches of compacted clay, a 30-mil thick PVC geomembrane, 12-inches of drainage sand, and 24-inches of FGD used as protective cover material. A stability improvement program featuring the use of geosynthetics to reinforce the 3H:1V slopes was implemented and no re-occurring or additional slides have occurred at the site.

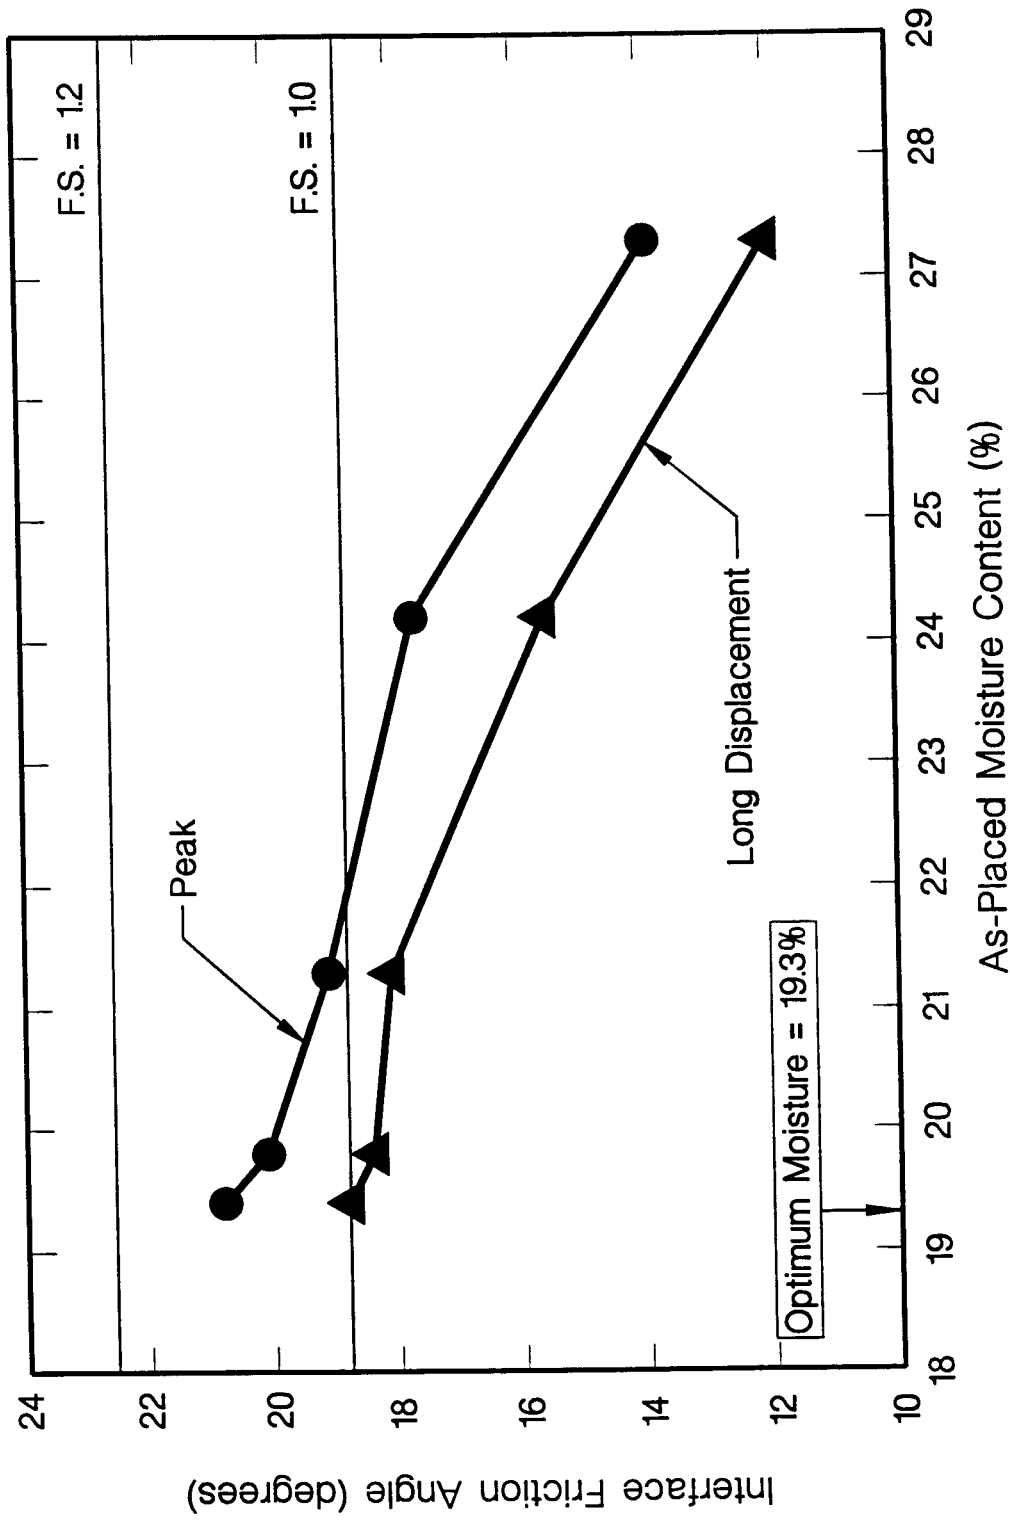
Figure 4 illustrates the impact of compaction moisture content on the shear resistance of the PVC geomembrane/CCL interface using large direct shear test results at a normal stress of 7.2 kPa (150 psf). A normal stress of 7.2 kPa (150 psf) simulates the normal stress applied by the drainage sand and protective cover material. It can be seen that the peak friction angle (ϕ) decreases from approximately 21 degrees to about 14 degrees with an increase in compaction moisture content from 19.8 to 27.3%, respectively. As shown, the optimum moisture content for the standard Proctor compactive effort is 19.3%. It can also be seen that the interface exhibited a post-peak strength loss (approximately 10%) that appeared constant with increasing compaction moisture content. This post-peak strength loss (~10%) is significantly less than that typically observed (40-45%) for high-density polyethylene (HDPE) geomembrane/compacted clay interfaces (Stark and Poeppel 1994).

A FS of unity corresponds to an interface friction angle of 18.5 degrees. As shown in Figure 4, a peak friction angle greater than 18.5 degrees corresponds to a compaction moisture content less than approximately 22.5%. If shear displacements are induced along the interface and a large displacement friction angle is mobilized, a compaction moisture content less than approximately 19.5% is required for a FS greater than unity. Also shown is a compaction moisture content less than 19% is required to develop a peak ϕ that would correspond to a FS of 1.2.

As mentioned previously, the PVC geomembrane/CCL interface was tested at a normal stress of 7.2 kPa (150 psf) using a large-scale direct shear device after the October 1996 slide. It can be seen from Figure 4 that the back-calculated interface peak friction angle of approximately 17 degrees corresponds to a compaction moisture content of about 25%, whereas a large displacement friction angle of approximately 17 degrees corresponds to a moisture content of about 22.5%. This was initially perplexing because the compaction moisture content of the CCL was 21.5%, which corresponds to a peak interface friction angle of about 19 degrees. After the October 1996 failure it was noted that a thin layer of wet clay (approximately 10mm thick) had formed on the surface of the CCL which had a moisture content of 27%. After the June 1997 failure, it was observed that a similar thin layer of wet clay (approximately 5mm thick) had also formed and it had a moisture content of 22.5% even though the compaction moisture content in this area had been 19.5%. This comparison suggests that moisture condensed under the PVC geomembrane or was drawn to the geomembrane/CCL interface resulting in the moisture content increasing at the surface of the CCL. This increase in moisture content reduced the peak interface friction angle from 19 degrees (moisture content of 21.5%) to less than 17 degrees (moisture content of 25%) as the final moisture content at the

Figure 4. Effect of compaction moisture content on PVC geomembrane/GCL interface friction angle at a normal stress of 7.2 kPa

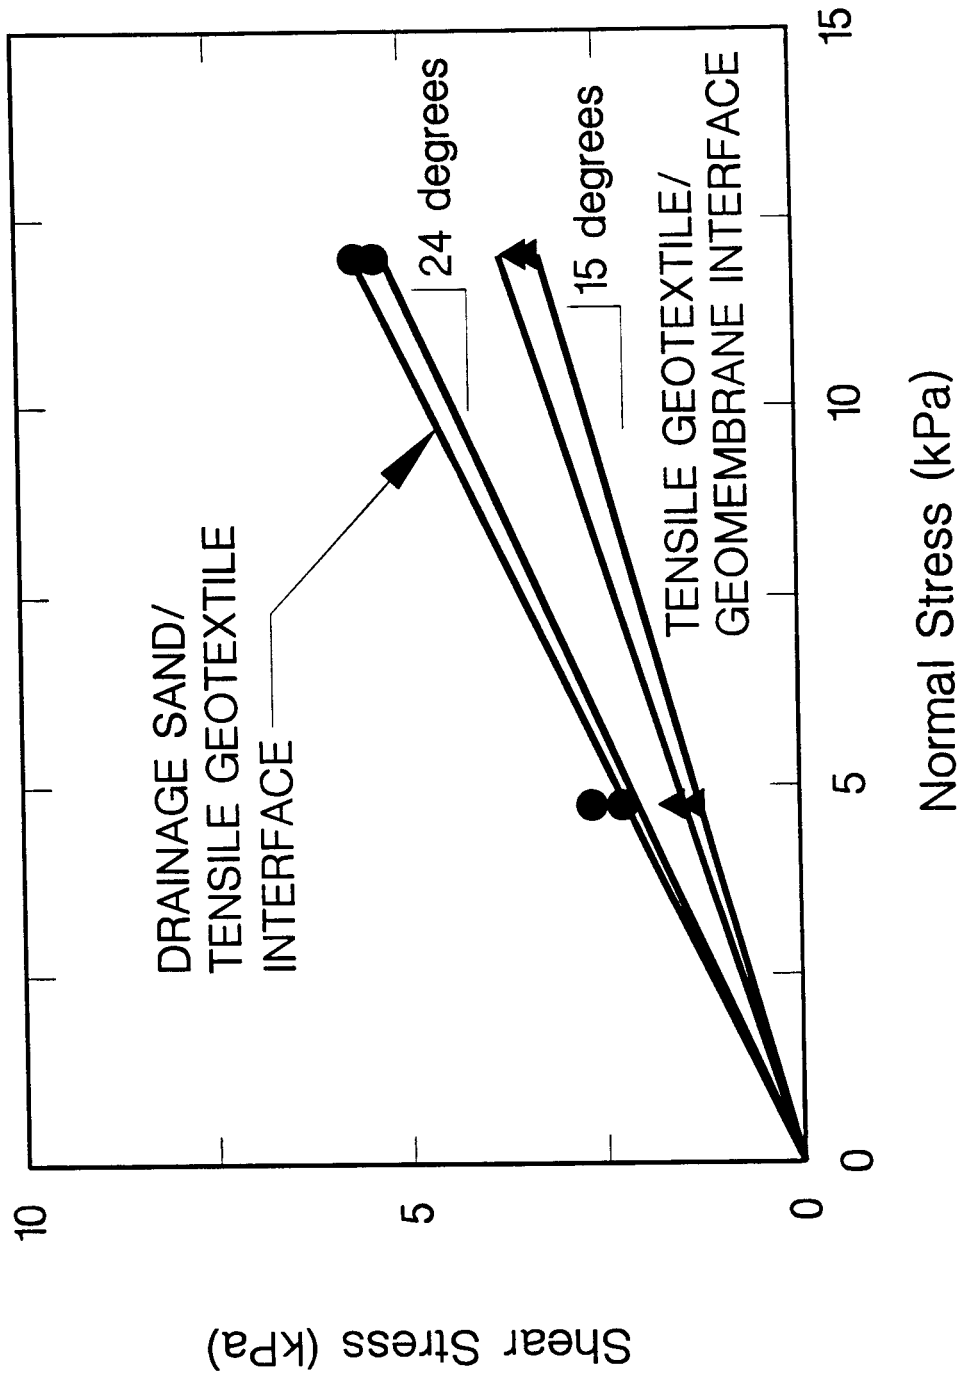
Figure 5 presents large-scale direct shear test results for the tensile geotextile interfaces. These results yield a peak interface friction angle of 24 and 15 degrees for the drainage sand/tensile geotextile and PVC geomembrane/tensile geotextile interfaces, respectively. The allowable tensile force for the woven geotextile is 3036 lbs./ft (16% strain) based on the stress/strain information provided by the manufacturer. This value reflects a reduction factor for creep, installation damage, and durability.

Figure 5. Shear resistance of tensile geotextile interfaces

Figure 5 presents large-scale direct shear test results for the tensile geotextile interfaces. These results were used to facilitate design of the successful remedial measures that included installation of a tensile geotextile above the PVC geomembrane to

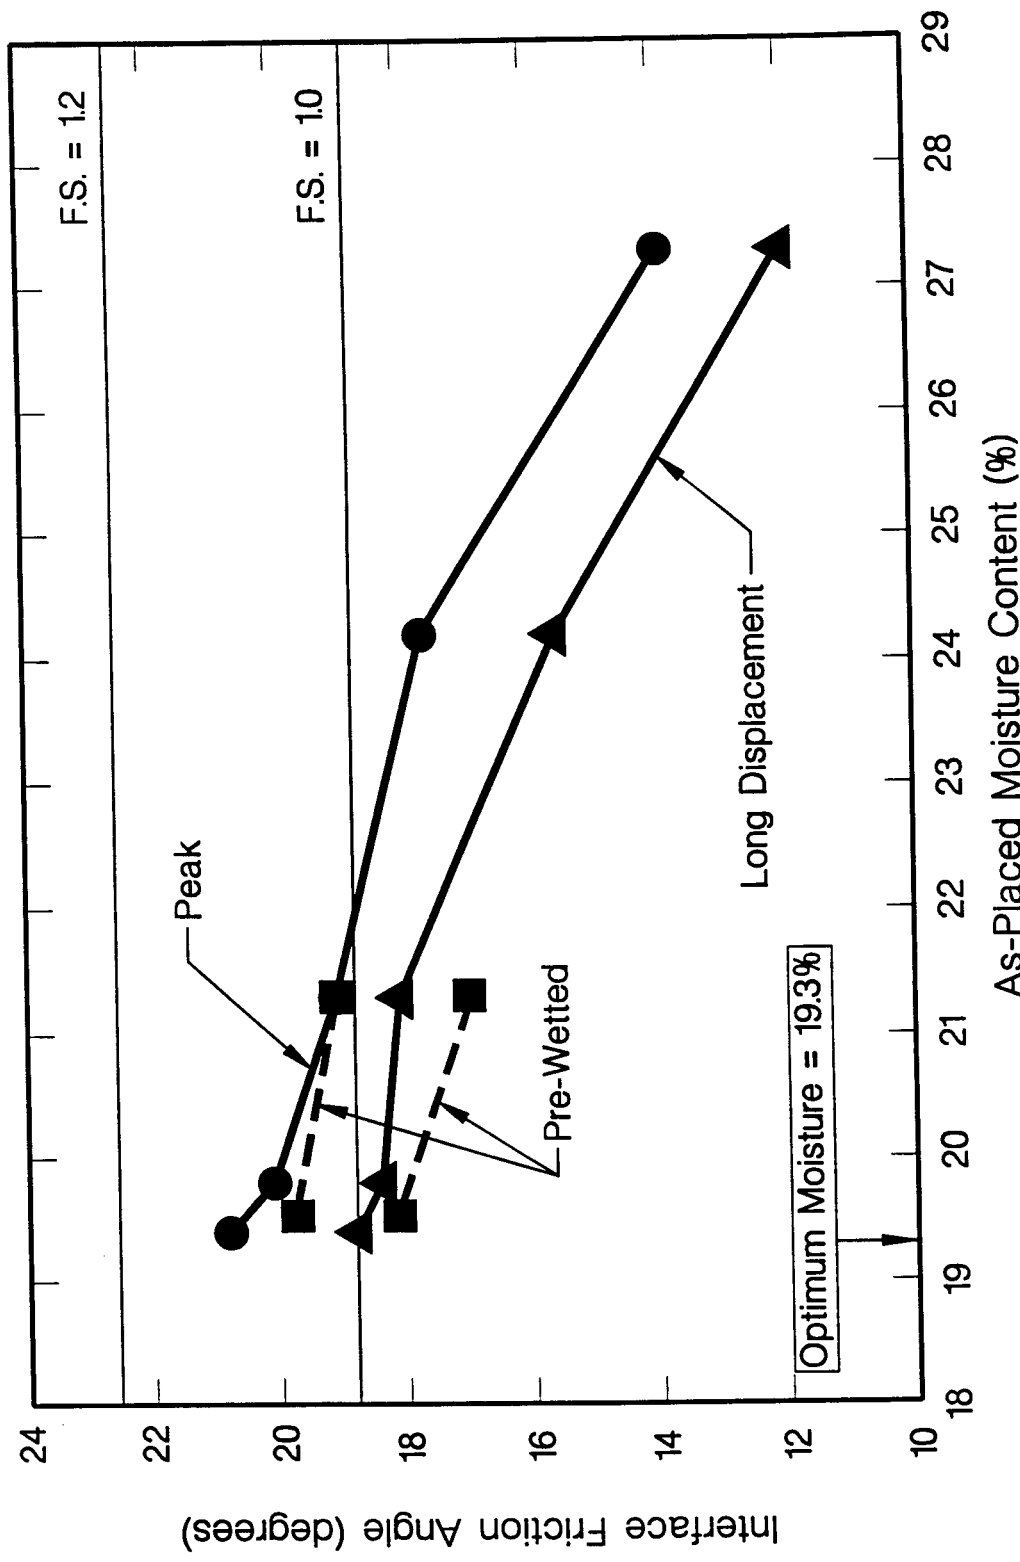
Figure 6 illustrates the impact of testing the PVC geomembrane/CCL interface under a wetted condition for a compaction water content of 19.6% (approximately optimum) and 21.3%. The pre-wetted interface tested at a moisture content of 19.6% exhibited a higher peak and large displacement friction angle than the interface tested at a moisture content of 21.3%. More importantly, the peak and large displacement friction angle relationships from Figure 4 are superimposed on the data in Figure 6. It can be seen that pre-wetting the interface with a spray bottle to simulate moisture buildup under the geomembrane can reduce the interface shear resistance. As discussed subsequently, the likelihood of moisture buildup at the interface suggests that the moisture content at a geomembrane/CCL interface may increase during construction and thus interface testing probably should reflect a moisture content that is several percentage points above the as-compacted moisture content and the interface probably should be pre-wetted.

Figure 6. Effect of pre-wetting PVC geomembrane/GCL interface on friction angle at a normal stress of 7.2 kPa
