# **AN INTERIM SLOPE FAILURE INVOLVING LEACHATE RECIRCULATION**

Paper Submitted to:  
**Municipal and Industrial Solid Waste Disposal Technology  
Waste Tech '2000  
March 6-8, 2000  
Orlando, Florida**

January 12, 2000

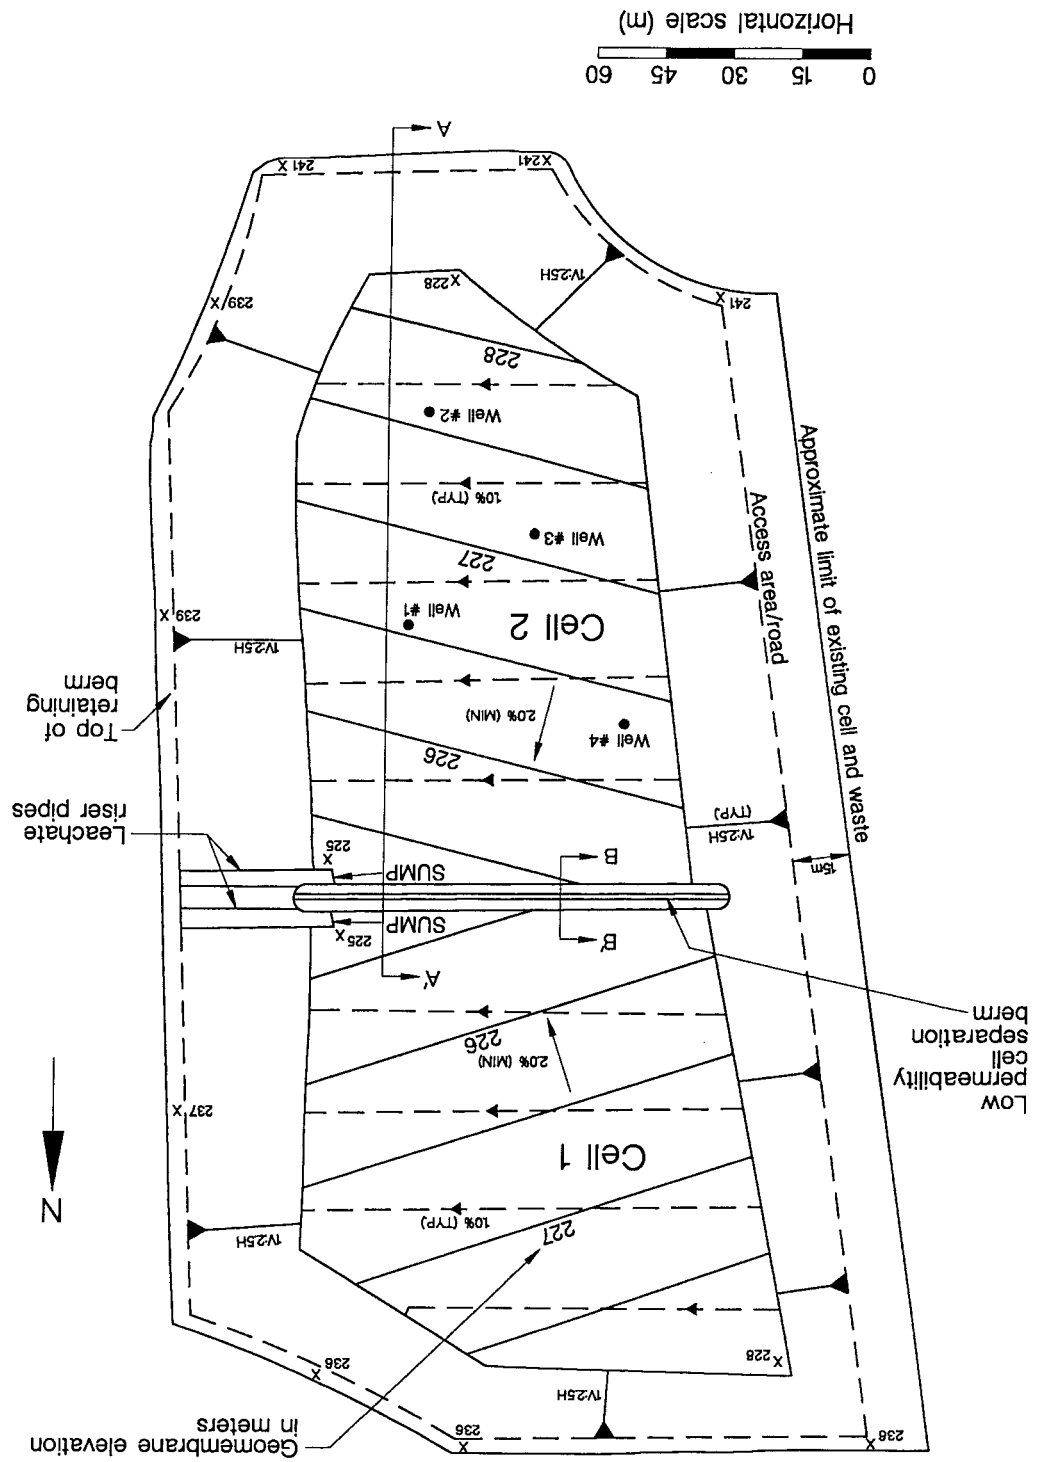
Figure 1. Plan view and cell layout for lateral expansion

Figure 1 shows a plan view of the landfill expansion, which is designed in such a way, that the two cells slope towards each other. Therefore, the middle of the combined cells is the lowest point between Cells 1 and 2. Leachate collection sumps are located in both cells (see Figure 1) with a low permeability soil berm separating the cells. The composite liner system at the facility in the area of the failure consists of, from the bottom up:

The leachate recirculation system consists of 4 vertical wells connecting multiple hubs of horizontal trenches. The four vertical wells are located about every 30 m (100 feet) horizontally from the cell separation berm (see Figure 1) throughout Cell 2. Each vertical recharge well has two hubs that connect to eight horizontal trenches that are filled with high permeability material, such as sand and/or tire chips (Figure 2). The trenches from the four vertical wells cover the majority of the cell floor to distribute the leachate.

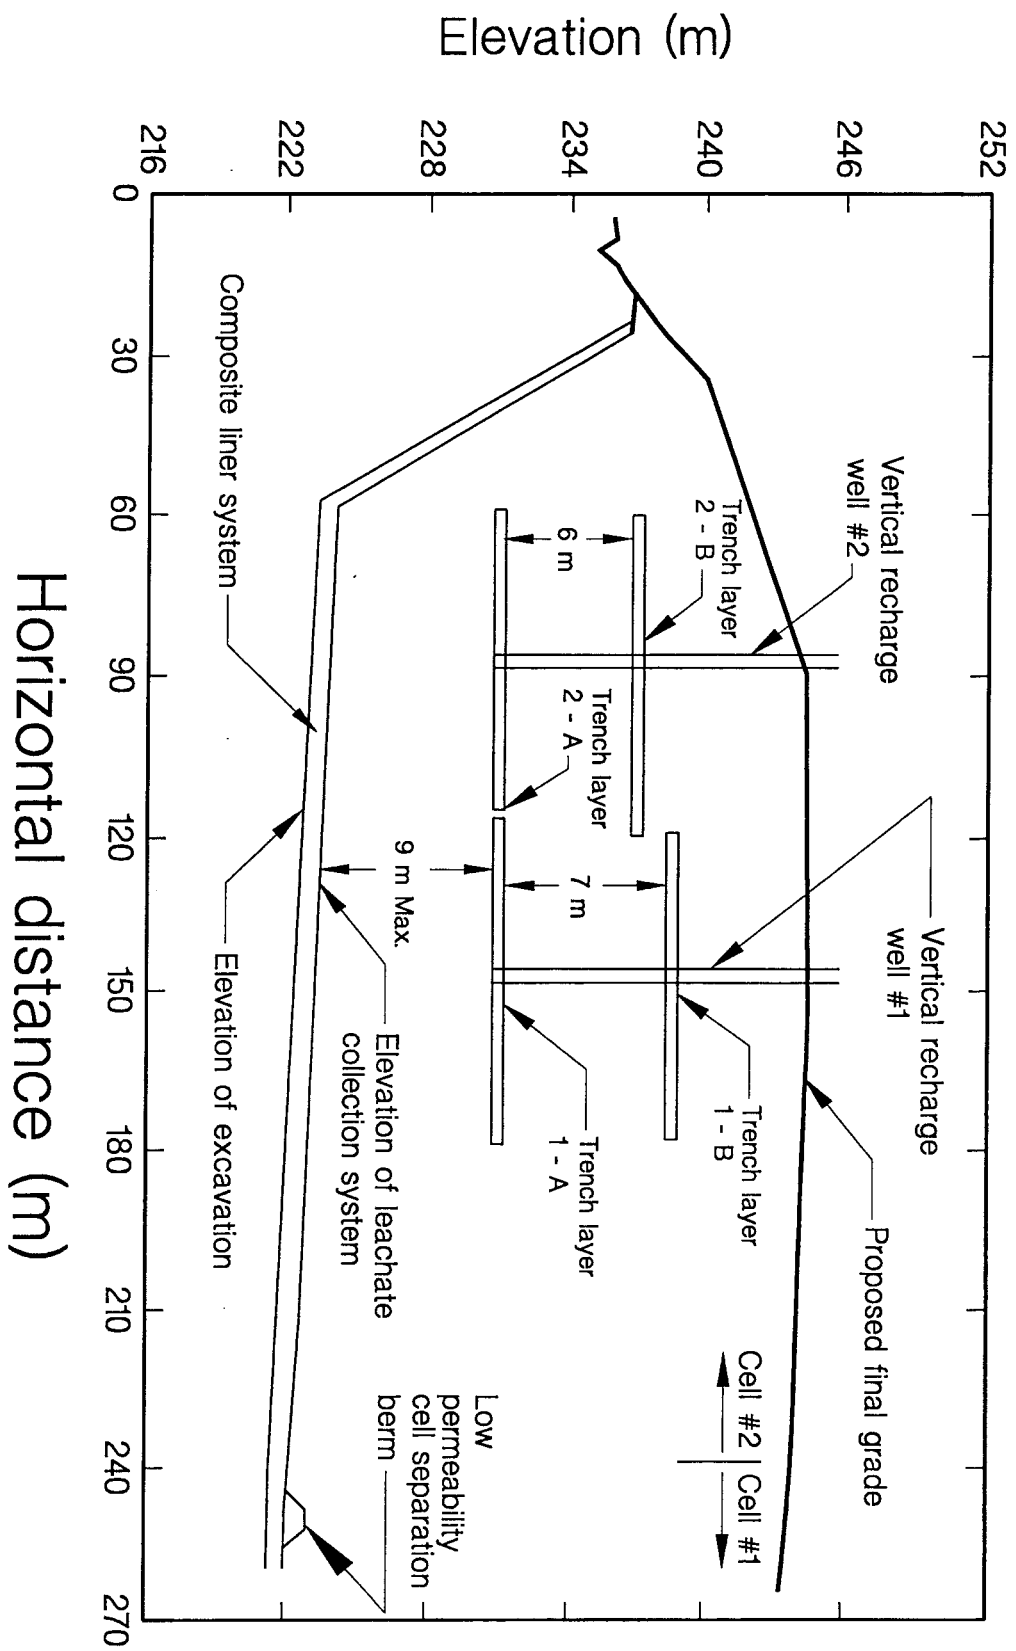
Figure 2. Cross-section A-A' in Cell 2

Horizontal, i.e. 40%, side slopes is similar, except the geonet was heat bonded to two geotextiles. Figure 2 presents a generalized cross-section through Cell 2 (see Figure 1 for location). The low permeability cell separation berm separating the two cells is shown and was underlain by the composite liner system. This cross-section also shows the proposed final configuration of Cell 2 and the leachate recirculation system.

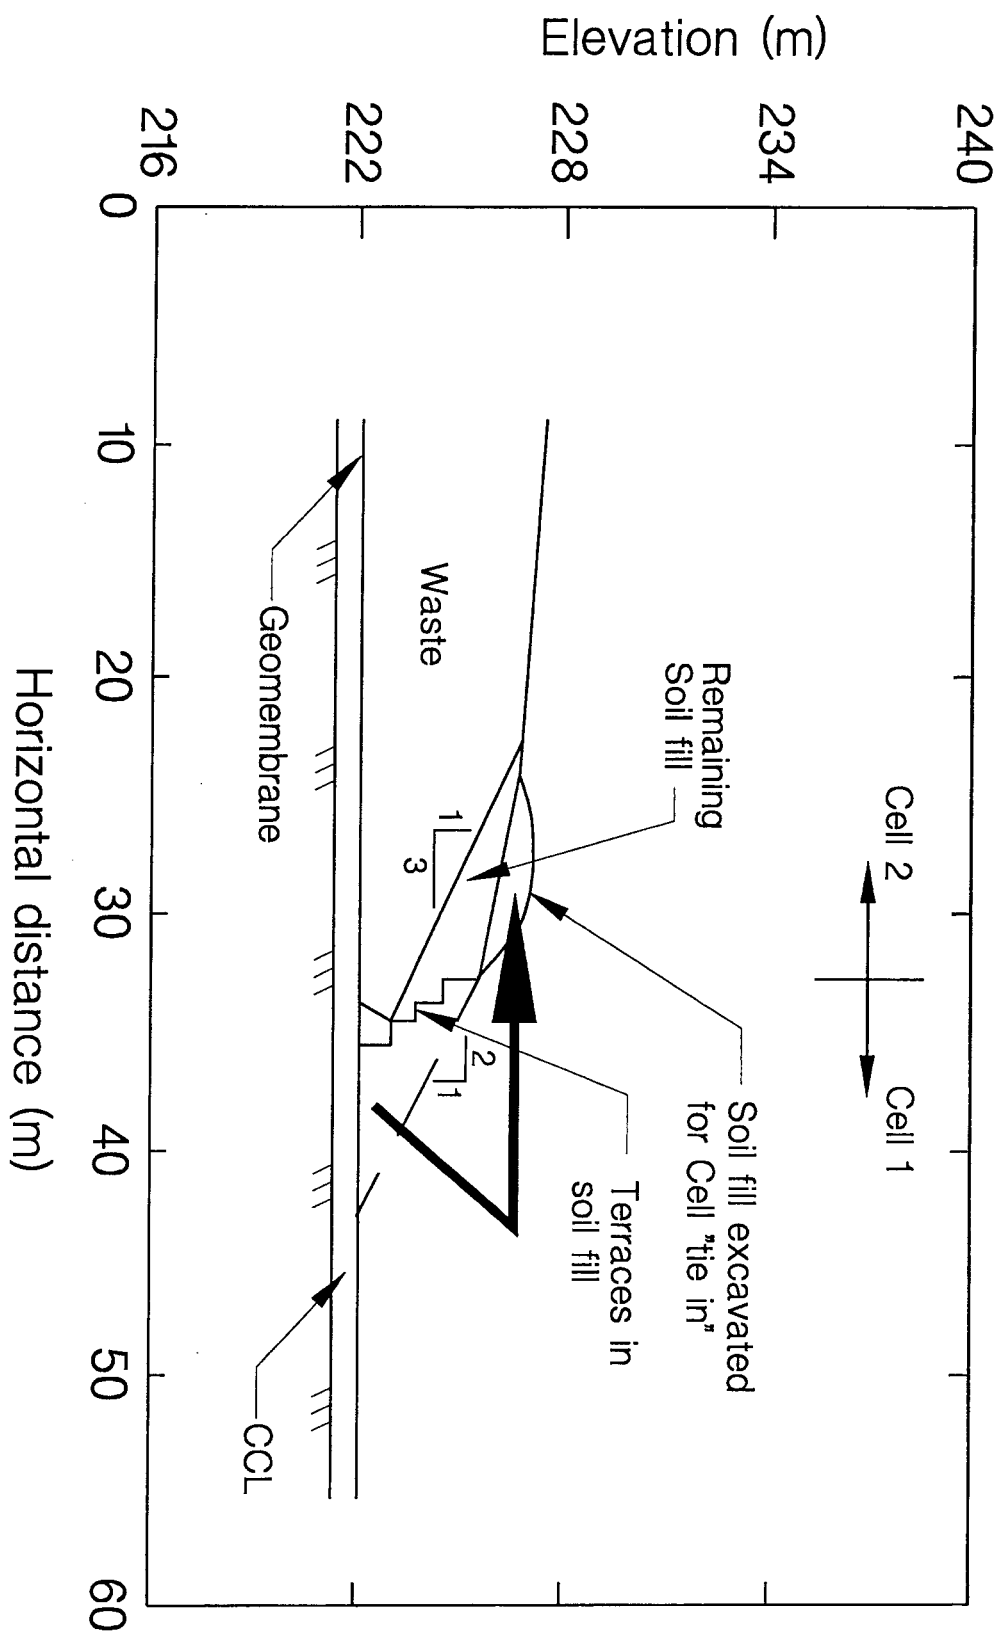
Figure 3. Cross-section B-B' in toe area showing soil fill to reduce leachate outbreaks

Figure 3 presents a detailed cross-section at the intersection between Cells 1 and 2 just prior to the failure. It is important to note that the soil fill shown in Figure 3 was placed on the 1V:3H waste slope in an effort to control the continual leachate outbreaks that occurred along the toe of the waste slope. Initially, a 0.6 m (2 ft) thick lift of soil was placed over the slope toe in an unsuccessful attempt to control the leachate outbreaks. Several subsequent 0.6 m (2 ft) thick lifts of soil were also placed in unsuccessful attempts to control the leachate outbreaks. Finally, an approximately 3 m (10 ft) thick lift of soil was placed over the toe. The soil fill then extended into Cell 1 the distance shown by the line at approximately a 1V:2H slope. The abundance and magnitude of the outbreaks were probably attributable to leachate recirculation, surface water infiltration, and the lowest portion of the cell being along the toe of the interim waste slope. In addition, the permanent sump is located at the northeastern end of the cell separation berm (see Figure 1) and thus a large distance away from the location of cross-section B-B'. Therefore, it was concluded that leachate was building up behind the low permeability cell separation berm and causing the leachate outbreaks.
