Waste Age®

February 2001

Avoiding the Slippery Slope

By V.L. Wilson, W.D. Evans and T.D. Stark

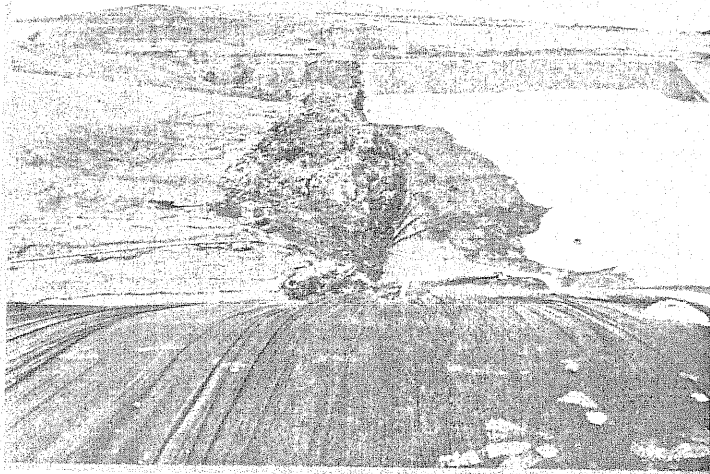
Workers examine terraces in the soil fill, the excavated soil placed at the top of slope and the damaged geomembrane at the slope's toe.

To investigate the potential for damage to the composite liner system a significant portion of the soil fill was excavated. Wrinkled and torn geomembrane was discovered in the portions of the liner system outside of the active cell area indicating that the failure plane occurred within the cover soil in the active cells. The sliding occurred at the interface between the compacted clay liner and the smooth geomembrane in the active and developing cell. However, operators also suspected that some of the damage was due to the saturated soil fill slumping or bulging into Cell 1.

To repair the facility, operators had to remove the soil fill, waste and damaged geomembrane, then replace the composite liner system's damaged portions.
