Title of Paper (maximum eight words): The 10 July 2000 Payatas Landfill Slope Failure

The 10 July 2000 Payatas Landfill Slope Failure

ABSTRACT: *This paper presents an investigation of the slope failure in the Payatas landfill in Quezon City, Philippines. This failure occurred 10 July 2000, after two weeks of heavy rain from two typhoons and killed at least 278 people. Slope stability analyses indicate that the raised leachate level, existence of landfill gas created by natural aerobic and anaerobic degradation, and a significantly over steepened slope contributed to the slope failure. The Hydrologic Evaluation of Landfill Performance (HELP) model was used to predict the location of the leachate level in the waste at the time of the slope failure for analysis purposes. This paper presents a description of the geological and environmental conditions, identification of the critical failure surface, and a slope stability analysis to better understand the failure to present recommendations for other landfills in tropical areas. In addition, this case history is used to evaluate uncertainty in parameters used in back-analysis of a landfill slope failure.*

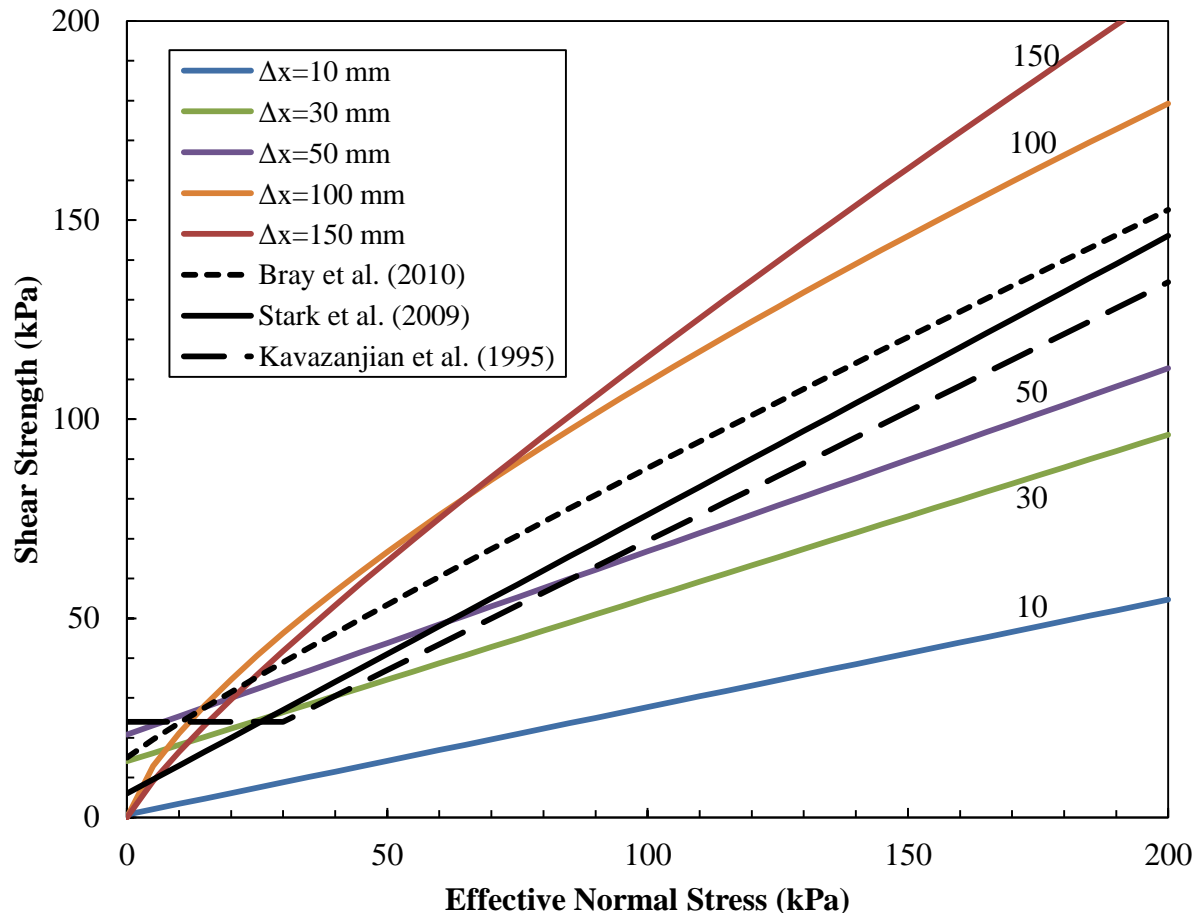
Figure 10. MSW shear strength envelopes.

In addition to being dependent on the effective normal stress on the failure plane, the shear strength of MSW is also shear displacement or axial strain dependent and tends to increase with increasing deformation (Eid et al. 2000). Review of existing laboratory data show that most of the laboratory shear tests investigated are not continued to sufficient displacement or strain to mobilize the peak shear strength of the MSW. As a result, Stark et al. (2009) provide MSW shear strength envelopes mobilized at horizontal displacements of 10, 30, 50, 100, and 150 mm. Table 3 shows equations for each strength envelope estimated from direct shear tests, where R^2 values are all above 0.90. For horizontal displacements of 10, 30, and 50 mm, the strength envelopes are linear and can be described by Mohr-Coulomb cohesion and friction angle parameters. As the displacement increases to 100 mm, the strength envelopes are stress dependent and described by a power trend with no apparent cohesion. Figure 10 compares the shear strength envelopes in Table 2 to envelopes recommended by others (e.g., Stark et al., 2009; Bray et al., 2010; Van Impe, 1998; Eid et al., 2000). As highlighted in Figure 10, all of the recommended envelopes fall between the 50 and 100 mm of shear displacement strength envelopes. In fact, for effective stresses lower than 200 kPa, recommended strength envelopes are about average of these two displacements.

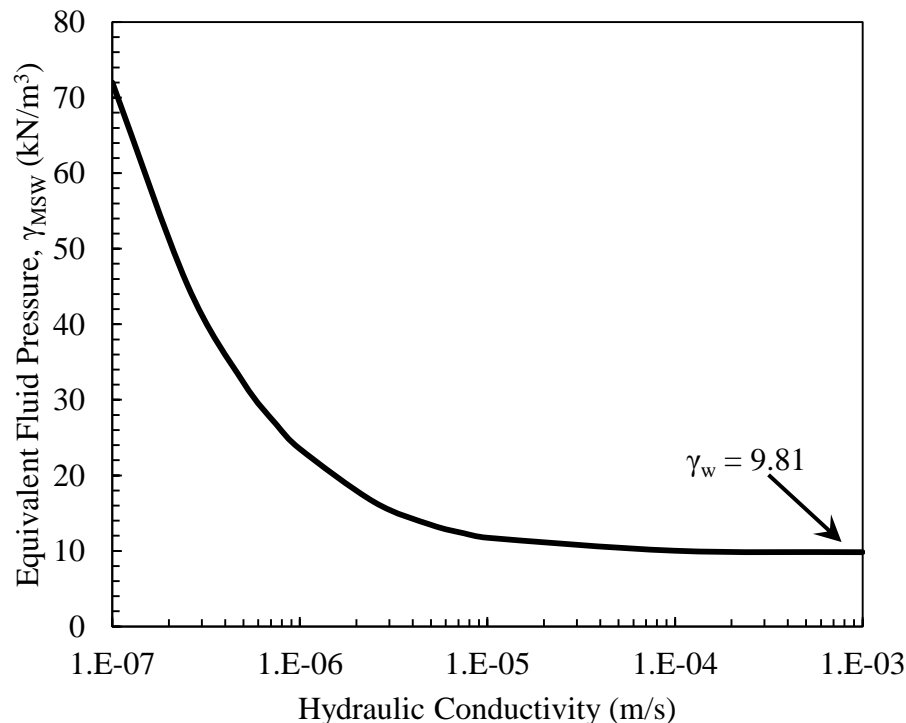
Figure 12. Dependence of equivalent fluid unit weight, $\gamma_{\text{fluid, equivalent}}$ on MSW saturated hydraulic conductivity, $K_{\text{waste, sat}}$

degradation. In landfills that are sufficiently dry, landfill gas migrates readily through the pore space and is released into the atmosphere with little build-up of pressure in the waste. However, as saturation levels in the waste rise, the permeability of the waste to landfill gas migration decreases. Merry et al. (2006) use a one-dimensional (1-D) column of saturated media where degradable waste exists only in the lowest portion of the column to model this situation. This model shows that below the level of saturation, the steady state excess gas pressure increases linearly similar to a hydrostatic condition. The combination of hydrostatic leachate pressure and gas induced pore pressure may be accounted for using an equivalent fluid unit weight for the pore fluid that is artificially higher than water. A subsequent parametric study of the input parameters shows that the equivalent fluid unit weight of the pore fluid is dependent on waste hydraulic conductivity (Merry et al. 2006). The corresponding MSW hydraulic conductivity for this case is to be assumed greater than 1×10^{-5} m/s. Figure 12 shows the relationship between waste hydraulic conductivity and equivalent fluid unit weight of the pore fluid used to estimate an equivalent fluid unit weight. The input parameters for Figure 12 are provided in Table 5. The gas generation rate (Q_i) is estimated by Eq. (1):

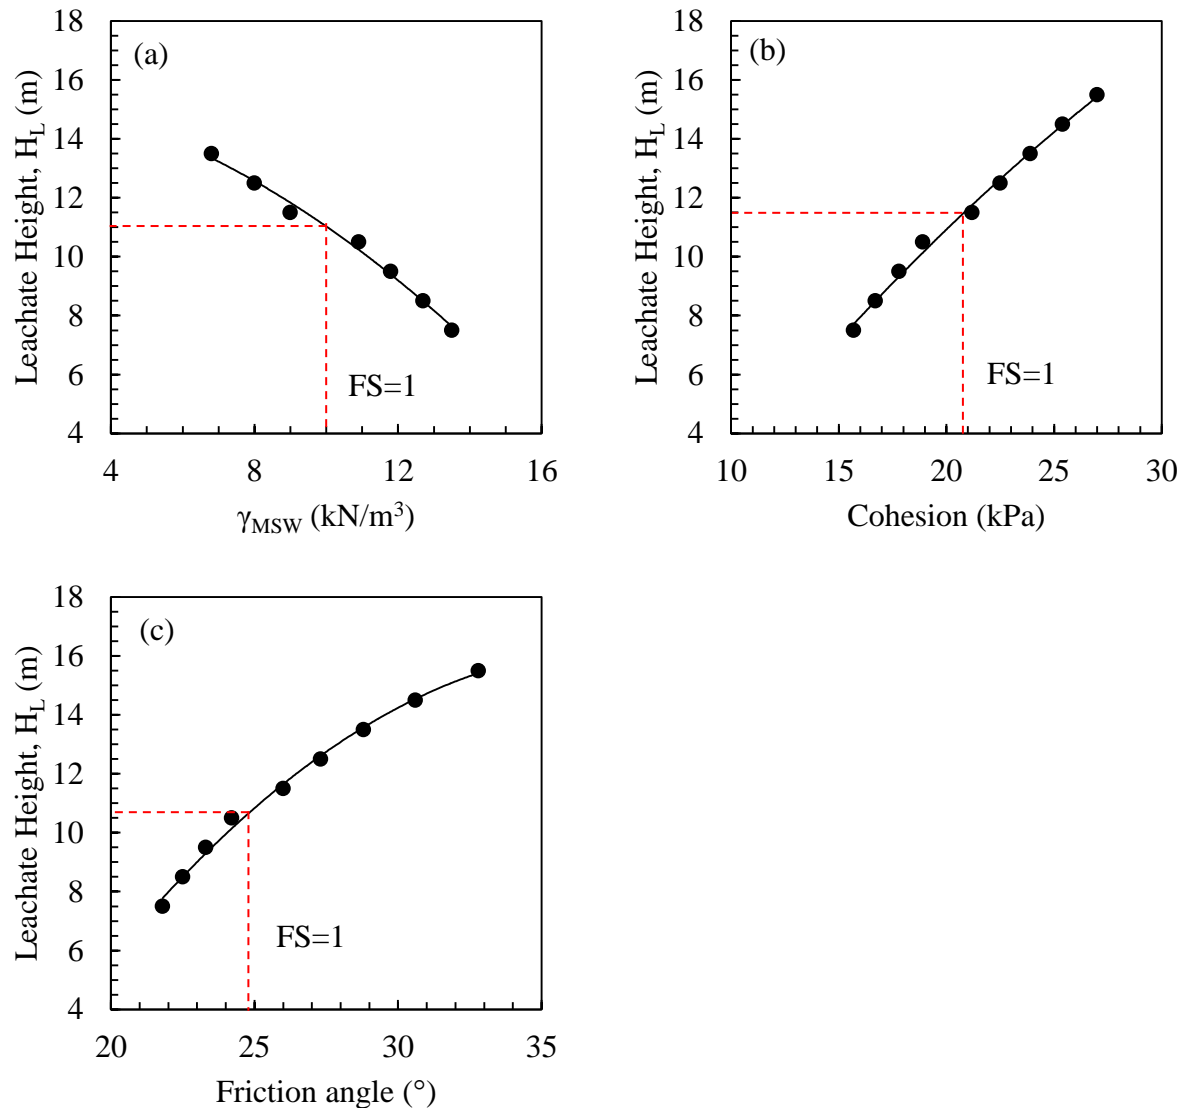
Figure 14. Sensitivity of Inverse analysis to MSW input parameters for FS of unity.

Using site reconnaissance information, pictures, and reports of the wasteland, the slope geometry, gas pressure, MSW shear strength and unit weight were estimated so an inverse analysis could be conducted to estimate the piezometric level at the time of failure. Figures 14(a), 14(b), and 14(c) show the sensitivity of estimated leachate level to the range in MSW shear strength parameters and unit weight. For each sensitivity parameter, the leachate level, H_L , was varied from 7.5 m to 15.5 m in one meter increments and the MSW unit weight, cohesion, and friction angle parameters were back-calculated using the circular failure surface in Figure 11(a) such that the computed FS equaled unity. The sensitivity analyses indicate that slight changes to each of the three MSW properties affect the leachate level at failure. For example, Figure 14(a) indicates that increasing the MSW unit weight by 2 kN/m^3 reduces the leachate height at failure by 1.7 m or 15% of 11.5 m. As expected, the driving forces from increased unit weight are contributing to slope instability. Figures 14(b) and 14(c) show that reducing the cohesion and friction angle by 1 kPa and 1° , respectively, reduces the leachate level on average by 0.7 m or 6% of 11.5 m. This shows that a slight reduction in shear strength, e.g., due to thermal degradation, along the failure surface can decrease the leachate level required for a computed FS of unity. A red dashed line drawn from the estimated MSW value in the stability analyses is also shown Figure 14 and is used to estimate the leachate height corresponding to a computed FS of 1.0. Based on these results, the recommended MSW unit weight, cohesion, and friction angle are 10 kN/m^3 , 20.8 kPa, and 24.7° , respectively; and the leachate height corresponding to a computed FS of unity are 11 m, 11.5 m, and 10.7 m, which is in generally good agreement with the values obtained from the HELP model and the inverse stability analyses.
