Differential Movement at Embankment-Bridge Structure Interface in Illinois

JAMES H. LONG, SCOTT M. OLSON, TIMOTHY D. STARK, AND EMILE A. SAMARA

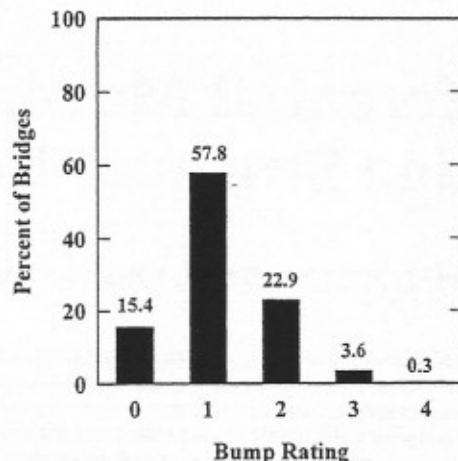
Figure 1 displays the results of all of the approaches surveyed in the visual survey. Approximately 15 percent of the approaches surveyed exhibited no noticeable bump at either the embankment/structure interface or the pavement/approach slab interface. Approximately 58 percent of the approaches exhibited a slight differential movement, usually less than 25 mm. Therefore, approximately 73 percent exhibited satisfactory performance for differential movement at the approach-structure interface. The remaining 27 percent exhibited poorer performance, with approximately 4 percent exhibiting differential movements greater than or equal to approximately 75 mm (ratings 3 and 4). Thus, approximately 46 of the 1,181 approaches surveyed exhibited a differential movement greater than or equal to about 75 mm and thus required repair. Overall, approximately 85 percent of the bridges surveyed exhibited some differential movement (ratings 1, 2, 3, and 4).

FIGURE 1 Ratings for all visual survey data, 1,181 approaches.

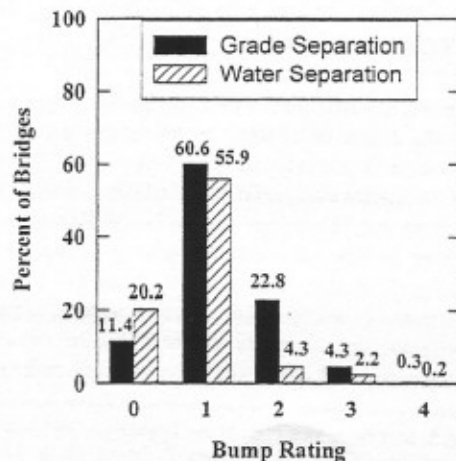
A comparison between bridges that are grade separations (e.g., highway or railroad crossings) and those that are water crossings (e.g., creeks, rivers, or lakes) is shown in Figure 2. During the survey, 578 approaches were identified as grade separations and 494 ap-

Previous investigations (2,11,19) suggested that water crossings usually are associated with larger differential settlements because of the compressible, saturated soils usually located near water crossings. Figure 2 fails to support this observation. The survey results indicated similar behavior for grade separations and water crossings, with a smaller percentage of water crossings showing readily recognizable differential movements. This probably was a result of the water crossings often being small creeks with minor embankments, but a large portion of the grade separations have approach embankments greater than 8 m in height.

FIGURE 2 Effect of type of crossing on bump rating.

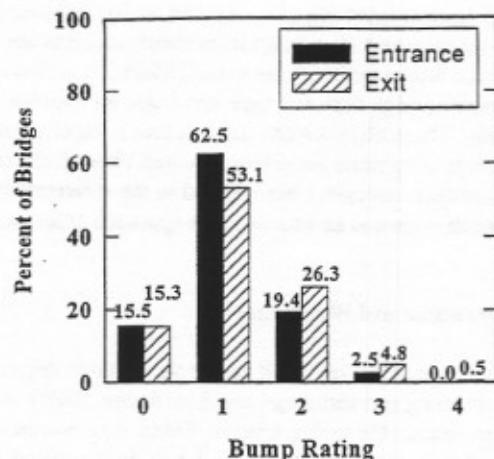
Bridge approach entrances and exits are compared in Figure 3. IDOT districts report that differential movements are equally likely

FIGURE 3 Entrance and exit approach comparison.

for entrances and exits; however, Figure 3 indicates that approach exits exhibit somewhat poorer behavior than entrances (ratings 2, 3, and 4). The difference may be caused by vehicles riding off the bridge structure, landing on the subsided exit slab, and generating an impact loading, or the differences simply may be a result of the limited number of observations.

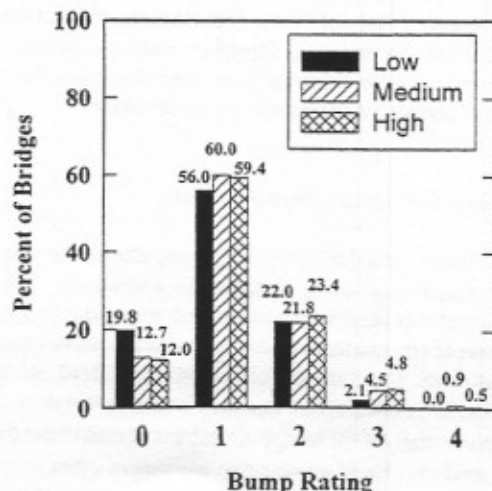
Figure 4 illustrates the effect of embankment height on approach differential settlement. Medium and high embankments display

FIGURE 4 Effect of height of approach embankment on bump rating.

nearly identical behavior, which is only slightly worse than the approach embankment-structure interface behavior exhibited by low embankments. The only significant differences are for ratings of 0 and 3. Low embankments were given a rating of 0 more often than medium and high embankments. Low embankments also received a rating of 3 less often than medium and high embankments. In summary, these data suggest that higher embankments (greater than 8 m high) are more susceptible to differential movement at the approach-bridge interface than low embankments (less than 3 m high).
