Back-analysis of a PVC geomembrane-lined pond failure

T. D. Stark¹, E. J. Newman² and R. L. Aust³

REFERENCE: Stark, T. D., Newman E. J. & Aust, R. L. (2008). Back-analysis of a PVC geomembrane-lined pond failure. *Geosynthetics International*, 15, No. 4, 258–268. [doi: 10.1680/gein.2008.15.4.258]

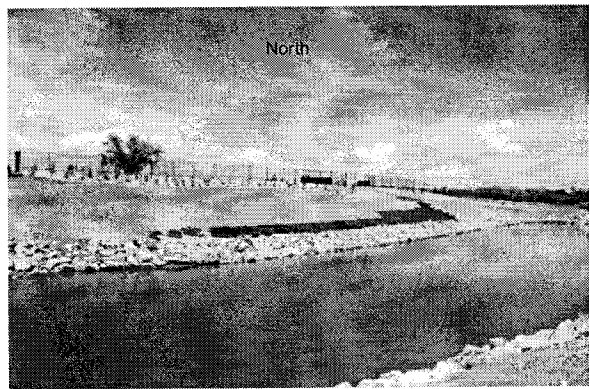
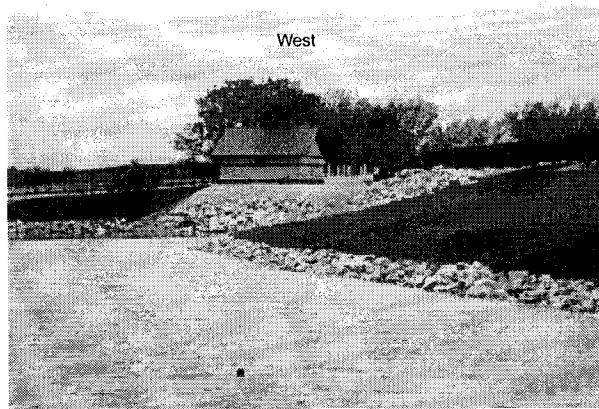
Figure 1. Water storage pond and pump station (a) during and (b) after construction

By comparison, the analyses performed herein show a factor of safety greater than unity for case 1 (factor of safety = 1.12) and case 2 (factor of safety = 1.19). These two factors of safety are in agreement with field observations of the slope being stable after construction and pond filling (see Figure 1). The factor of safety is higher for case 2 (pond full) than case 1 (end of construction) because the water provides some buttressing effect to the slope. The slope became unstable with the pond full and the occurrence of a significant rainfall that was modelled using the intermediate water level.
