Evaluation of Seepage from an Embankment Dam Retaining Fly Ash

Abstract: Observations, data, and analyses used to investigate the cause of fly ash-laden seepage from the right abutment of an earthen dam are presented herein. The investigation shows that the sediment-laden seepage occurred through permeable/jointed bedrock in the right abutment that was exposed by a landslide prior to construction of the dam. When the level of the impounded fly ash reached the level of the prior landslide, the fly ash-laden seepage migrated through the jointed bedrock of the abutment and exited on the downstream right abutment. The joint bedrock was exposed to the fly ash reservoir because the landslide removed the clayey colluvium and/or residual soil overlying the jointed bedrock that formed a natural impervious barrier to seepage. This sediment-laden seepage initially was a great concern because of the potential for erosion and piping in earth dams. However, the rapid investigation into and subsequent monitoring of the seepage revealed that accumulation of fly ash and other coarser particles created a filter cake that reduced the seepage and eventually sealed the joints and fractures in the sand

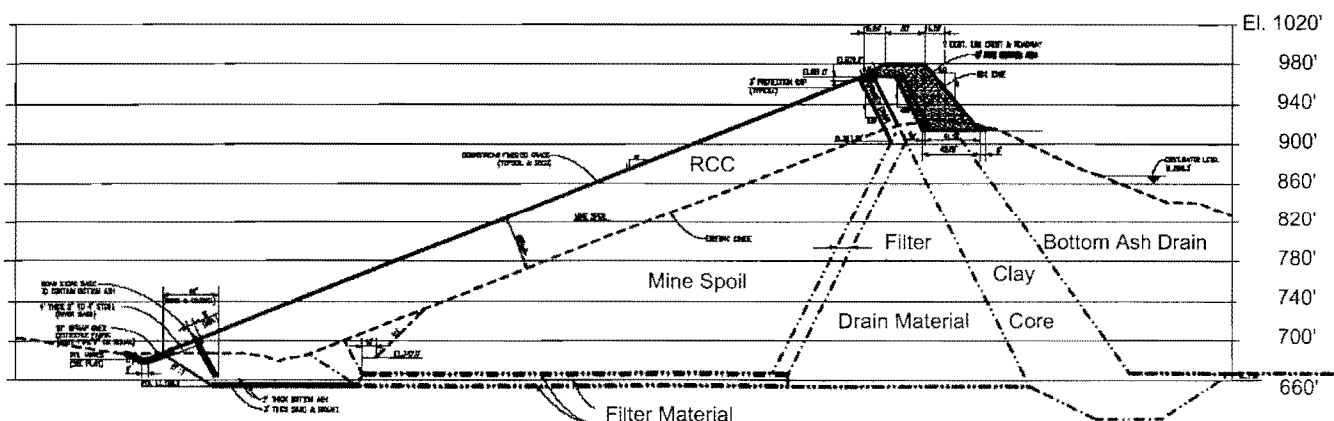
Fig. 2. Cross section of FAD2

FAD2 consists of a 67 m (220 ft) high arched embankment with a roller-compacted concrete (RCC) upstream face and emergency spillway channel. The spillway channel is located in a cut through rock of the left abutment. The dam has a crest elevation of 296 m (970 ft), a crest width of 10 m (30 ft), and is 427 m (1,400 ft) long. The RCC upstream face has a 0.83H:1V slope and is constructed in 0.3 m (1 ft) stair-stepped lifts above elevation 279 m \pm 1.5 m (915 \pm 5 ft). The upstream slope below the RCC slope is 2.5H:1V and consists of soil. A central clay core and 3 m (10 ft) of bottom ash (sandlike) material chimney drain provides seepage control through the dam. The downstream slope of FAD2 is 2.5H:1V and is protected from surface erosion with a vegetative cover. A general cross section of FAD2 showing the final dam raising is presented in Fig. 2.
